INSPECTION REPORT NO. XX

VISUAL CHECKING THE QUALITY OF CARGO, TALLY COUNT SEALING OF CONTAINER, PHOTOS REPORT.

CARGO : EGGS

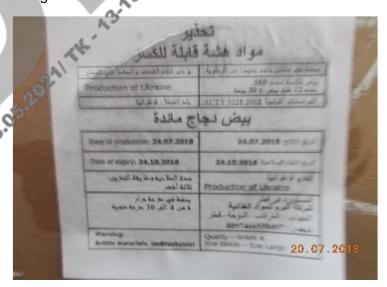
Each carton has the marking.

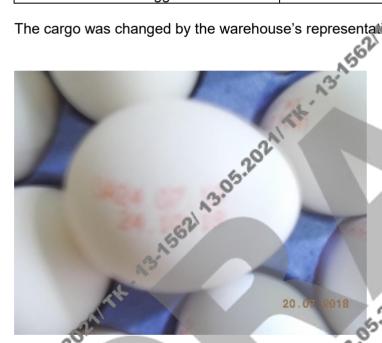
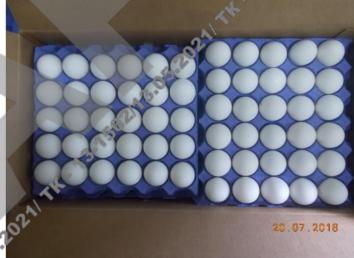
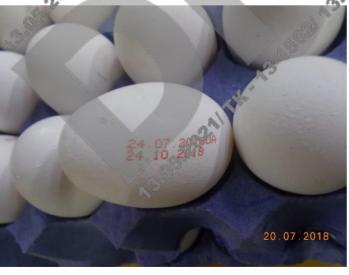
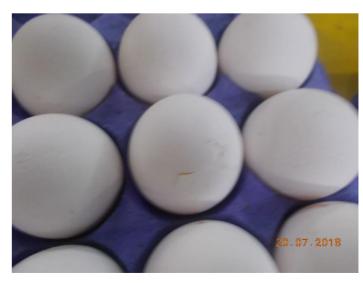
Egg breakage, pcs	Cracked,pcs	Dirty egg shells,pcs
11 eggs	13 eggs	16 eggs

The cargo was changed by the warehouse's representatives in presence of CISS inspector.

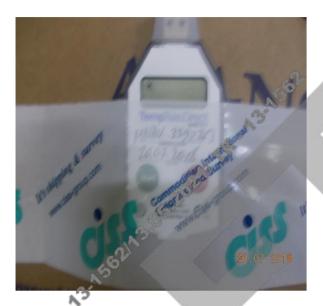
In accordance with instructions CISS inspector installed 1 pcs of TempTale Direct during the loading supervision putting it in the middle of container MNBU3392763.

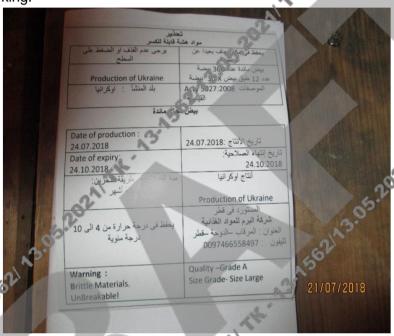
Each carton has the marking.

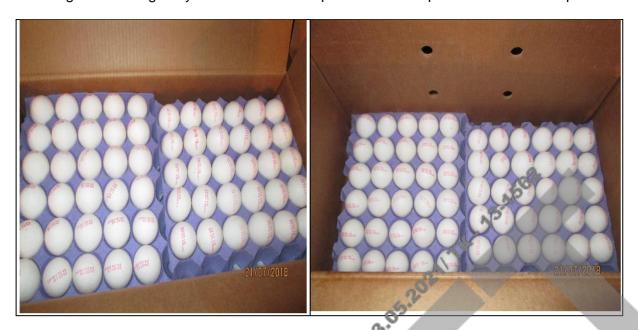
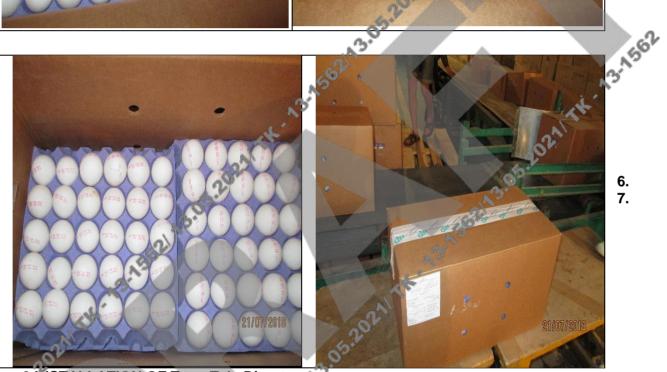
V,2.		
Egg breakage, pcs	Cracked,pcs	Dirty egg shells,pcs
3 eggs	1 eggs	- eggs

The cargo was changed by the warehouse's representatives in presence of CISS inspector.

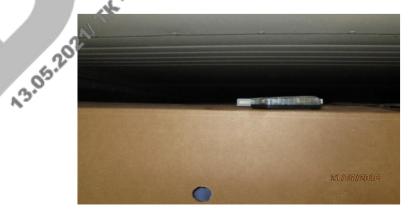
In accordance with instructions CISS inspector installed 1 pcs of TempTale Direct during the loading supervision putting it in the middle of container MNBU0062691.

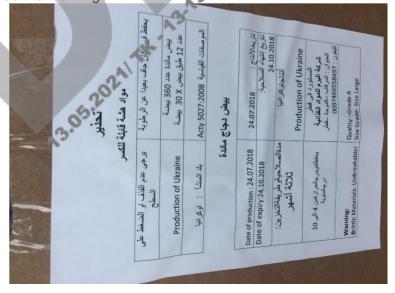
Each carton has the marking.

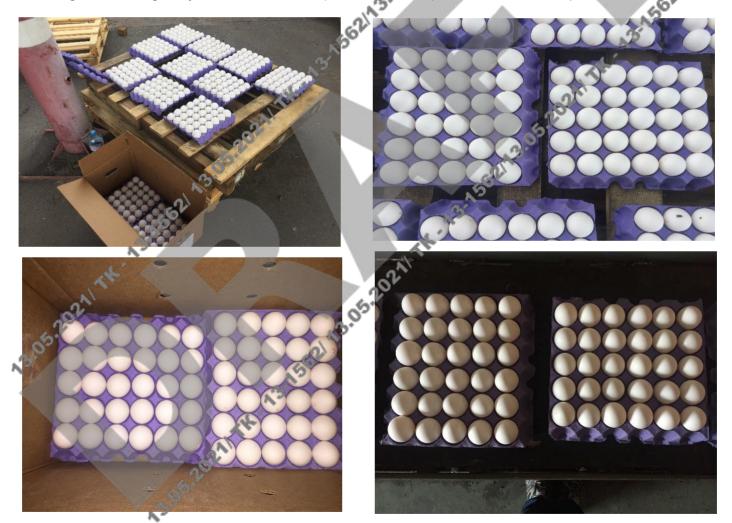
- Al	
Egg breakage, pcs	Cracked,pcs	Dirty egg shells,pcs
8 eggs	0 eggs	62 eggs

The cargo was changed by the warehouse's representatives in presence of CISS inspector.

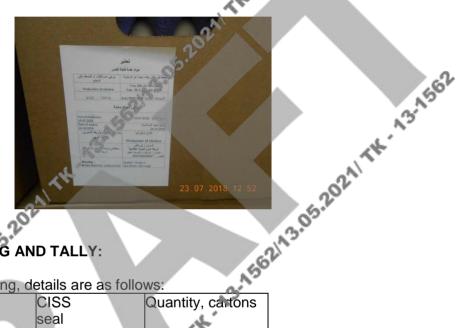
Each carton has the marking.

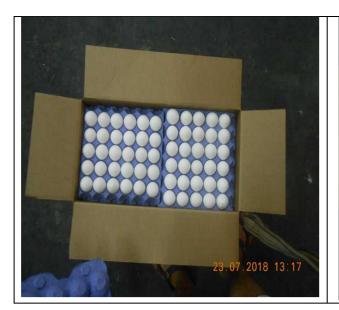
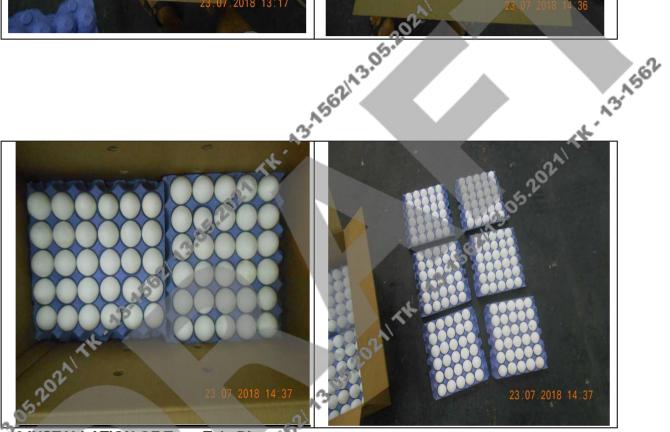
, A	5	
Egg breakage, pcs	4.	Cracked,pcs	Dirty egg shells,pcs
0 eggs	'Ale	0 eggs	0 eggs
