VESSEL GENERAL CONDITION INSPECTION REPORT

Tug boat "H.N. HODDER"

Address of inspection: 16031 River Road, Richmond,
B.C. Canada V6V 1X5
Date of inspection: October 10-th, Oct.13-th 2024
Time of inspection: 12:50 – 4:00 PM, 9:30-11:30 AM
CUSTOMER: Hodder Tugboats CO. LTD.

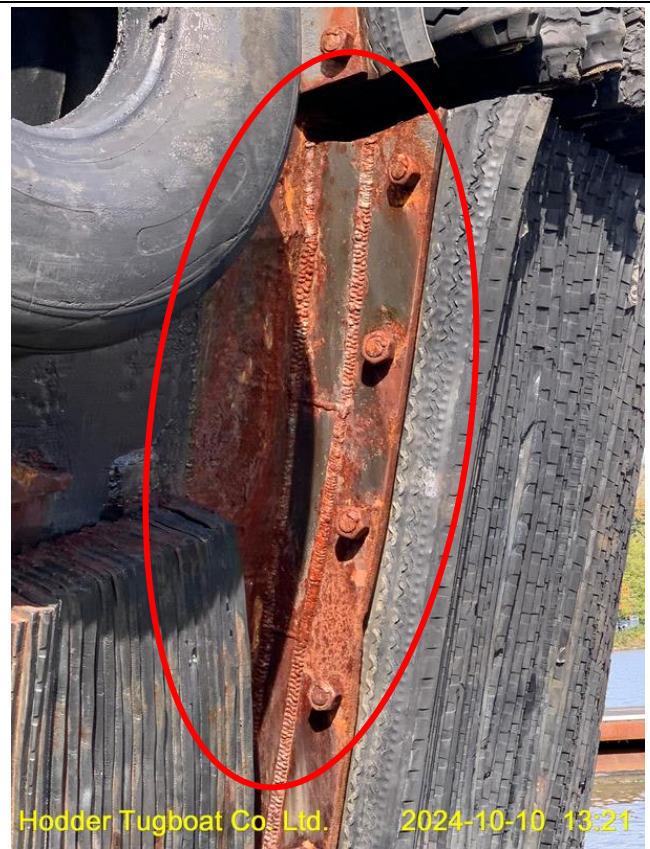
Close-up view of rusted metal surface (including welded seams and bolts) on the bow fender holders

Hull: Sandblasting of the hull and fendering system (metal parts, bolts) is necessary, followed by the removal of rust and the application of primer paint and multi-layer anti-corrosion coatings. Additionally, hull thickness should be measured in critical areas, with possible local repairs or replacement of metal panels.

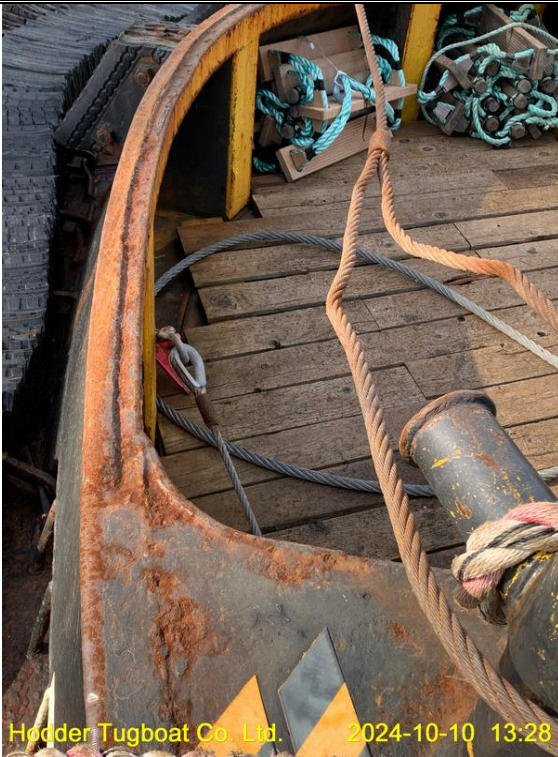
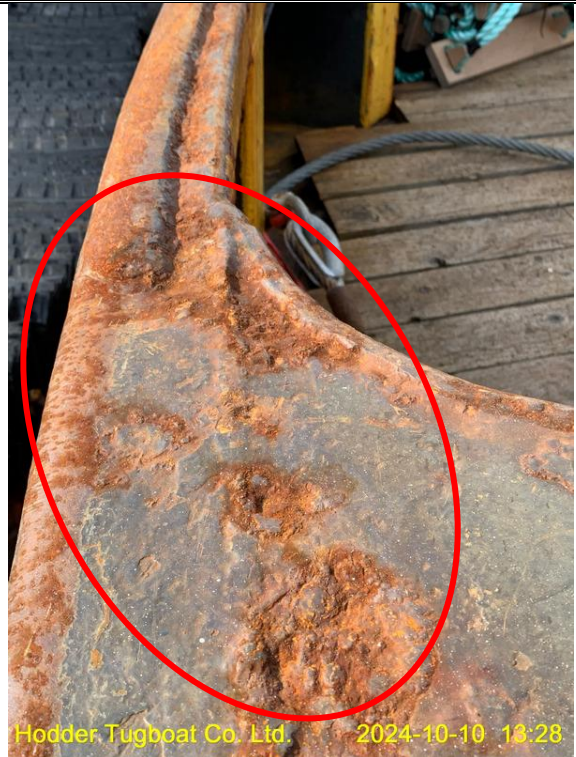
The rusted and visibly pitted starboard side of the boat

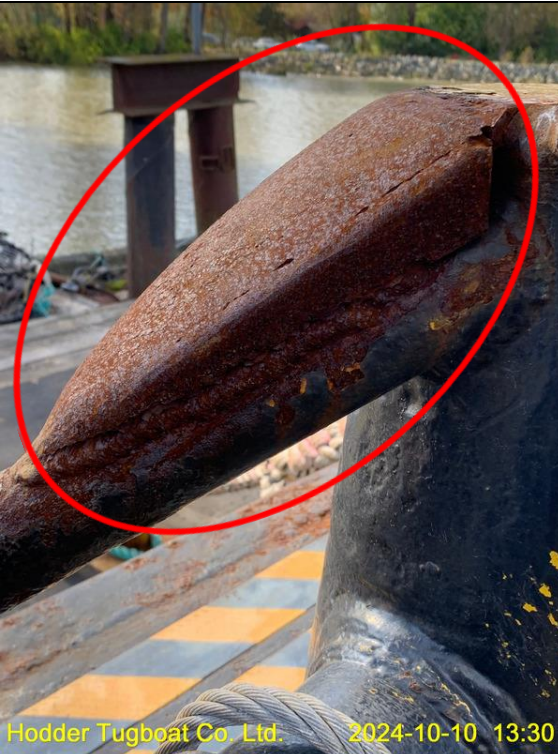
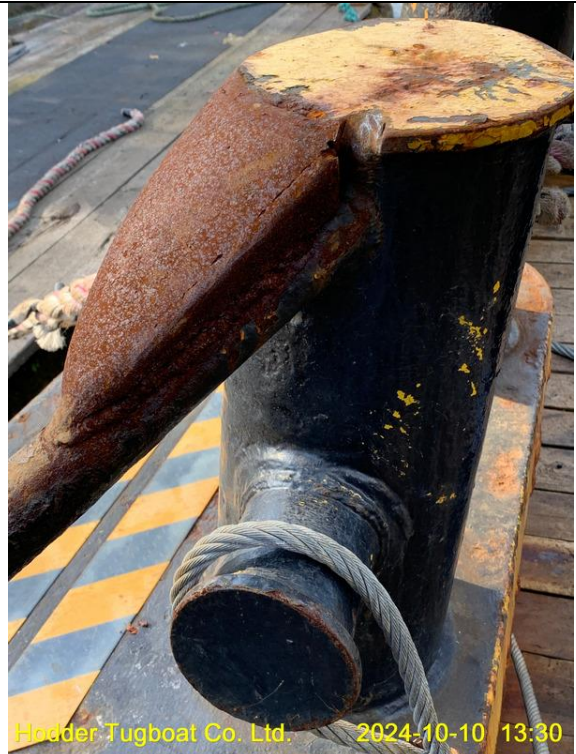
The boat's substantially rusted bollard mount

Mooring Equipment: All corroded fastening elements should be replaced. Servicing of winches and tension mechanisms should be conducted. Braking lines should be inspected thoroughly. Structural load-bearing parts and force transmission systems should be inspected and repaired.

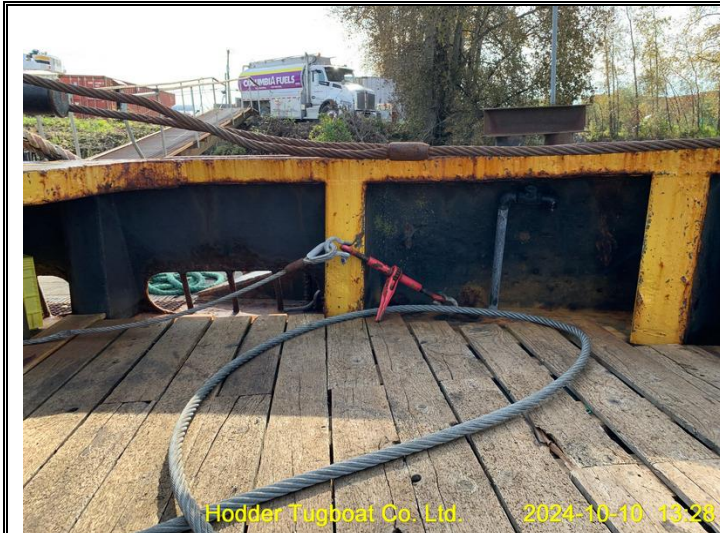
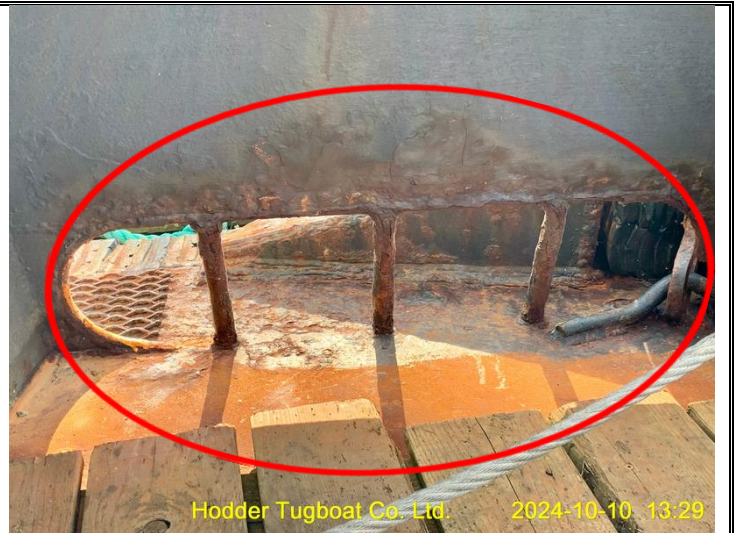
Rusted waterway of the boat's deck

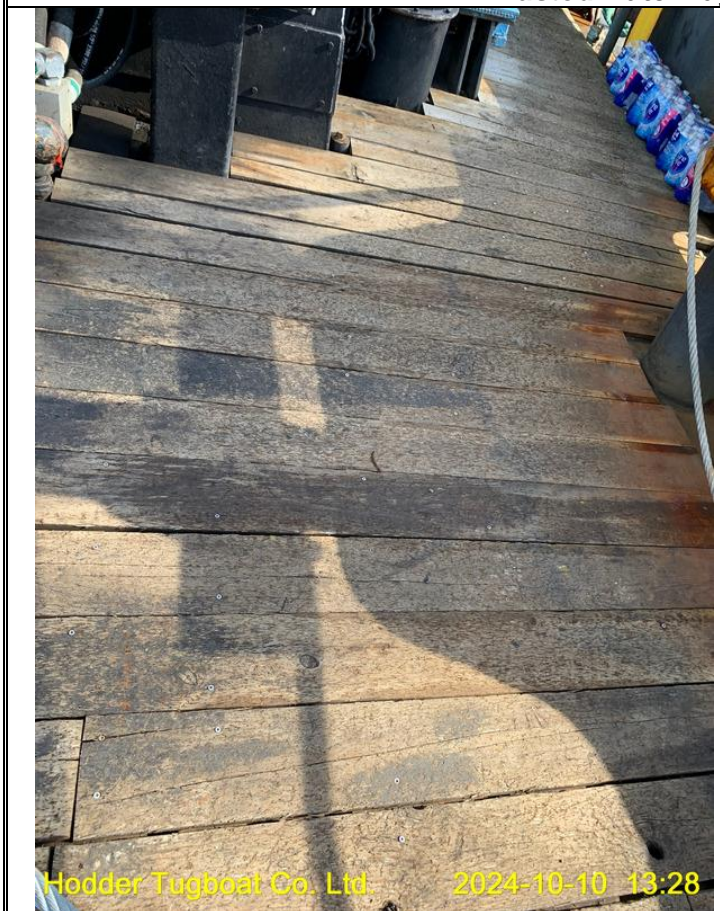
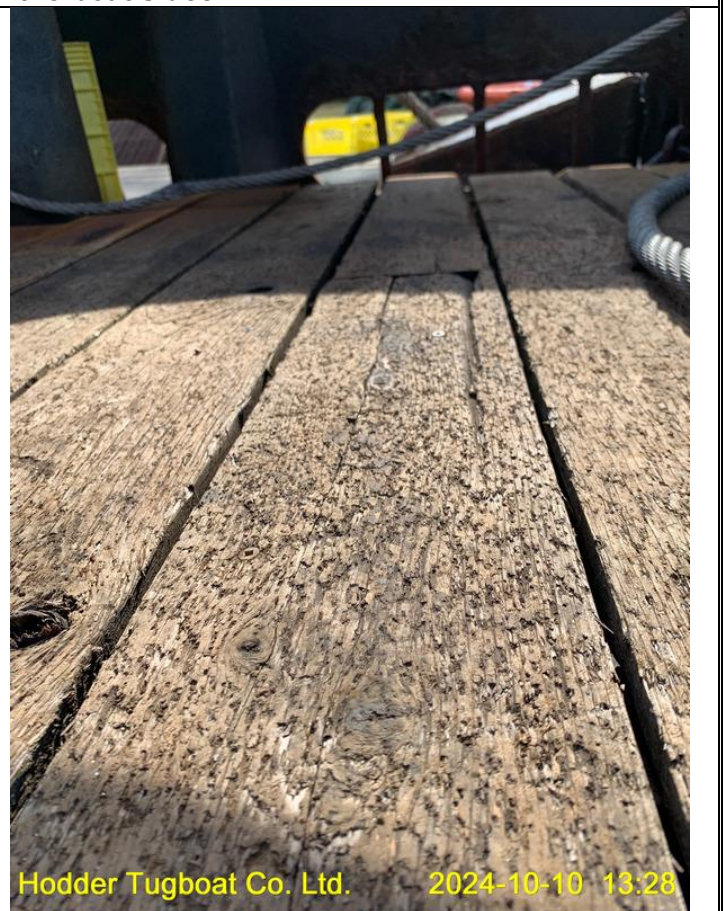
The wooden deck covering shows severe wear and biological/physical damage. The surface is deformed, potentially compromising crew safety. Replacement of damaged deck sections is required.

Condition of the wooden flooring of the deck

Deck: The complete replacement of the wooden deck covering is recommended, using panels treated with antiseptic and anti-corrosion compounds capable of withstanding marine conditions.

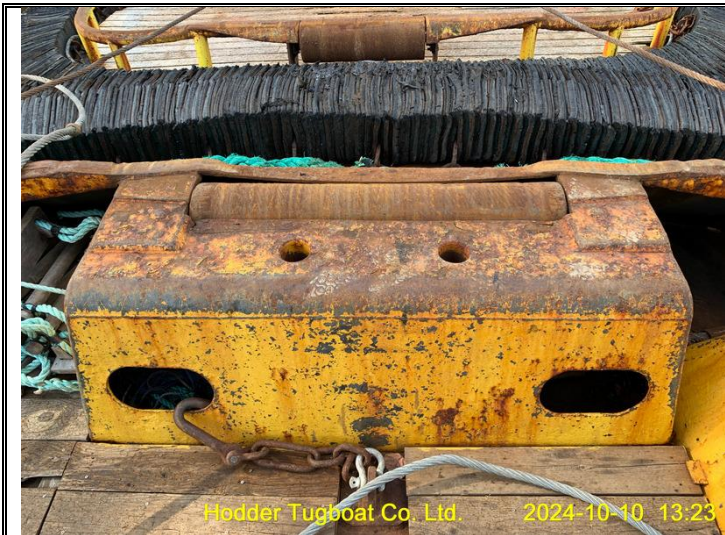
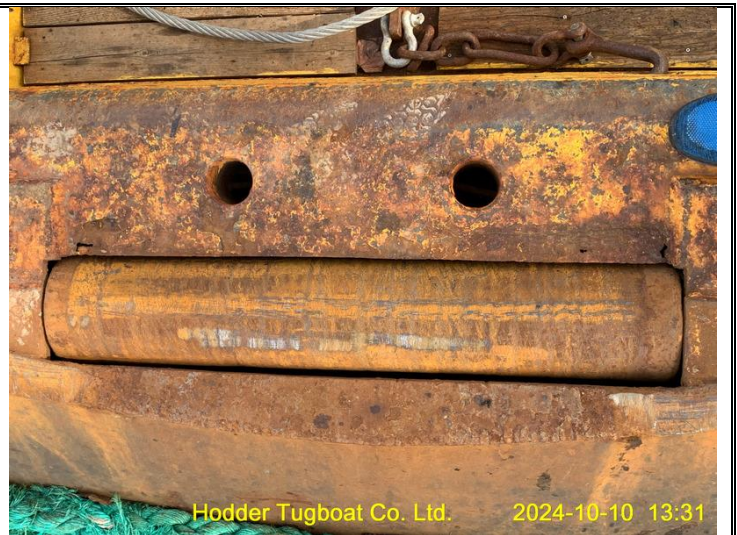
Rusted fairlead roller and foundation

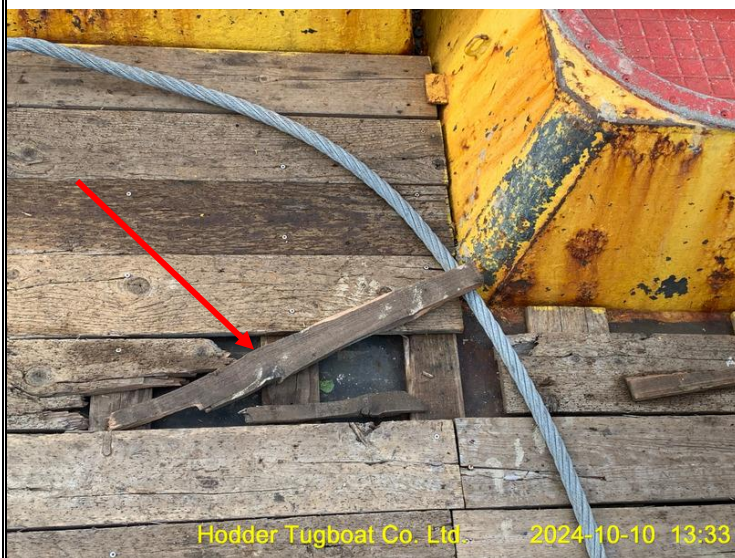
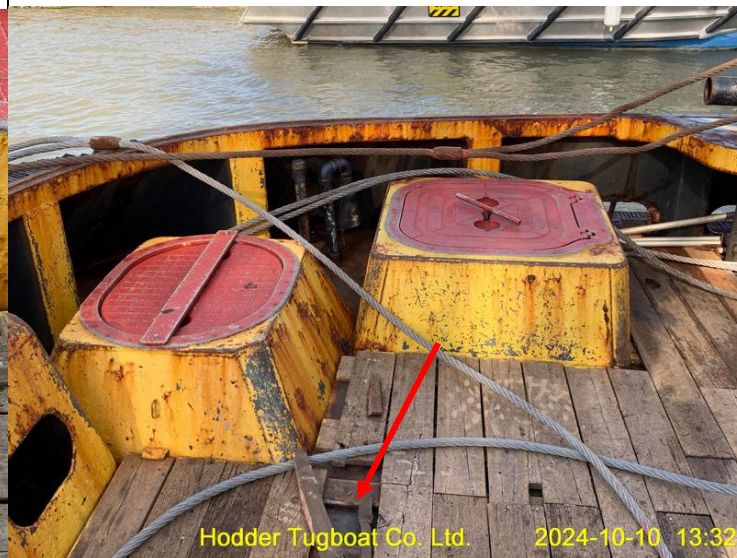
Damaged wooden deck flooring next to the emergency exits from the engine room

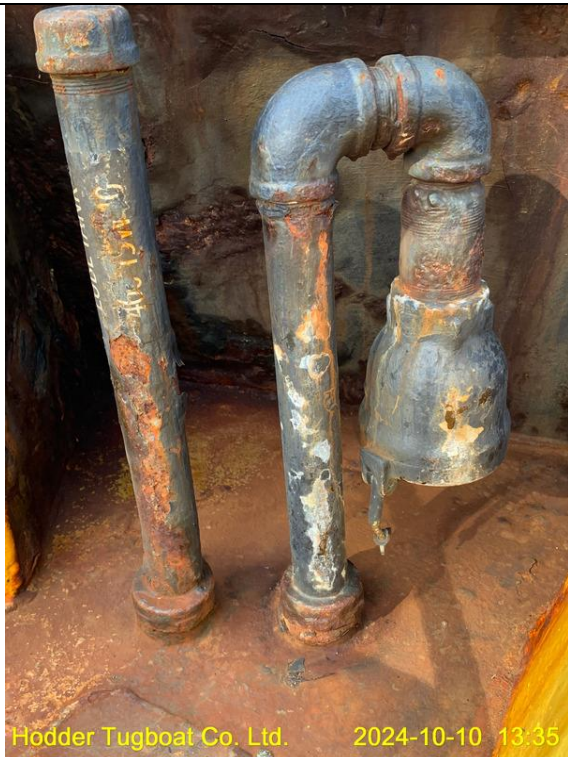
Rusted lube tank pipes and vent/air pipes

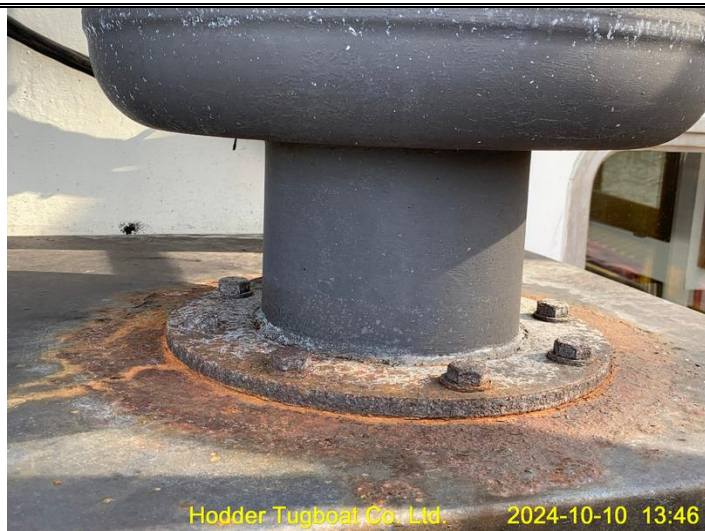
Rusty exhaust pipe mounting

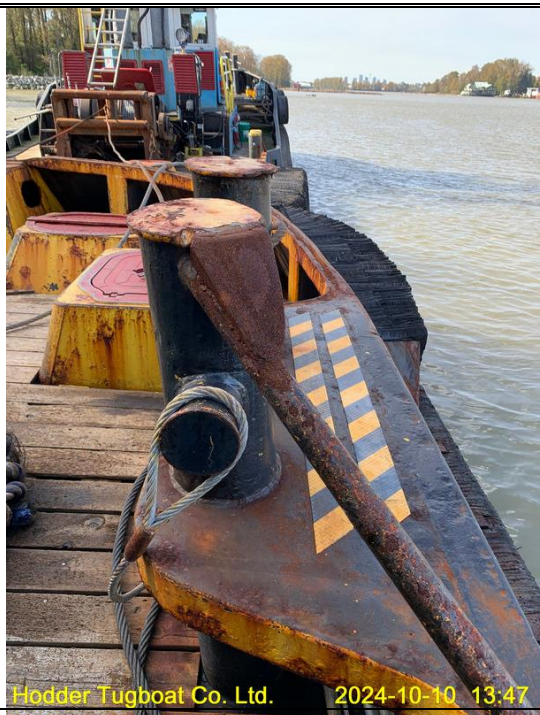
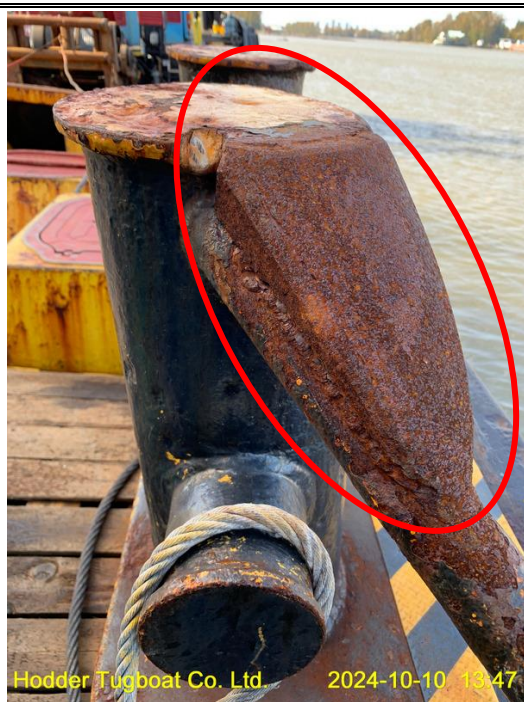
Port side rusted bollard mount

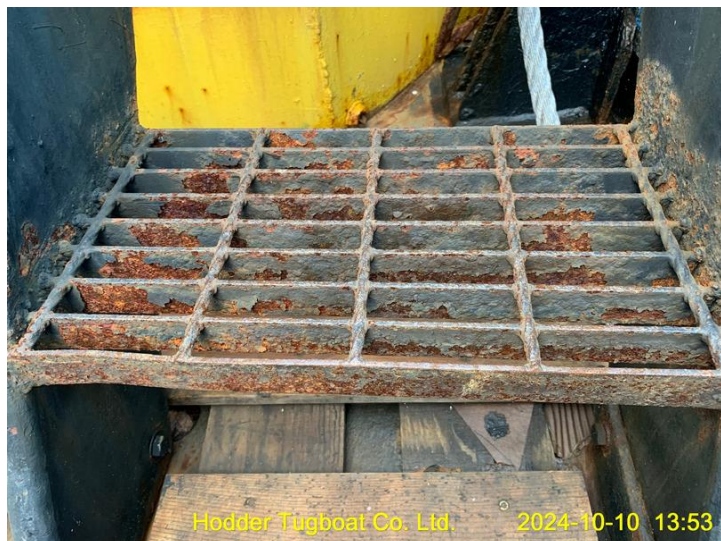
Rusted metal grating

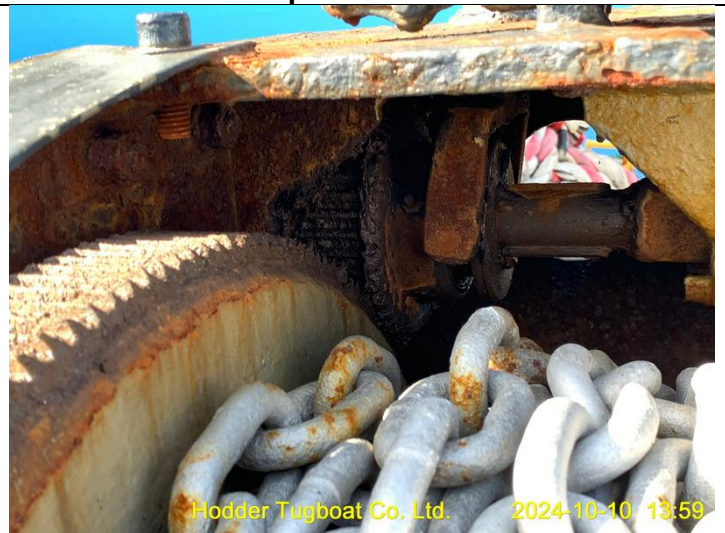
The bow deck is fitted with a drum-type anchor windlass equipped with a large reserve of anchor chain, coiled on the drum. The windlass and chain show signs of corrosion, indicating the need for repair or, at the very least, anti-corrosion treatment. Despite the corrosion, if the mechanical components (gears, shafts, axles) are operational, the equipment can be restored with minimal cost.

Rusty gear/anchor winch station close-up

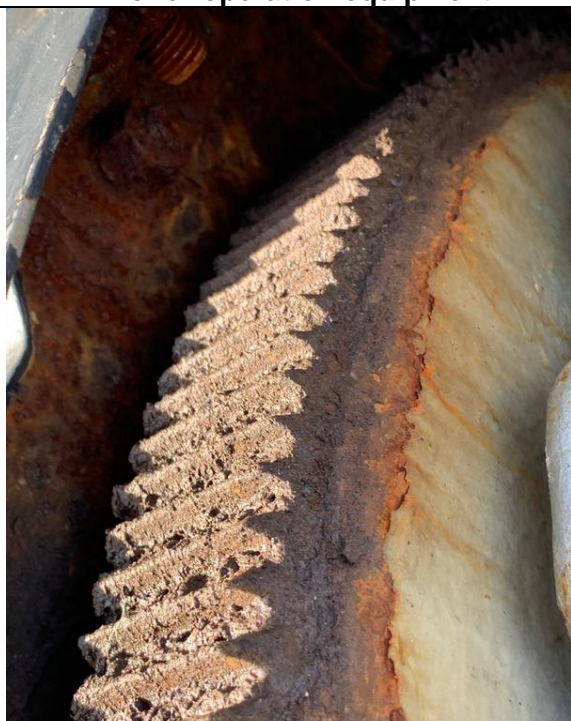
Corrosion on the cogwheel

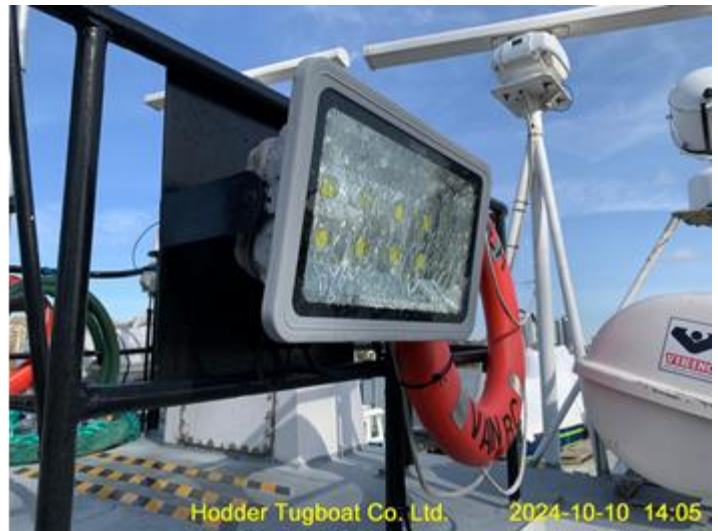
Broken spotlight

Two spotlights, each with a power of up to 500 watts, are mounted on the flybridge handrails on both the starboard and port sides. The spotlights are rated IP65, indicating they are dustproof and waterproof. These lights provide additional illumination for the vessel's lateral hemispheres, ensuring safety during docking maneuvers at night or in poor visibility conditions. The lens of the starboard spotlight is damaged and cracked, which may lead to loss of sealing and failure of the LED arrays. To maintain functionality, the glass should be replaced and resealed or a new spotlight installed.

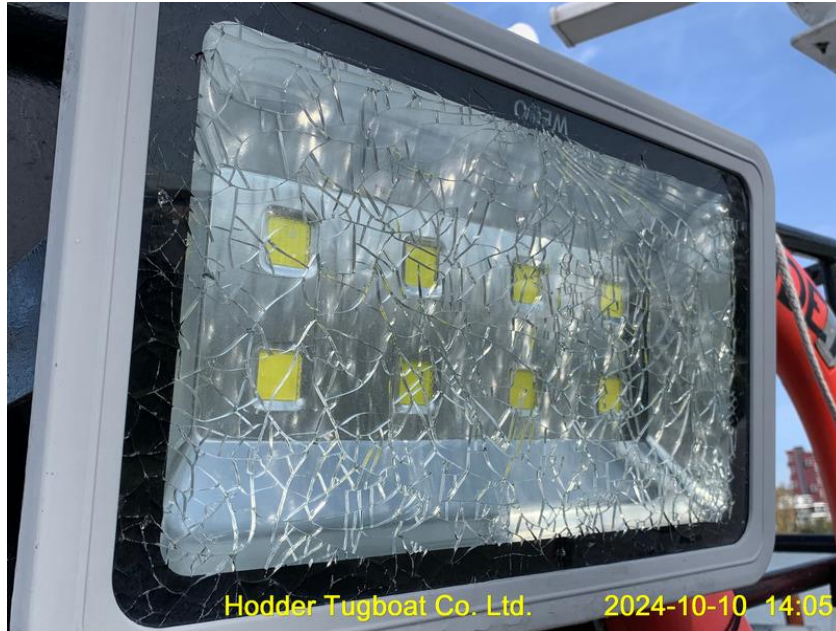
Broken spotlight

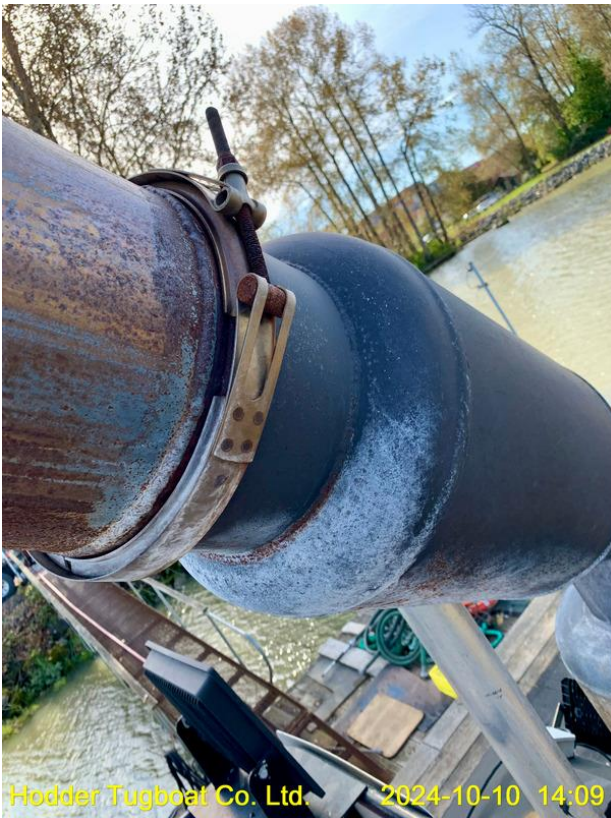
Close-up rust on an exhaust pipe

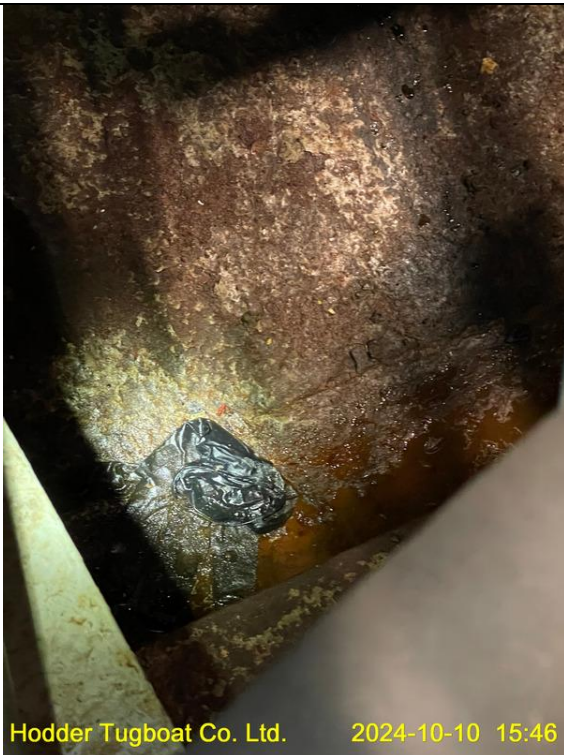
Rusty section of a hull
