SURVEY REPORT

INSPECTION AT DOCKYARD AFTER FIRE ACCIDENT

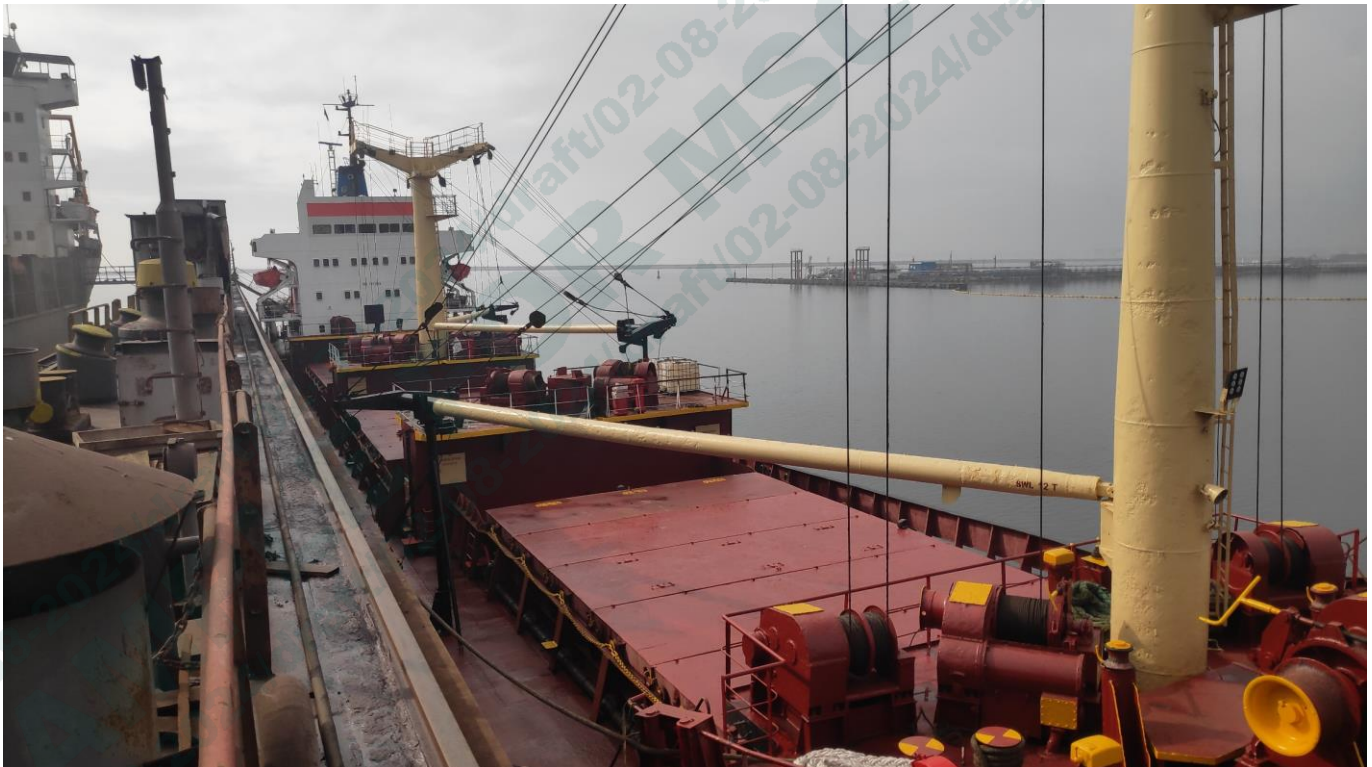
General view at dockyard.

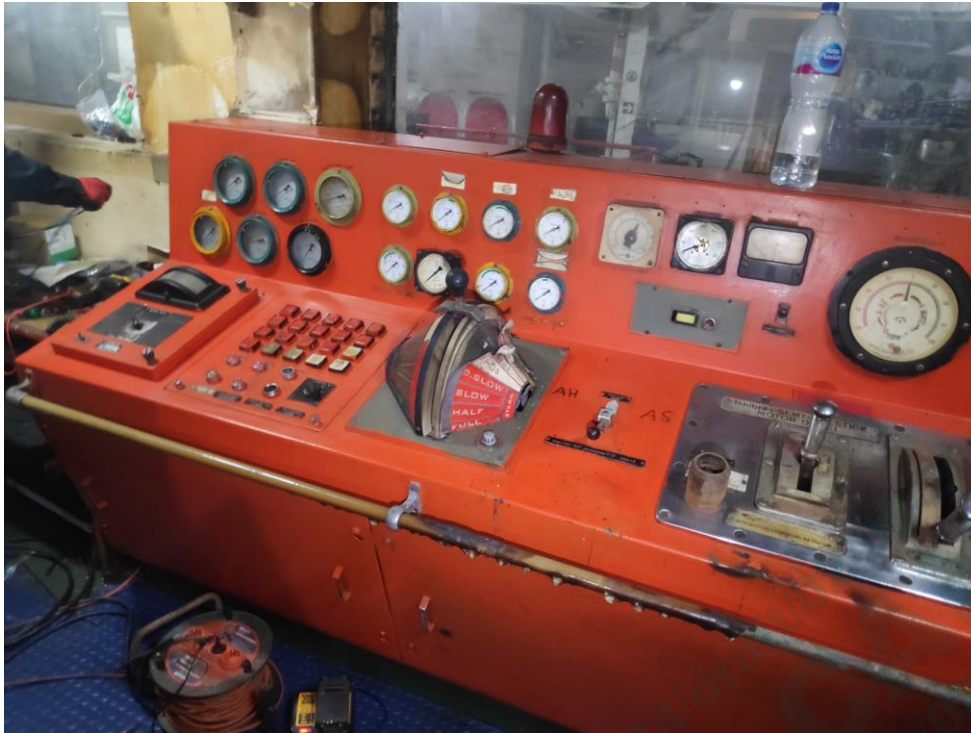
Main Switchboard.

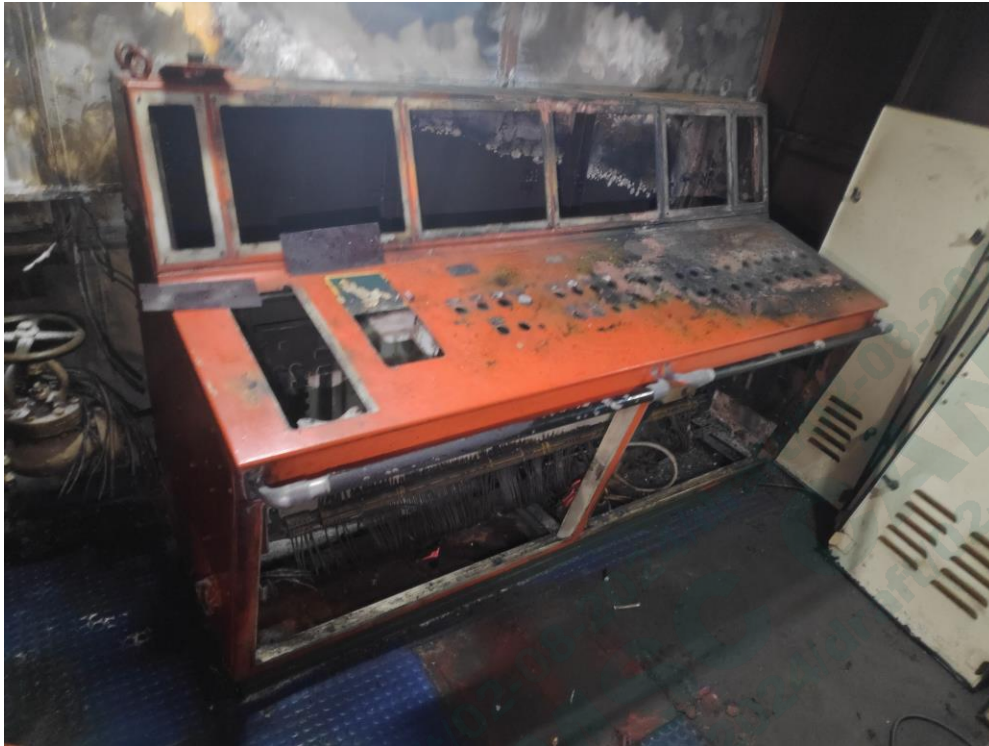
Main Control Panel totally burned.

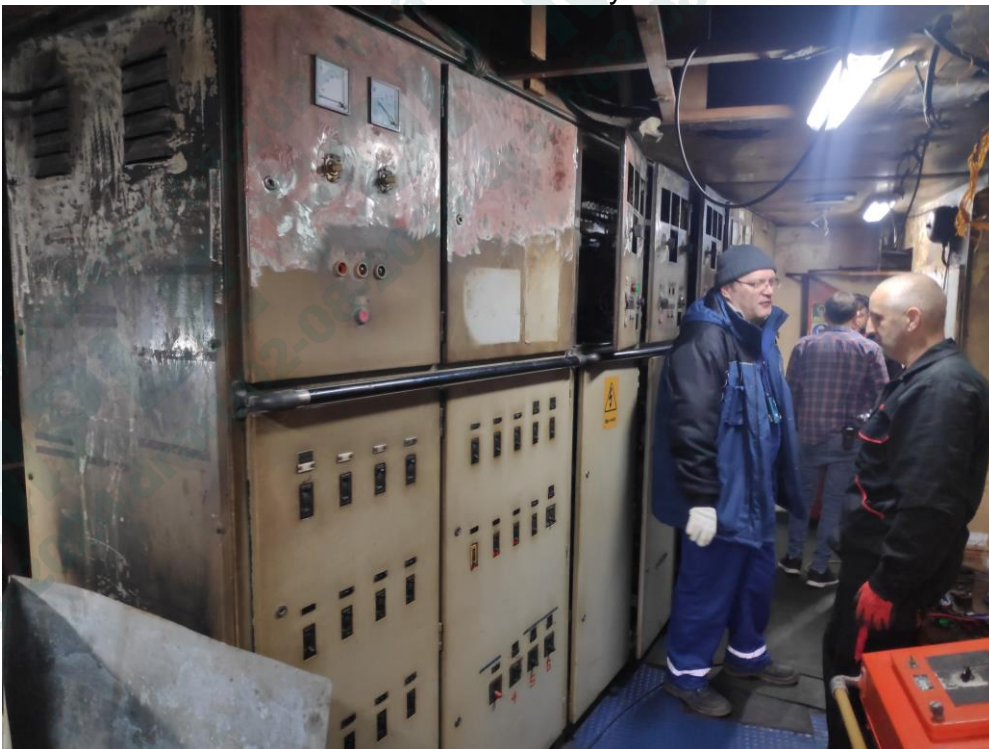
Control Panels partly burned.

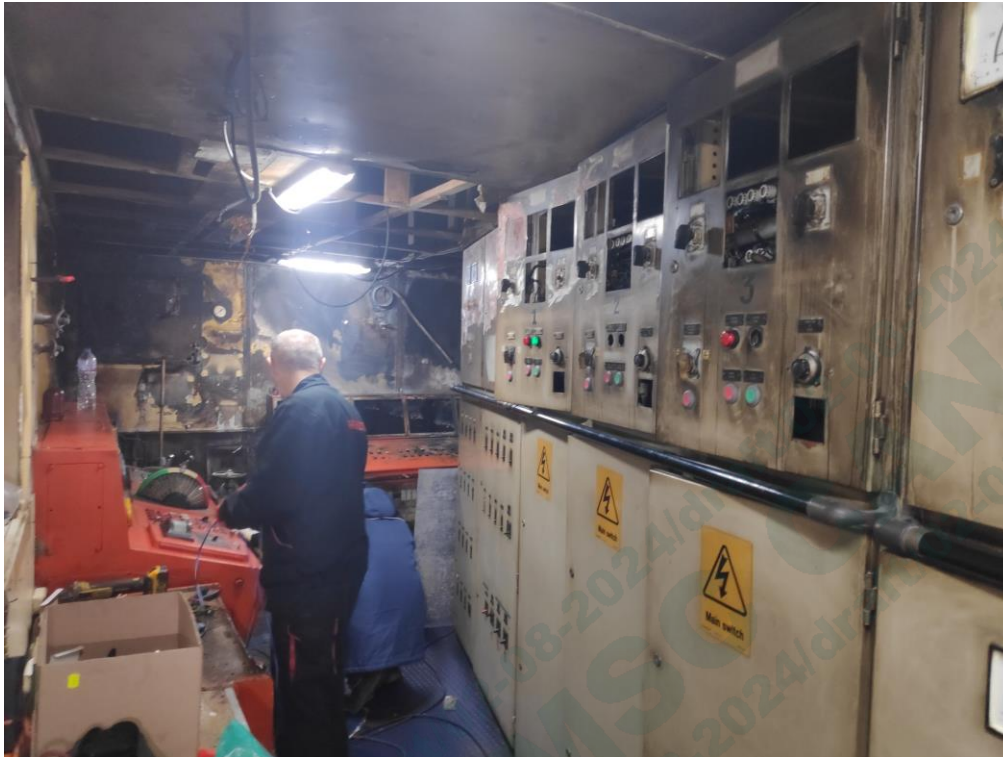
Control Panels partly burned.

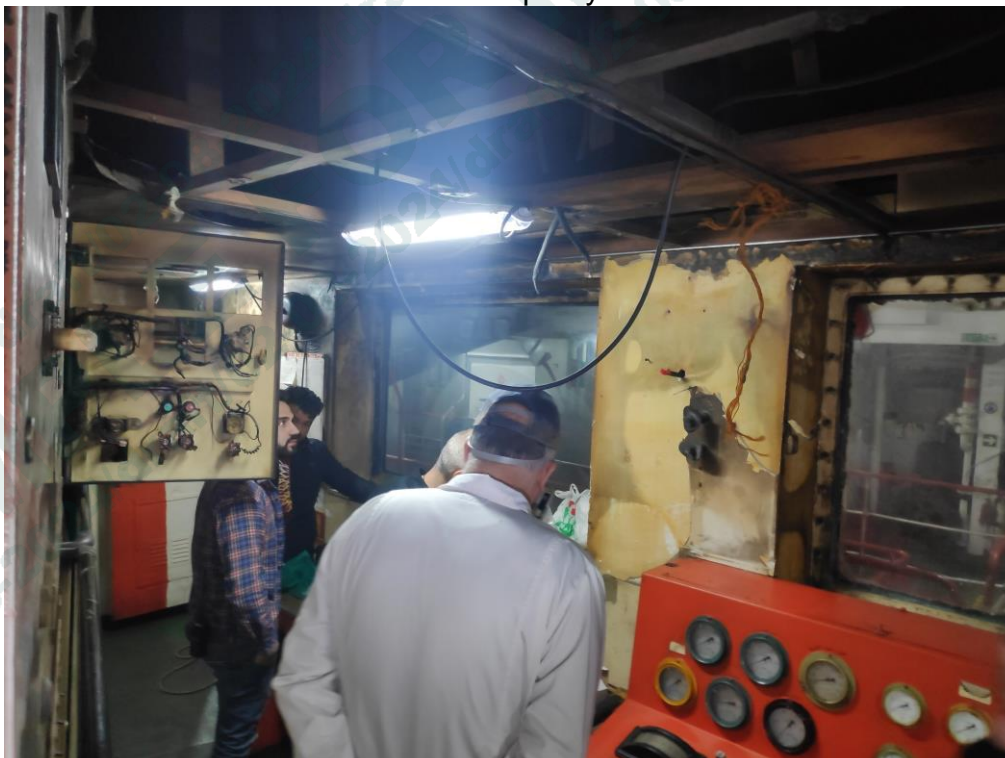
Ceiling totally burned and removed. Walls and floor partly burned.

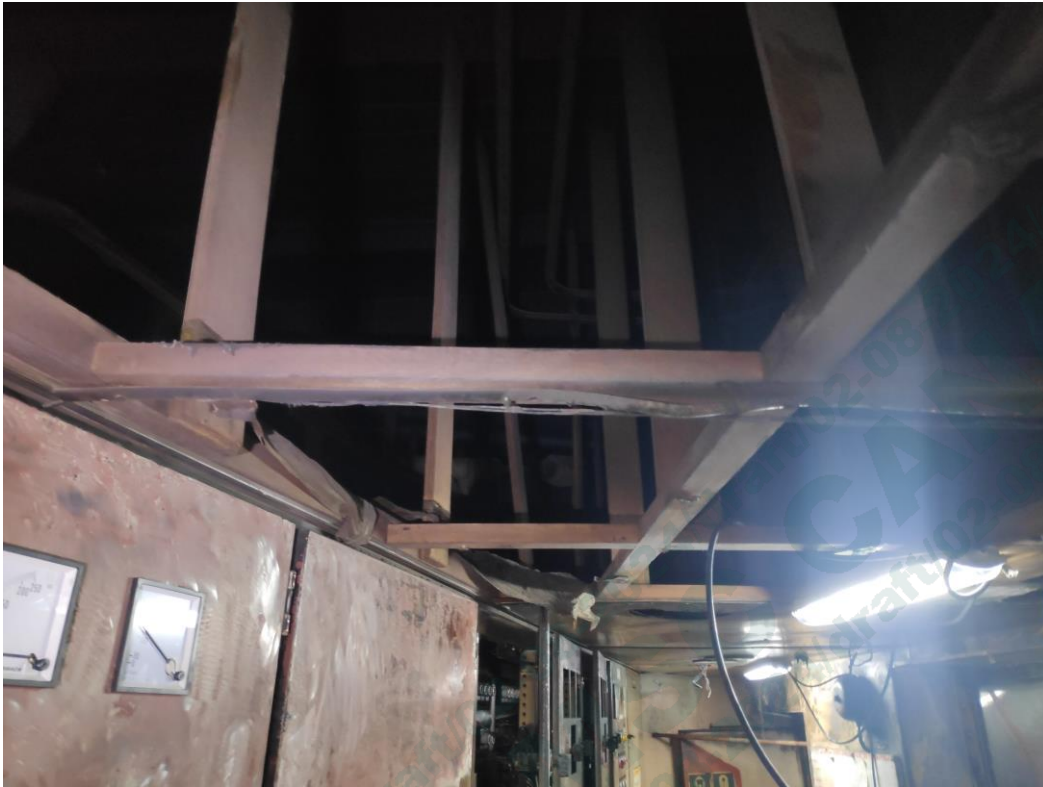
Ceiling totally burned and removed.

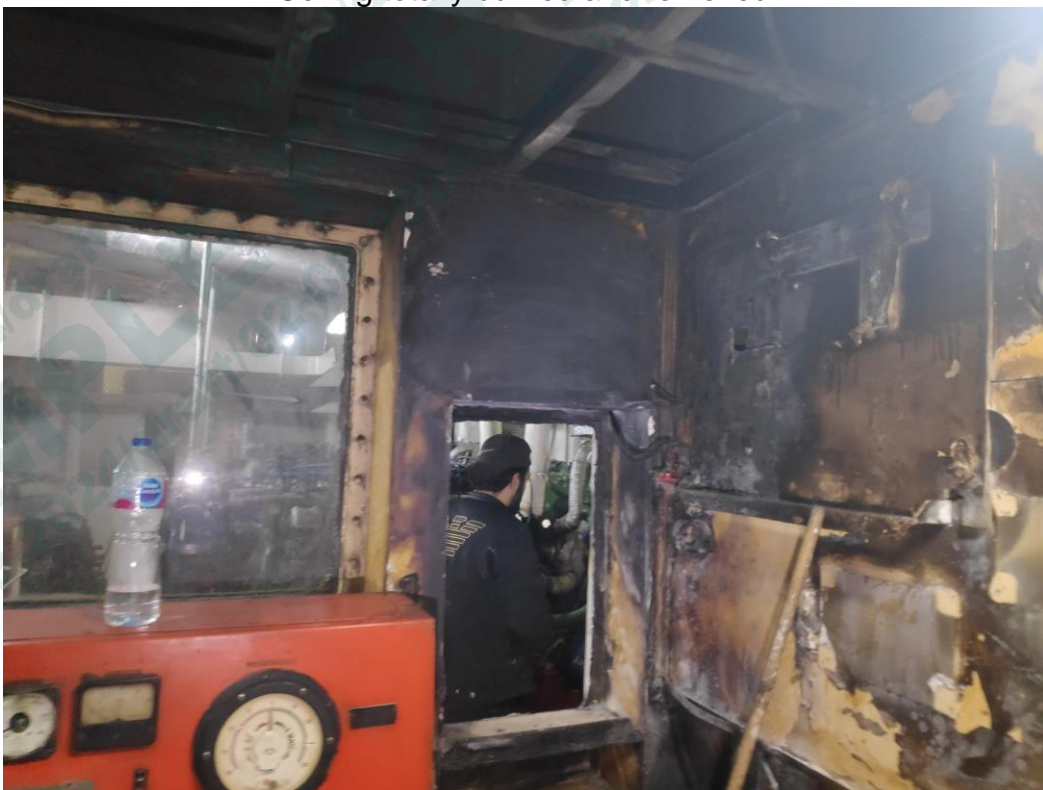
Control Room window broken.

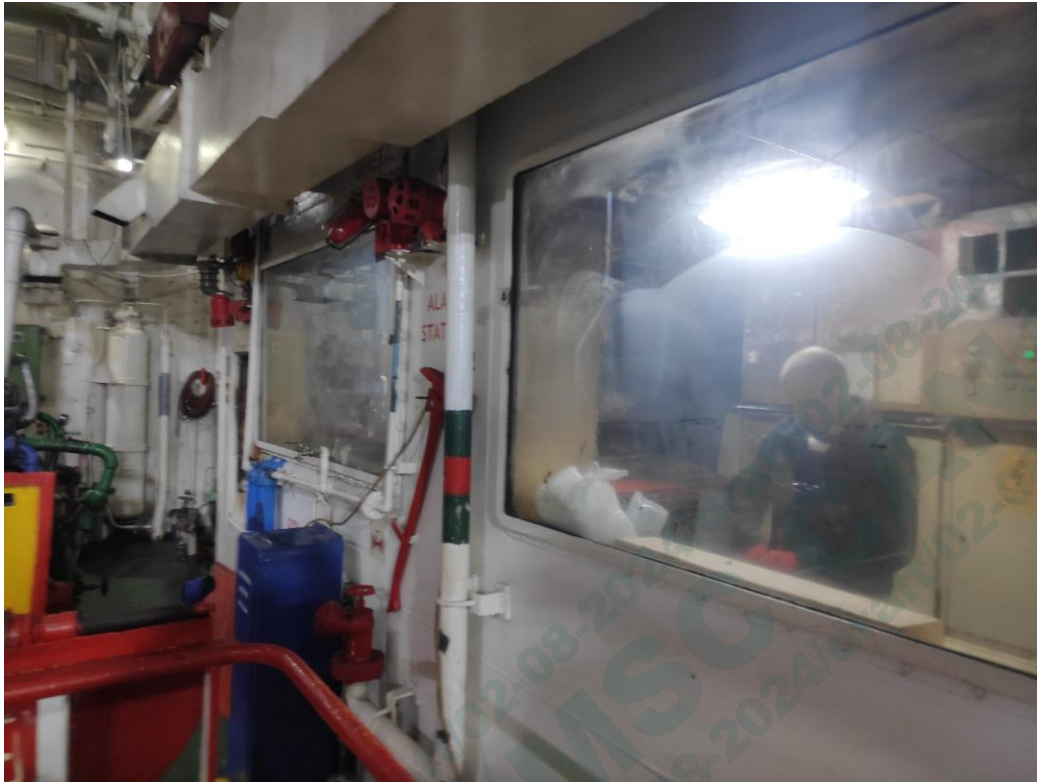
Control Room, view from Engine Room.

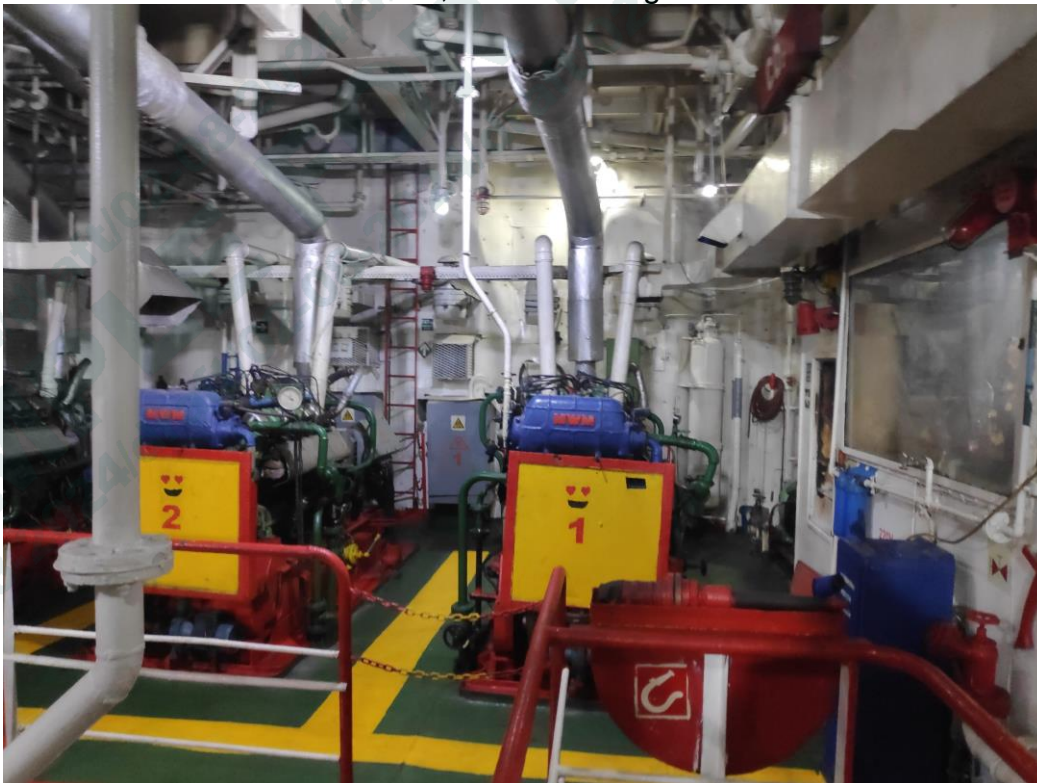
Engine Room. General view.
