## INSPECTION REPORT

Date of inspection: 2020-02-05

Cargo: Oil

From Container No.: CMAU2079210 / Flexitank No.: BWH2007002-2-320FV099

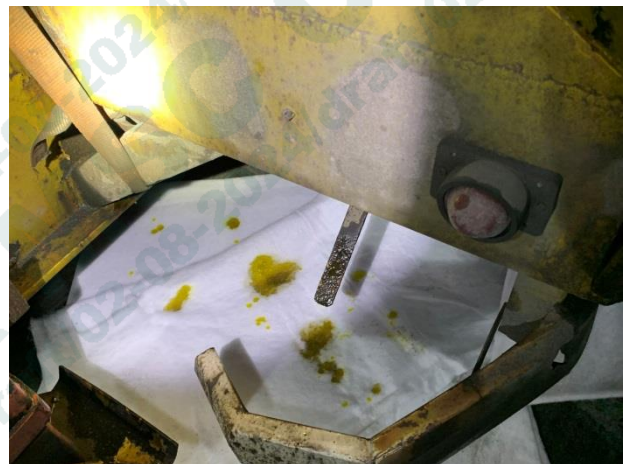
Time Log	
Time	Contents
19:30	Inspector arrived at site
19:32-20:40	Check container and investigation of place of oil leaks
20:41-20:45	Oil spills places from the both corner at bottom on the container walls has been observed

**Investigation of place of oil leaks at container**

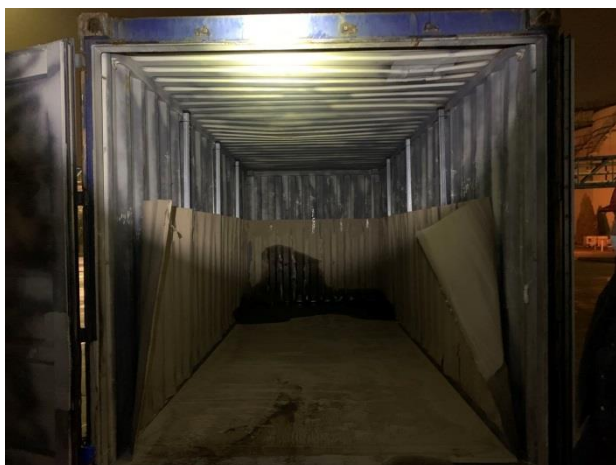
21:35-21:40	Oil bag take out from container and lifted off the ground in order to ensure all of oil flow to out
21:40-21:45	Check inner of the container again and oil spots has been observed at the bottom

Oil spills places of container

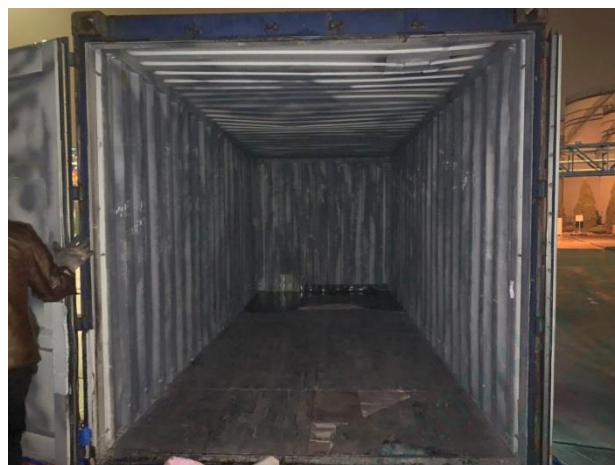
Oil spills places of container

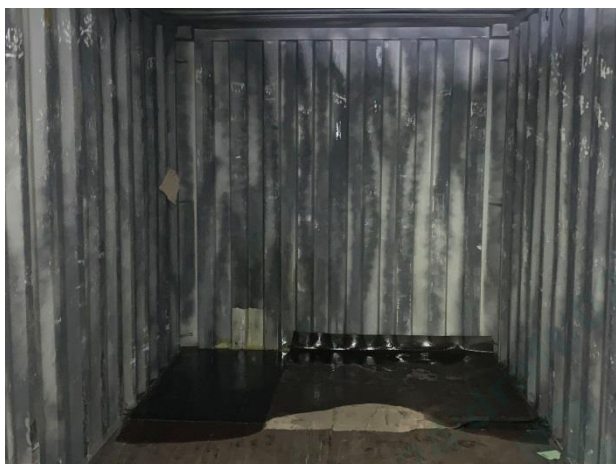
Oil spills places of container

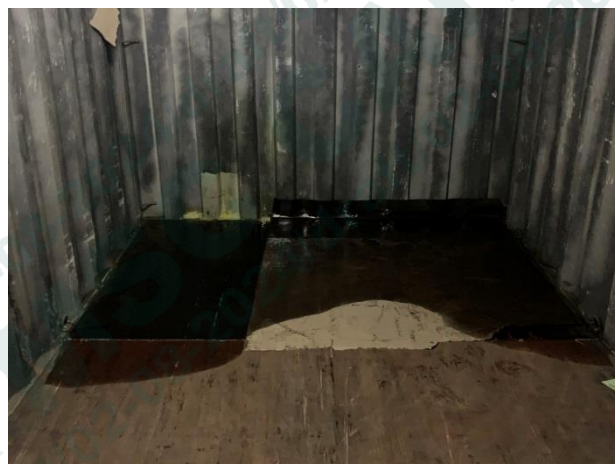
Oil spills places of container

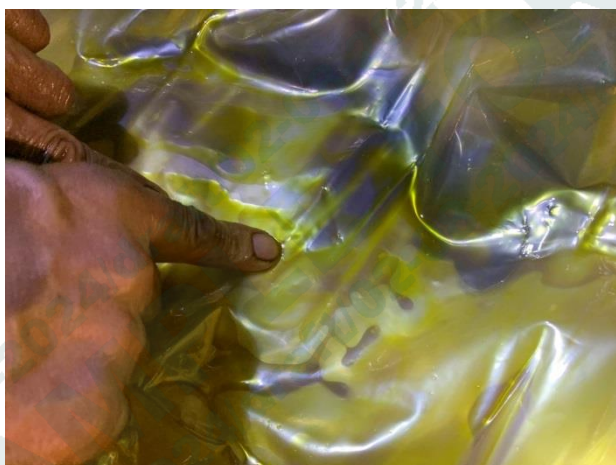
### Finding position of the leak

21:45-21:50	Weighing trucks and container
21:50-22:30	Finding position of the leak and found the open at edge of the plastic bag
22:35	Finished work and leave the site

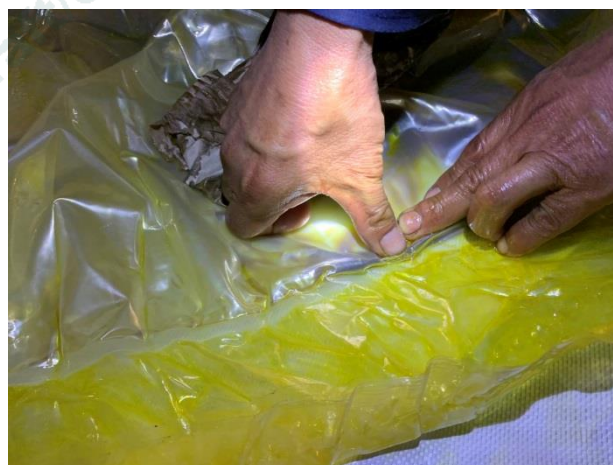
1. The inspection shows that the container and cargo require immediate attention due to oil leakage from the flexitank and traces of oil.
2. Necessary measures were taken to resolve the issue and the oil was transferred from the container.

Found the open at edge of the plastic bag
