## **STOWAGE/LASHING CERTIFICATE No UA00462**

That the undersigned independent Surveyor inspected at the condition and manner of stowage/lashing of the cargo of 5 Tippers "BELAZ" on FR containers №№ TRIU0808970, AMZU4179794, CAXU5715084, BHCU4704721, TRIU0772331 at Odessa port.  
STOWAGE/LASHING CERTIFICATE No UA00462.

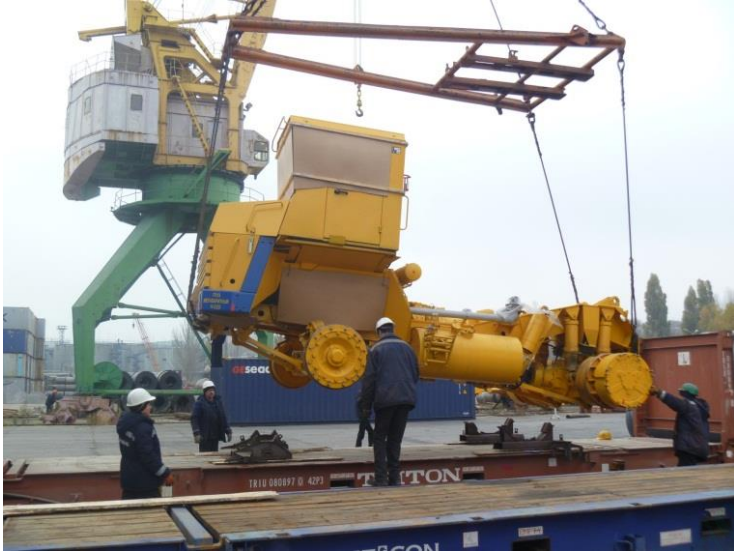
1. Overloading to the container

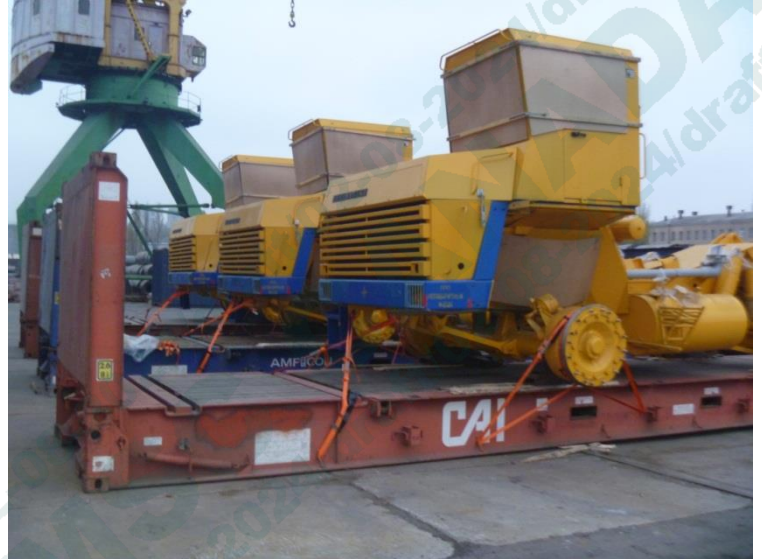
2. General View of the cargo of containers platform.

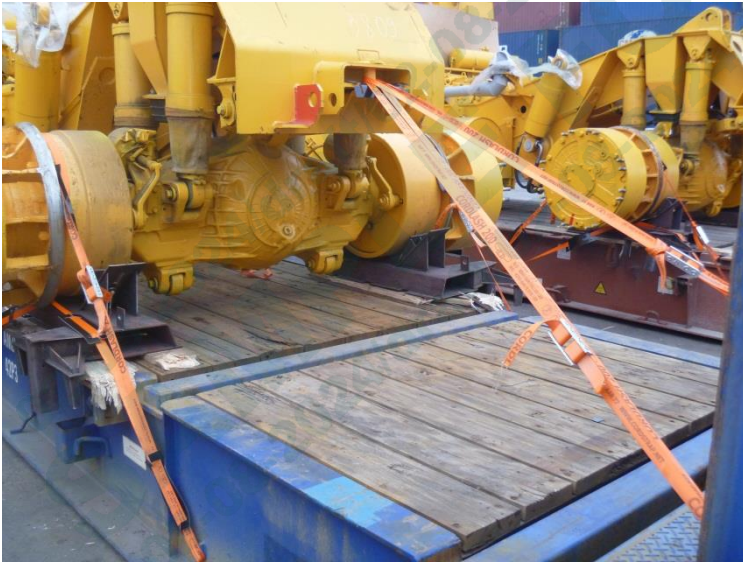
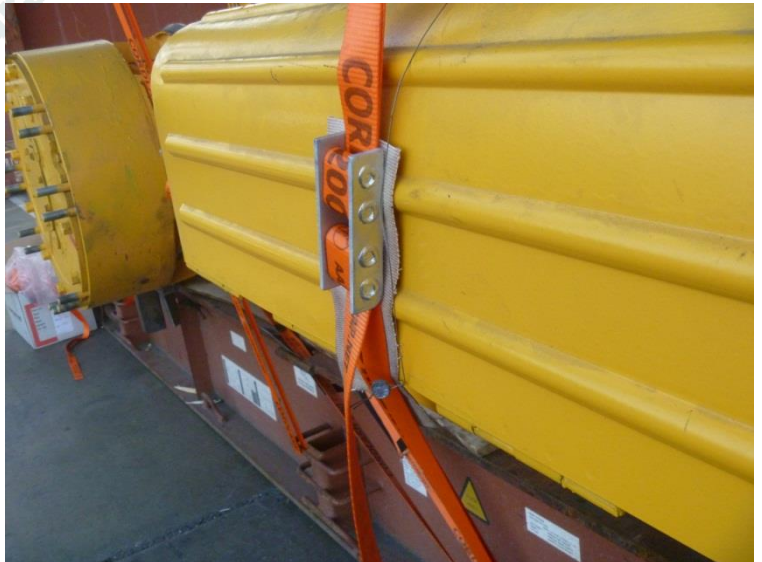
Each tipper was secured by means of sling ropes-tape "CORDLASH 200".

2. Lashing
