INSPECTION REPORT

Inspection of pineapple juice concentrate in 40-foot HIGH-Cube (9'-6") reefer container in Acheson, Canada, August 26, 2024

Date and time of inspection : August 26, 2024 08:10 – 13:15 L.T.
Place of inspection : Acheson, Canada
Address : 29160 Acheson Rd, Acheson AB
Container : 40' HIGH CUBE REEFER, No. **OTPU6093526**
Cargo : PINEAPPLE JUICE CONCENTRATE
DEHUMIDIFICATED: NO VENTS SETTING: CLOSED,
92 DRUM(S) as per BL **MEDUSD202215**

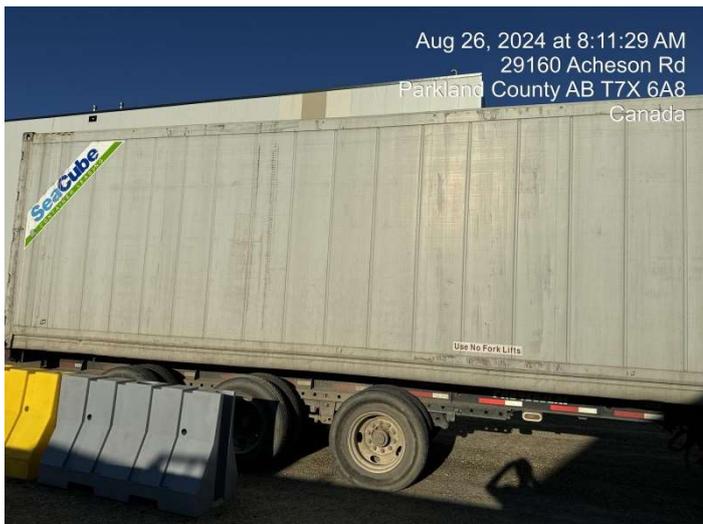
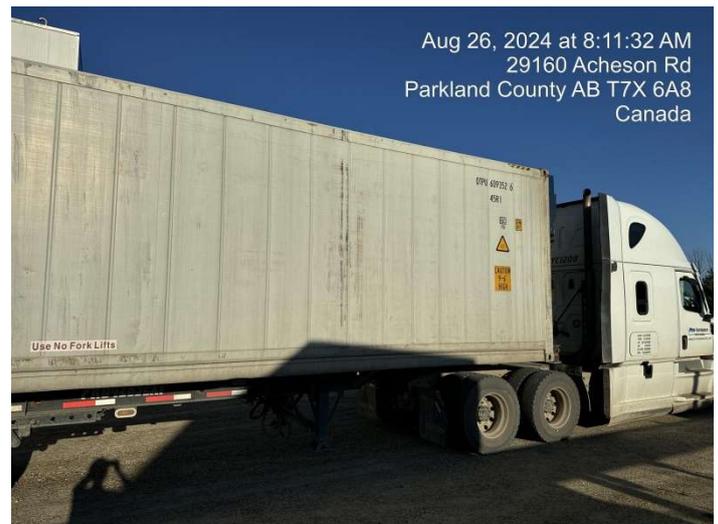
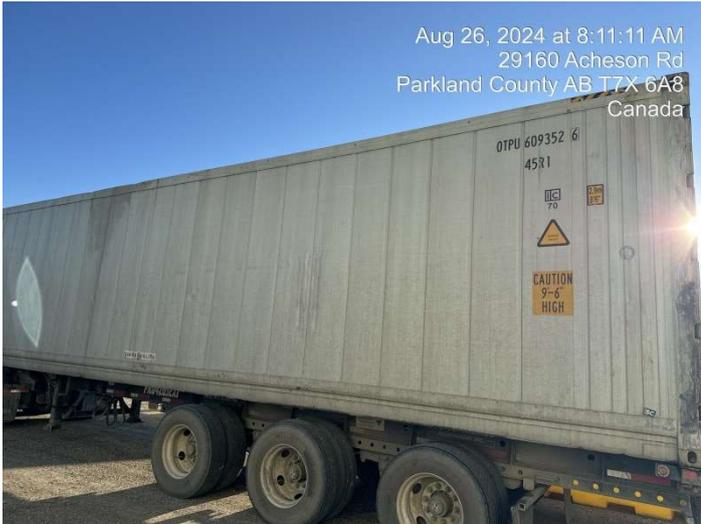
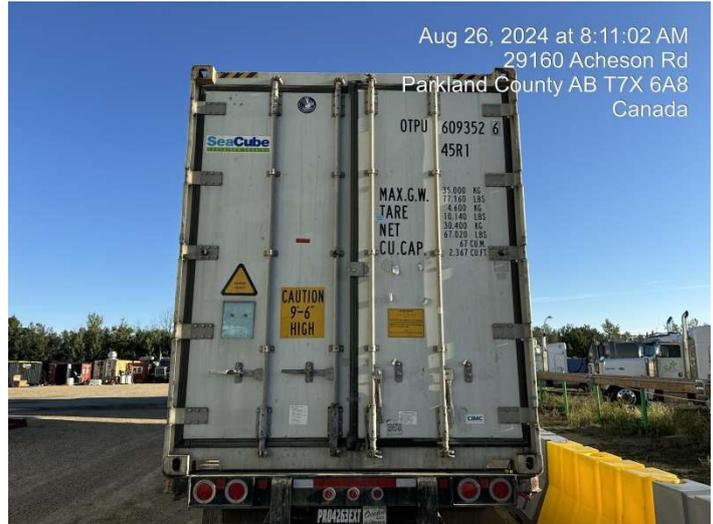
There is no external damage to the container from the visible sides.

General view of container

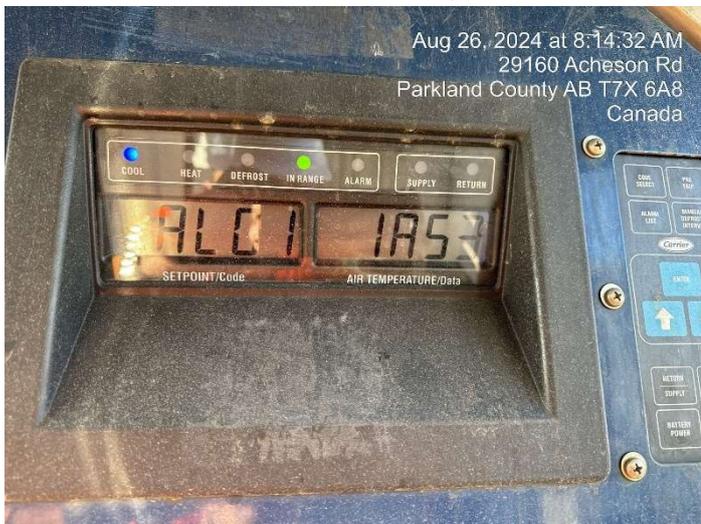
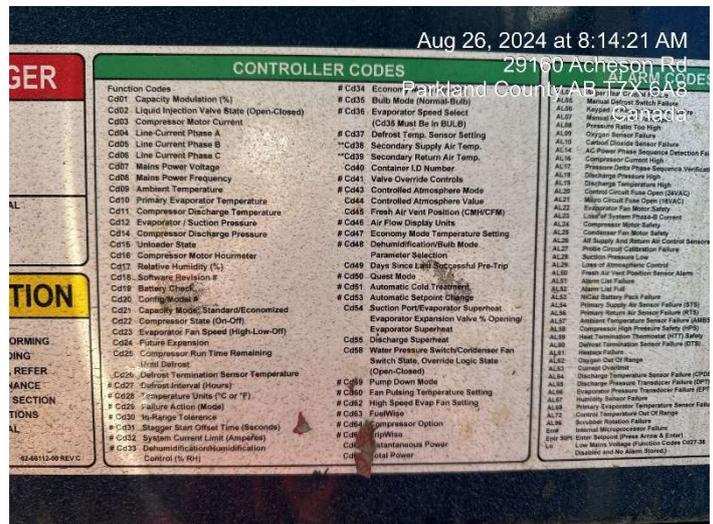
Display of recorder, the following error codes found

Controller codes

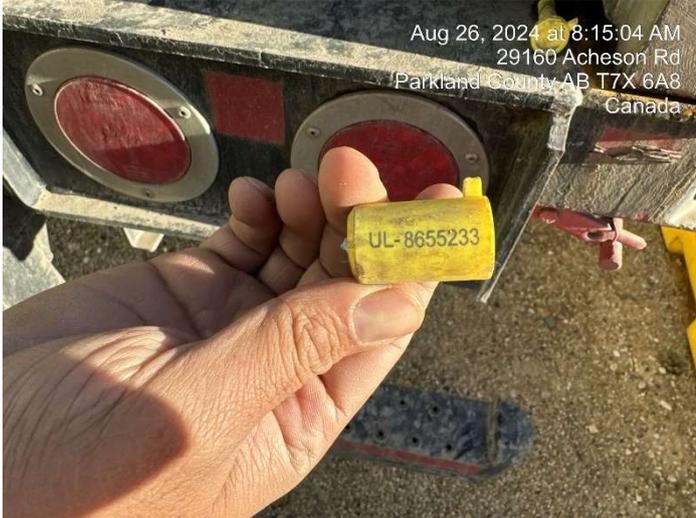
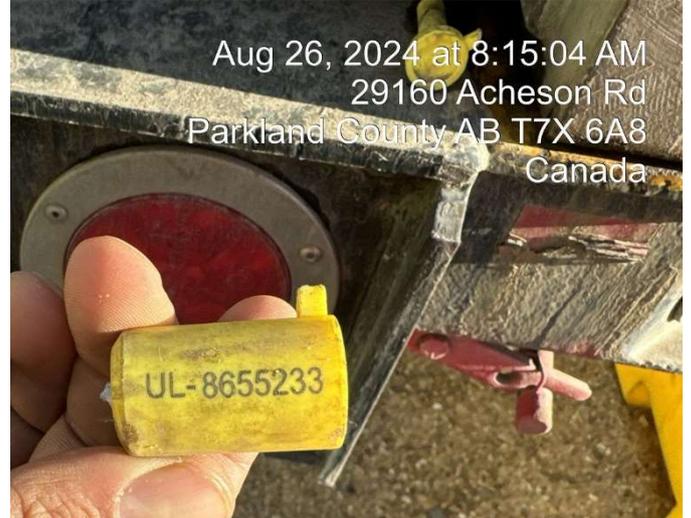
There was no seal in place of the container lock/locking device.

The driver showed a broken seal with the number **UL8655233**, which does not correspond to the seal number shown in the Bill of Lading (**QHH04342**).

Seal of container

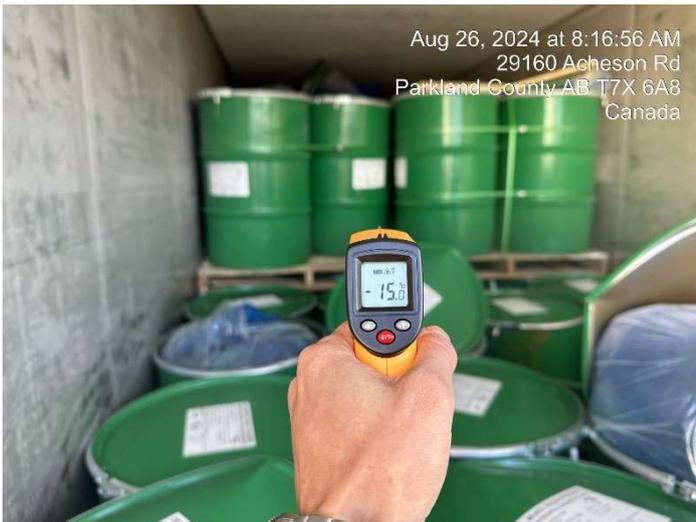
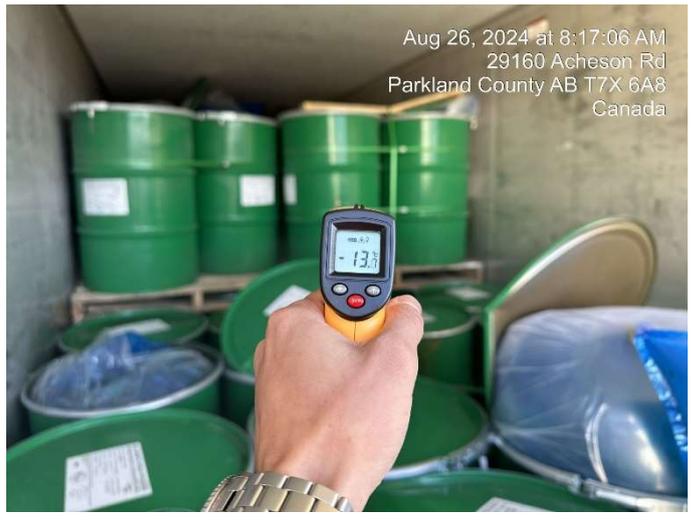
The cargo PINEAPPLE JUICE CONCENTRATE DEHUMIDIFICATED, 92 DRUM(S) was found in a 40' HIGH CUBE REEFER container (number **OTPU6093526**), corresponds to the one stated in the bill of lading **MEDUSD202215**. The temperature readings performed by infrared instant thermometer inside the container. The cargo (drums surfaces) is in the range between **-15°C** and **-13,7°C**, which does not correspond to the temperature of the recorder and the one stated in the Bill of Lading.

Temperature readings inside the container

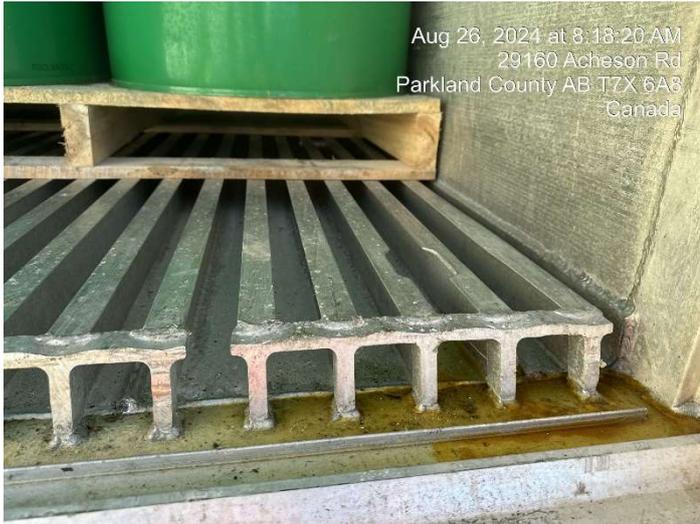
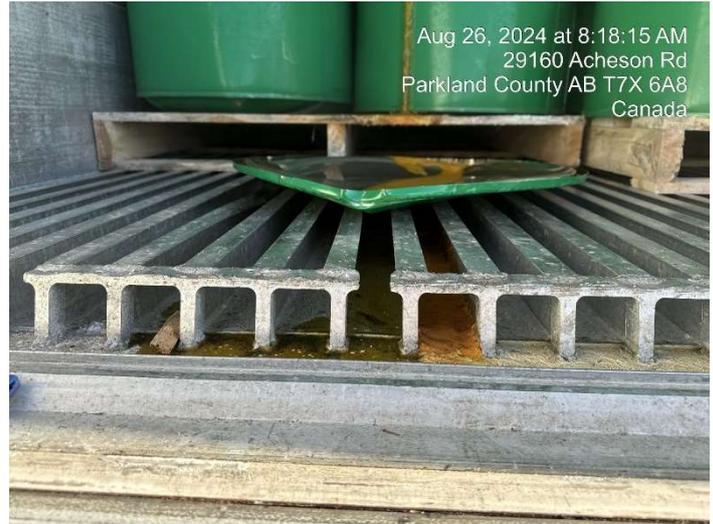
The cargo in the container is arranged in two tiers, in the center of the container and evenly distributed over the entire area. The barrels/drums are installed vertically on pallets in bundles of 4 pcs. There is no additional separation. The condition of the barrels before unloading: **damaged covers, deformation of barrels' shape, and visible leakages inside the container on the floor and on the walls of barrels as well.**

Leaks inside the container

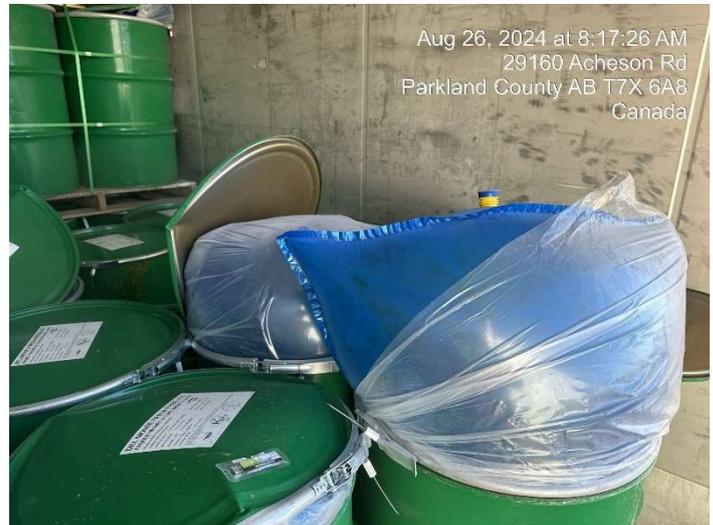
Warped drum lids

- Dented and Warped Drum Lids: multiple drum lids are observed to be severely dented and deformed. This deformation likely occurred due to excessive pressure inside and/or improper handling during transportation. This was probably the reason for prolonged exposure to high temperatures inside the refrigerator, as well as incorrectly set temperature of the refrigeration equipment and its automation devices.
- Compromised Seals: The deformation of the drum lids has compromised the integrity of the seals, as evidenced by visible bulging and displacement of the lids from their original positions. This may have led to potential leakage or contamination.

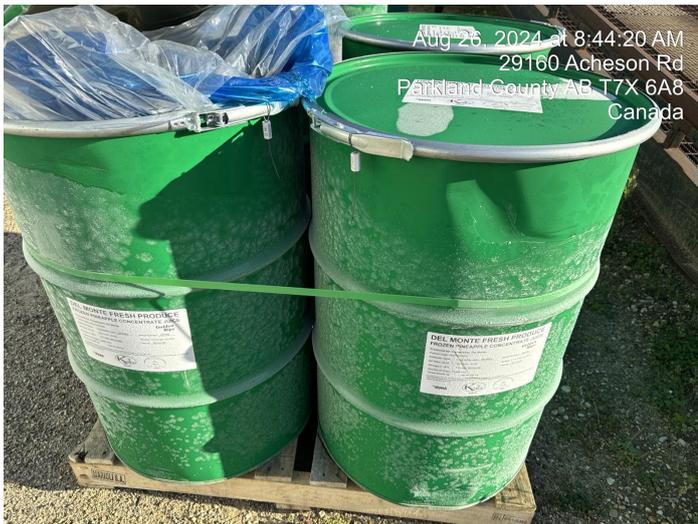
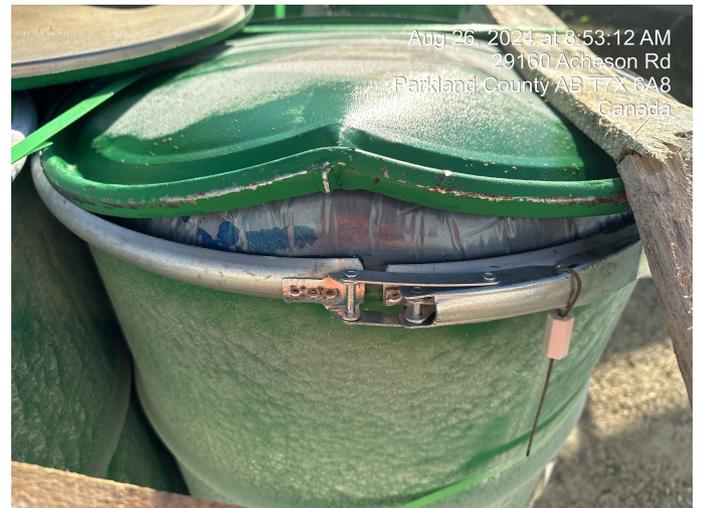
Several drums containing pineapple juice concentrate show significant physical deformation. The most notable issues include:

Damaged Drums

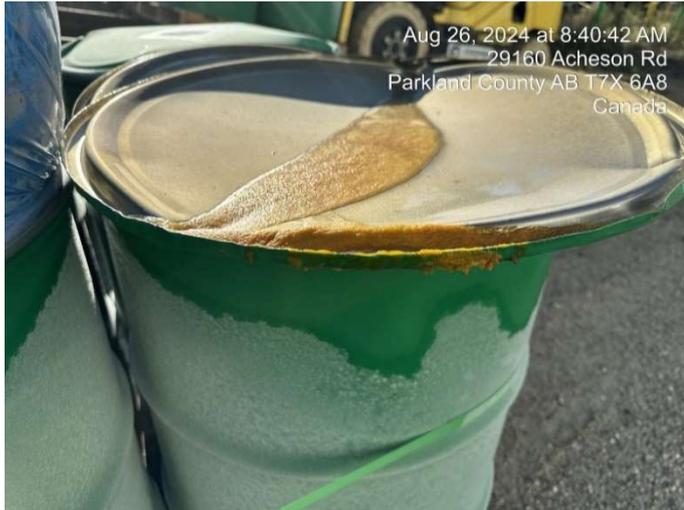
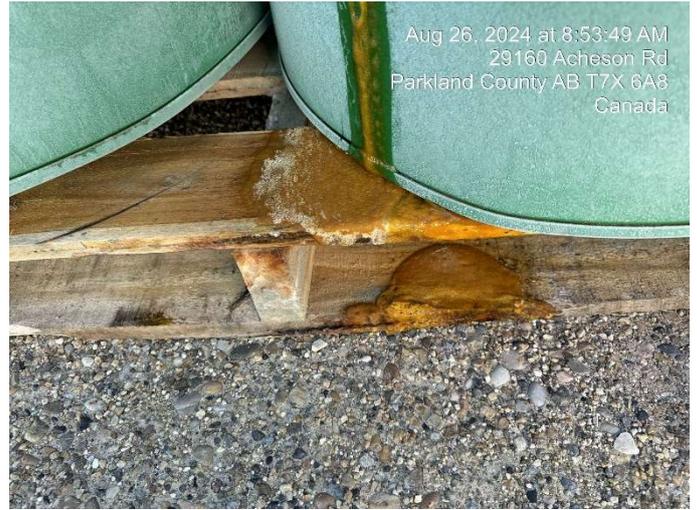
- Traces of pineapple juice concentrate are visible on the exterior surfaces of some drums, indicating that leakage has occurred.
- This leakage appears to have originated from the compromised seals mentioned above.
- The leaked product has also contributed to the formation of sticky residues on the drum surfaces, further attracting dust and contaminants, which could impact the quality of the remaining contents.

Leakage of cargo

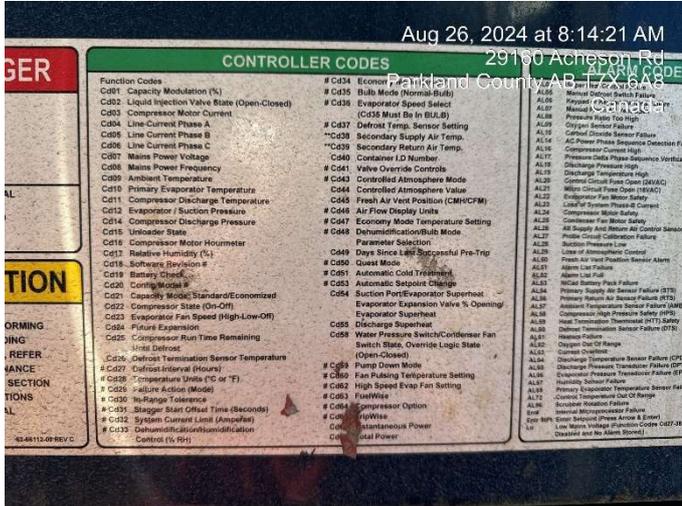
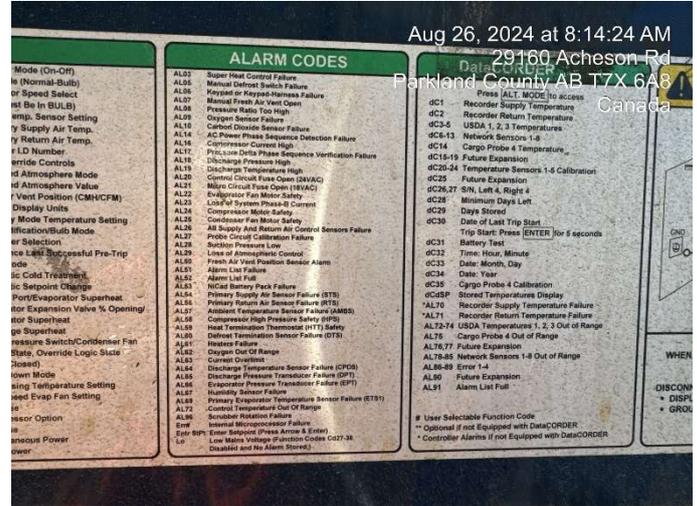
Controller codes

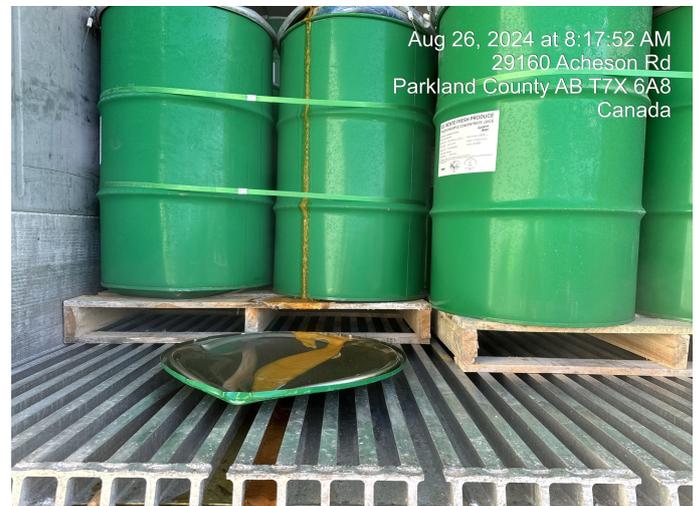
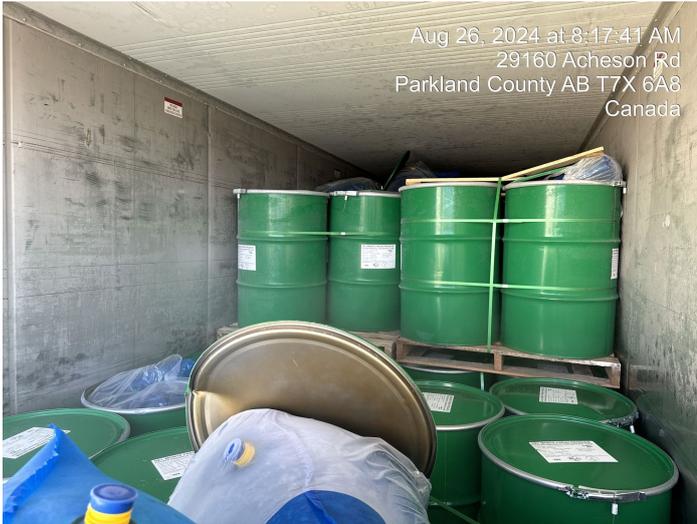
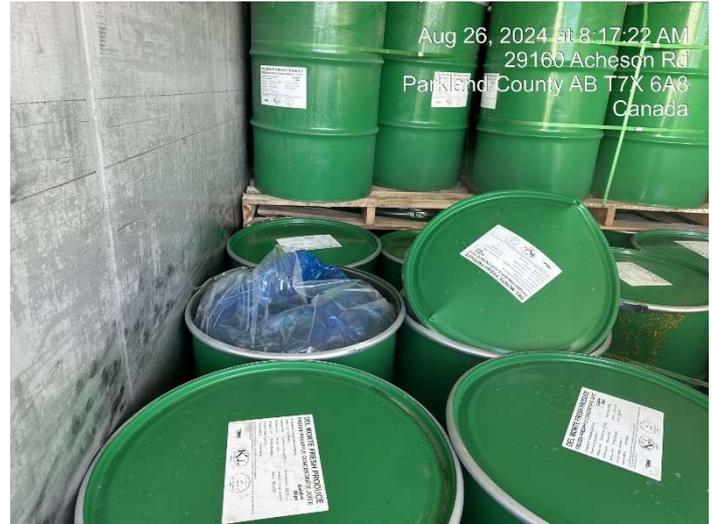
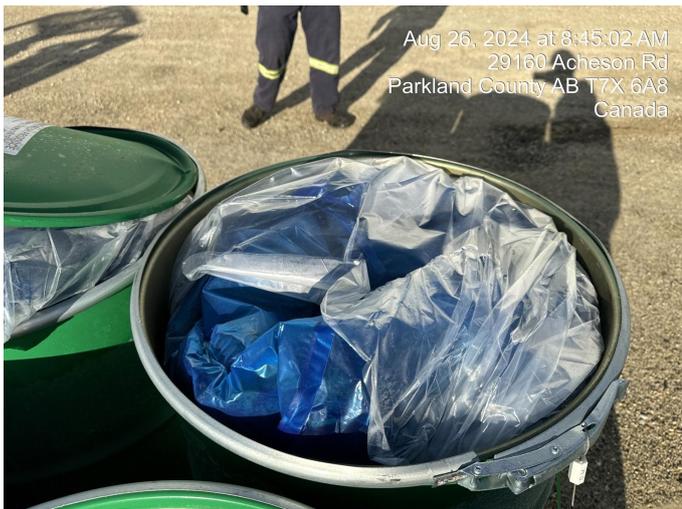
Damaged Drums

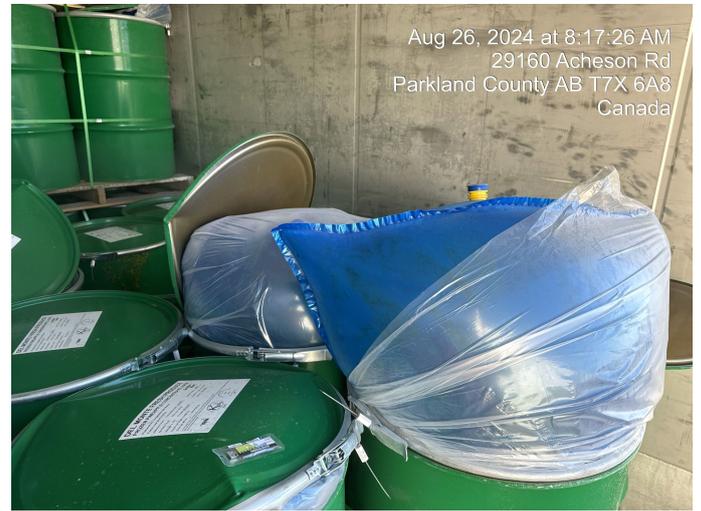
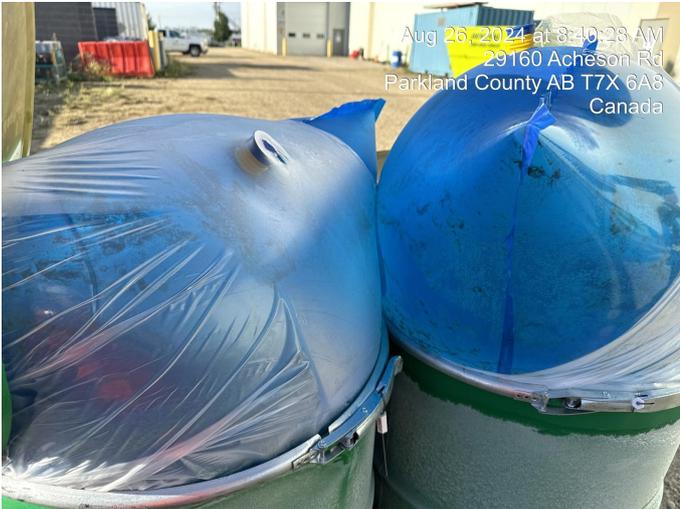
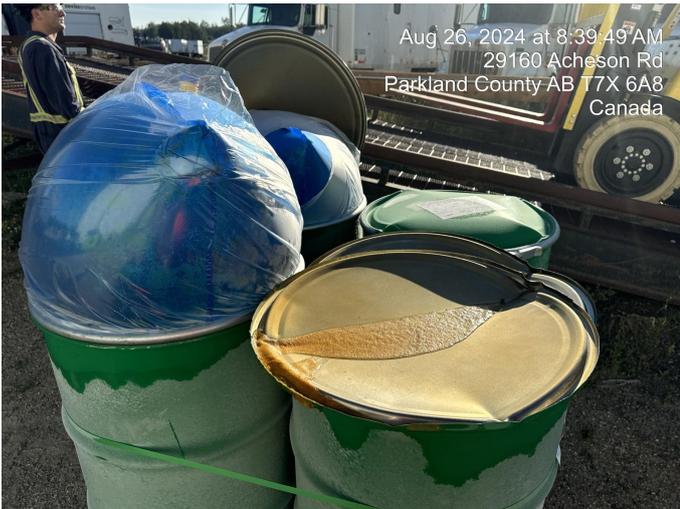
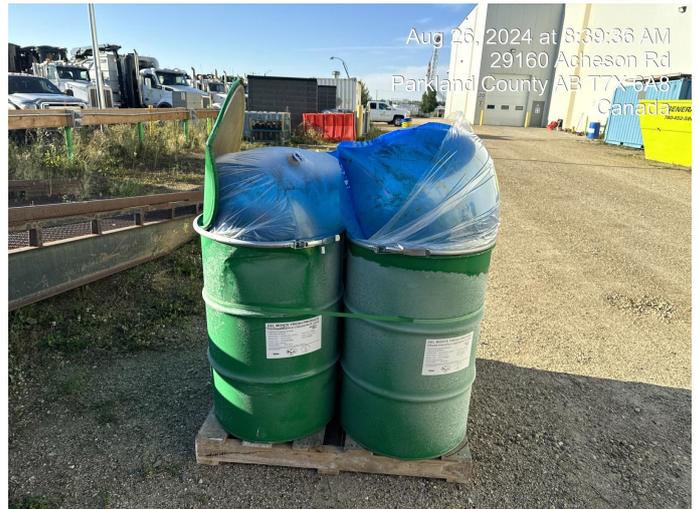
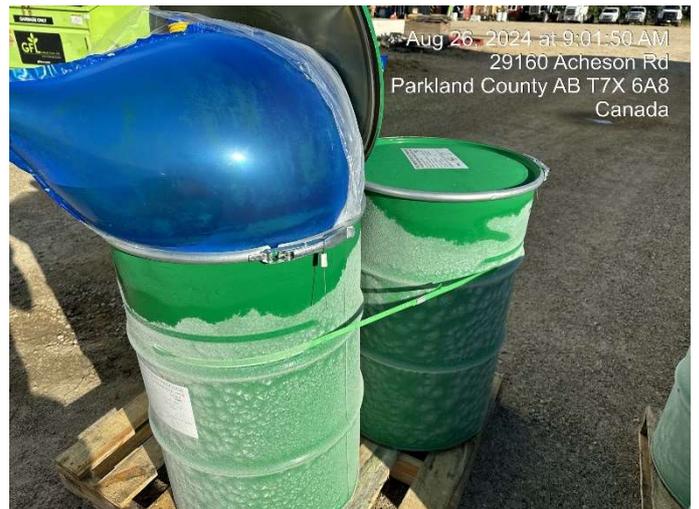
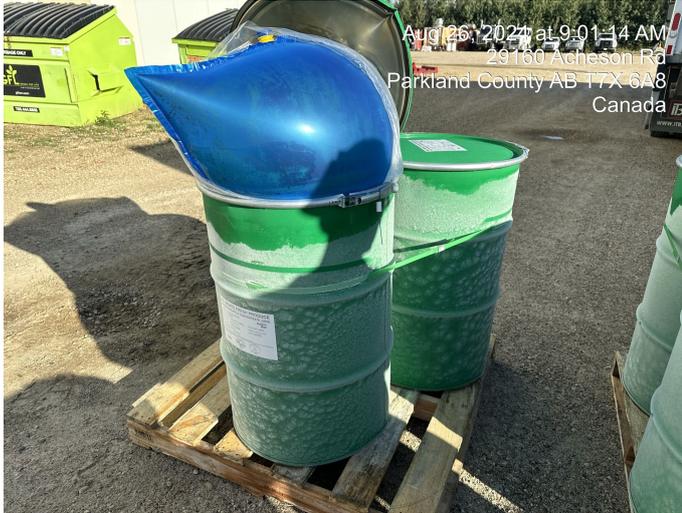
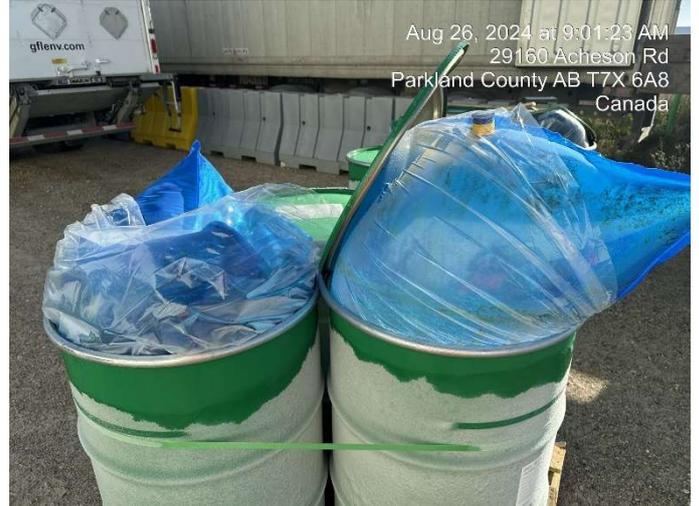
Exploded drums - **32 pieces**

Exploded Drums

34 drums were sent for disposal.

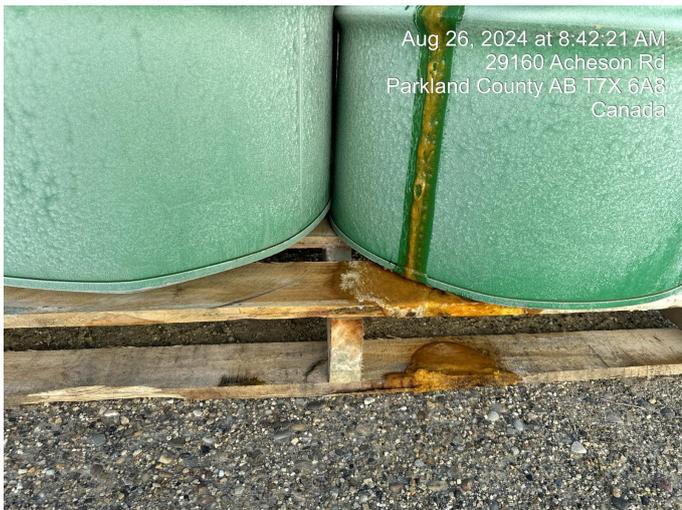
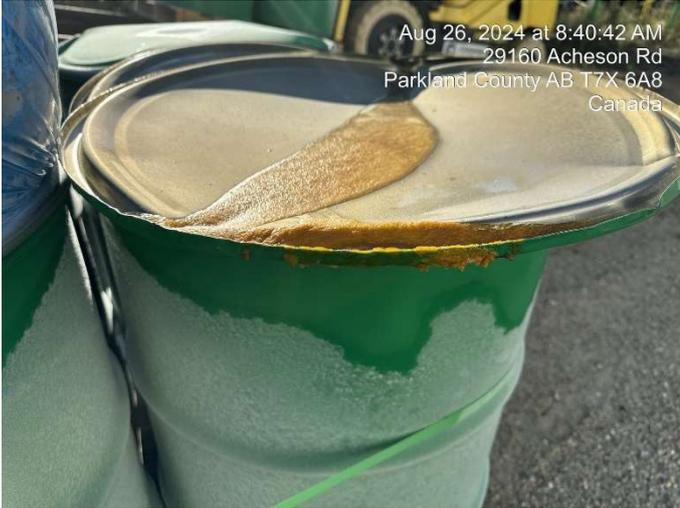
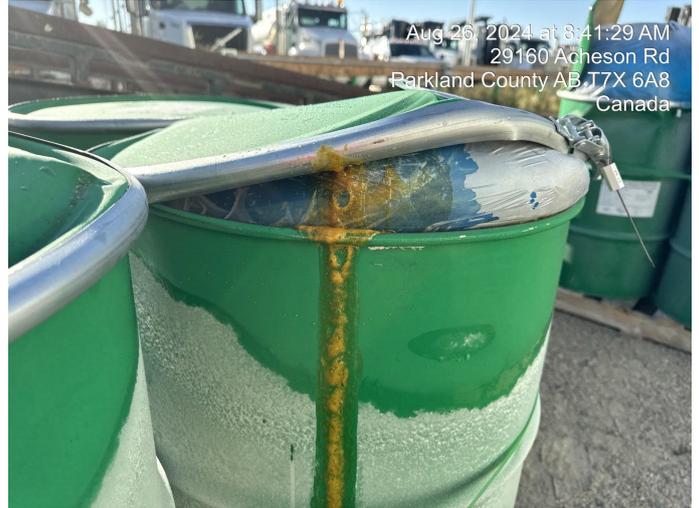
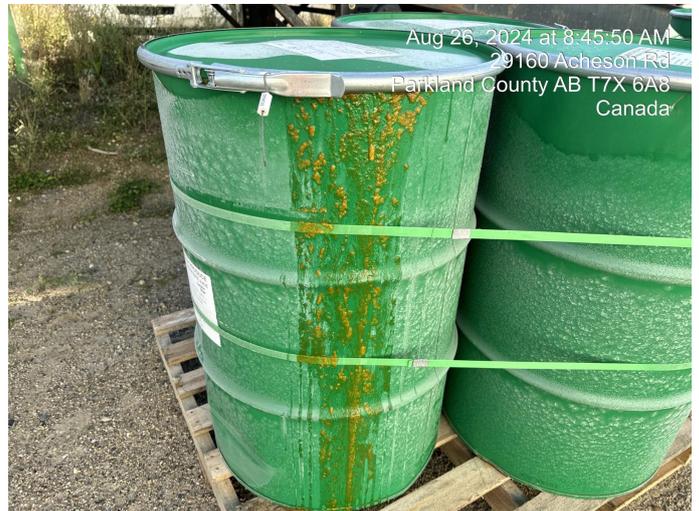
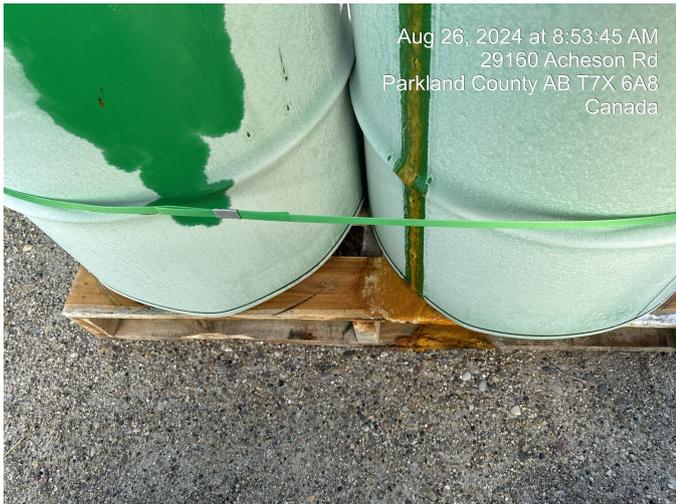
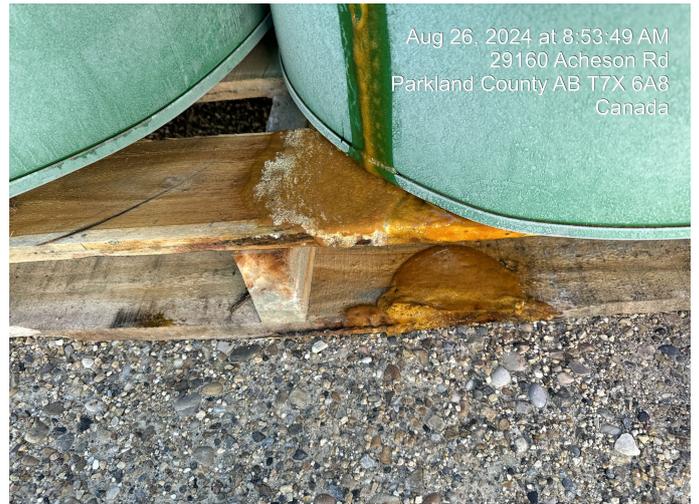
Leakage of cargo

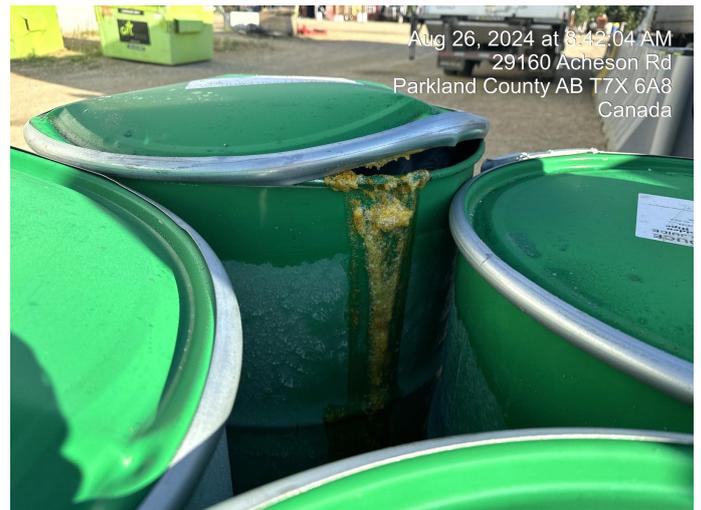
Warped Drum Lids, cargo leakage

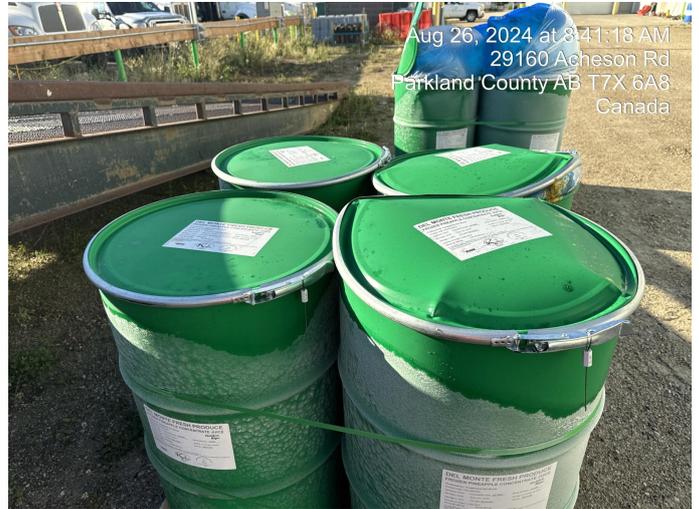
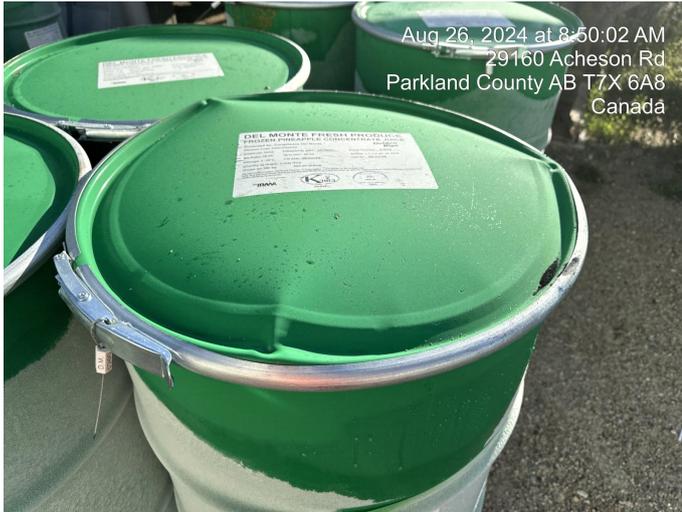
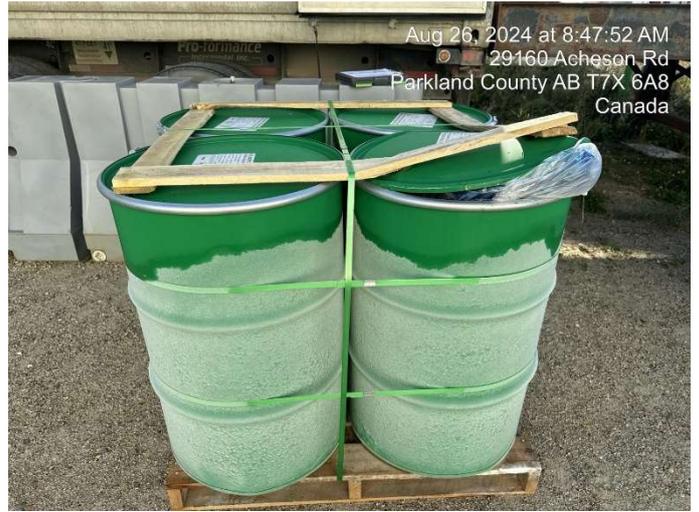
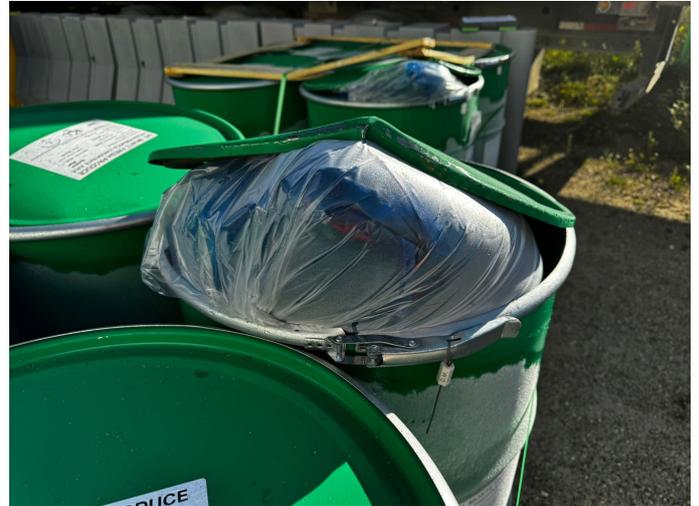
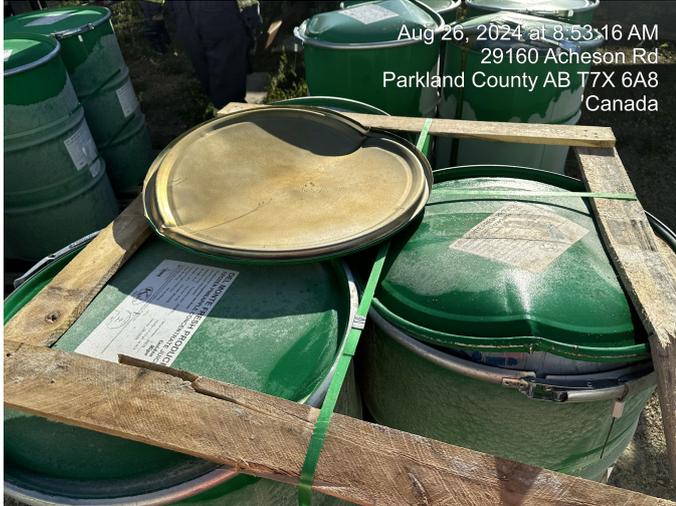
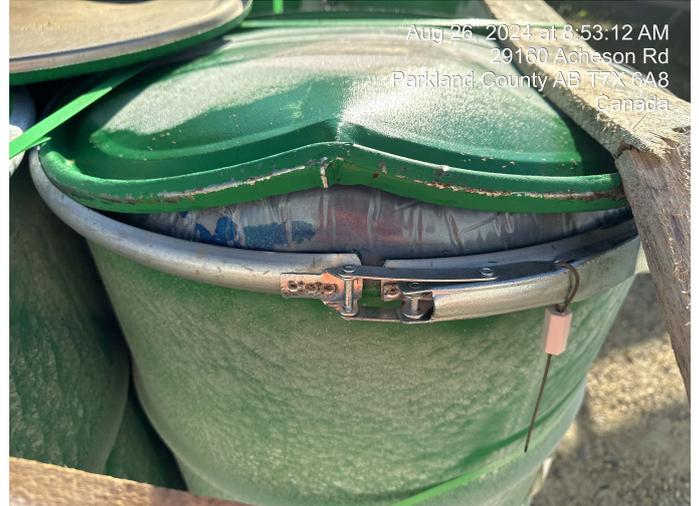
Warped Drum Lids

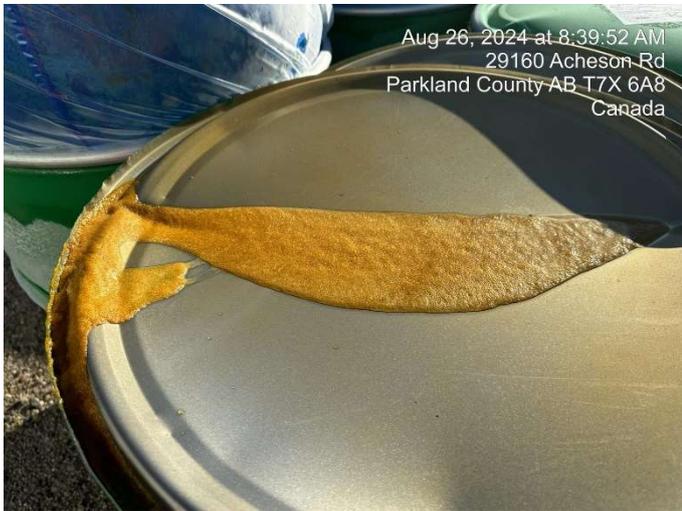
Leakage of cargo, deformed lid

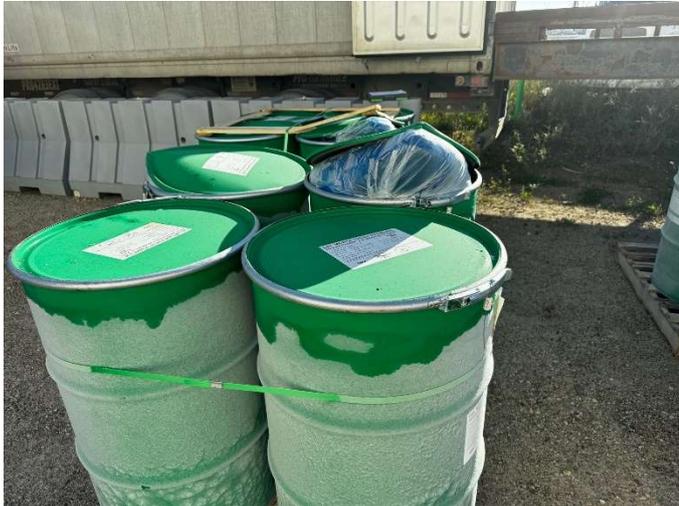
Warped Drum Lids, exploded barrels

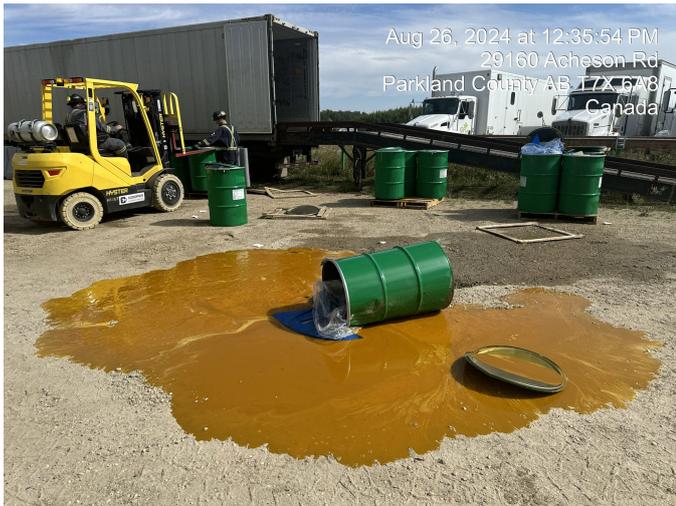
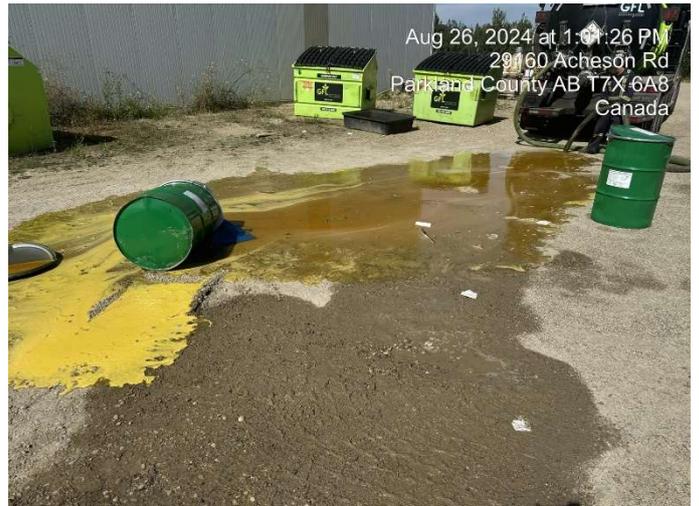
During the re-loading process, one of the barrels (which intended for disposal) fell down and the contents were spilled. Road surface washed up by cleaning service company.

Fallen barrel during loading back to truck

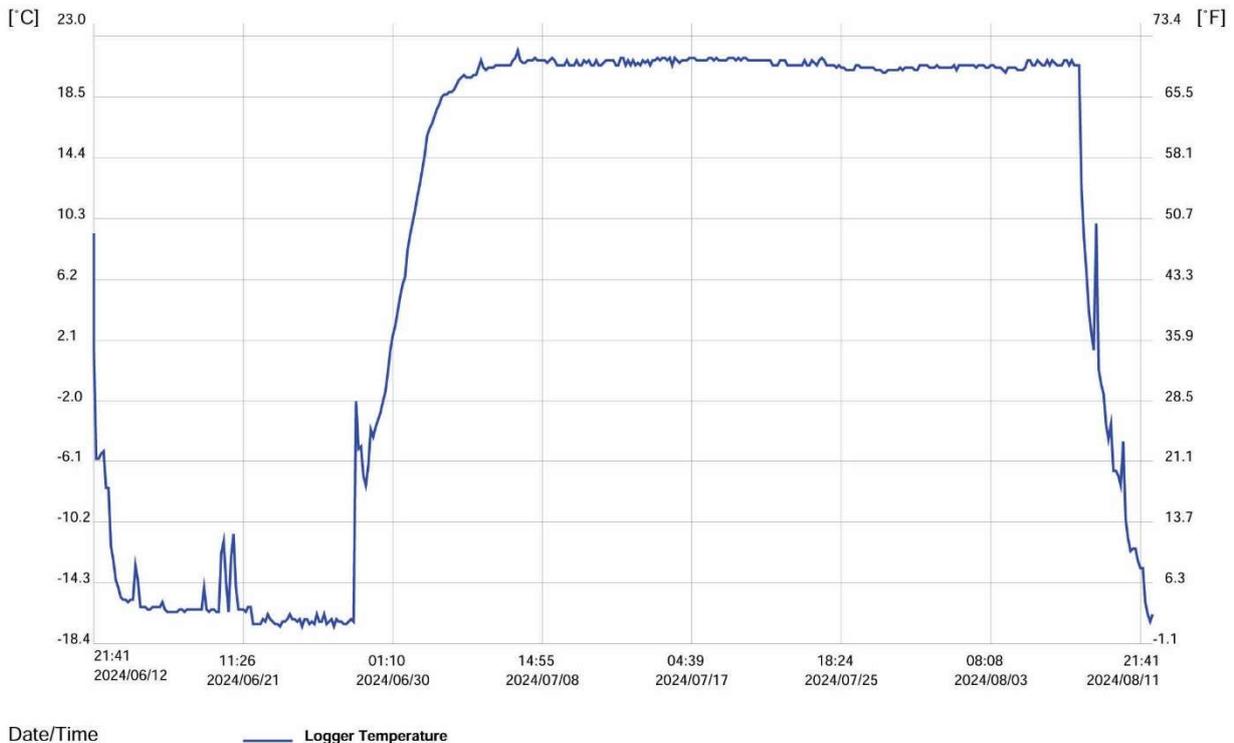
Max Temperature:	22.0°C	71.6°F	Start Time:	2024/06/12 21:41:31
Min Temperature:	-17.4°C	0.7°F	Stop Time:	2024/08/11 21:29:31
Average Temperature:	8.9°C	48.0°F	Total Time:	59 day 23 hr 48 min
MKT:	17.0°C	62.6°F	Data Points:	7200

Data Report from thermograph/thermometer sensor Emerson GO PDF Mini Logger with barcode No. XAA6825.
