**QUALITY INSPECTION REPORT UA 13-1480/2**

<b>Client / Exporter</b>	XXXXXXXXXXXX
<b>Description of goods:</b>	HOT ROLLED STEEL WIRE RODS in coils
<b>Type of inspection:</b>	VISUAL INSPECTION OF CARGO; CHECKING OF QUALITY AND QUANTITY; LOADING SUPERVISION; TALLY COUNT; PHOTO REPORT; CHECKING OF MILL CERTIFICATE .
<b>Vessel:</b>	MV "GAMBELLA" VOY 06-NS-B
<b>Shipping order:</b>	№ 186(Lot 2)
<b>Quantity as per S/O:</b>	526 COILS ; 996.296 MT GROSS; 994.192 MT NET
<b>Port of loading /Place of inspection:</b>	PORT OF ODESSA, UKRAINE
<b>Destination:</b>	DJIBOUTI
<b>Date of inspection:</b>	31.01.2014 – 01.02.2014

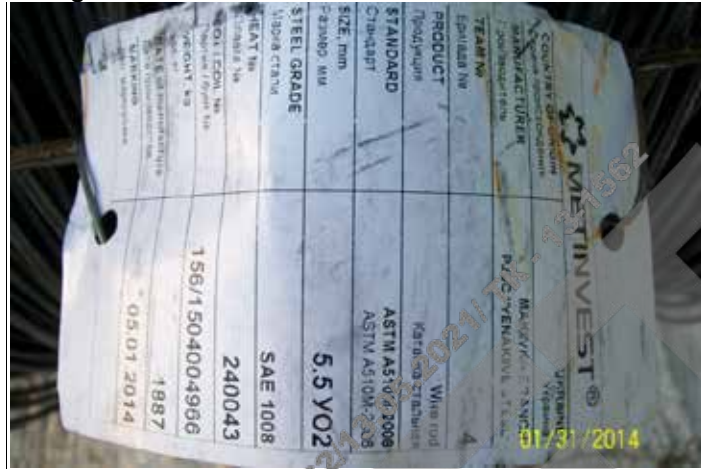
Tag (example):

Ø5.5 mm – 526 coils – **white** tags+ **additional** tag; colour marking – **two red** stroke;

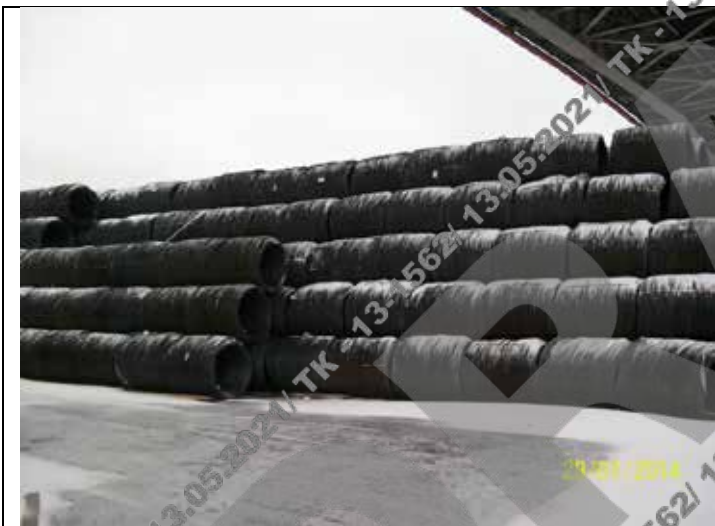
The cargo as presented to us was stored in the open area of warehouse without protection from the weather conditions. Cargo is partially covered with ice and snow (abt 5%). HOT ROLLED STEEL Wire Rods were stored in stockpiles. The cargo was found secured by four tying wires along through the eye.

General view of the cargo

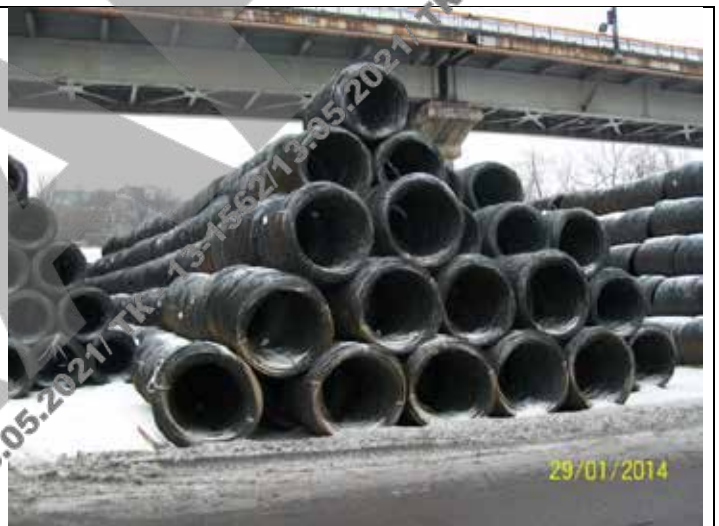
General view of the cargo

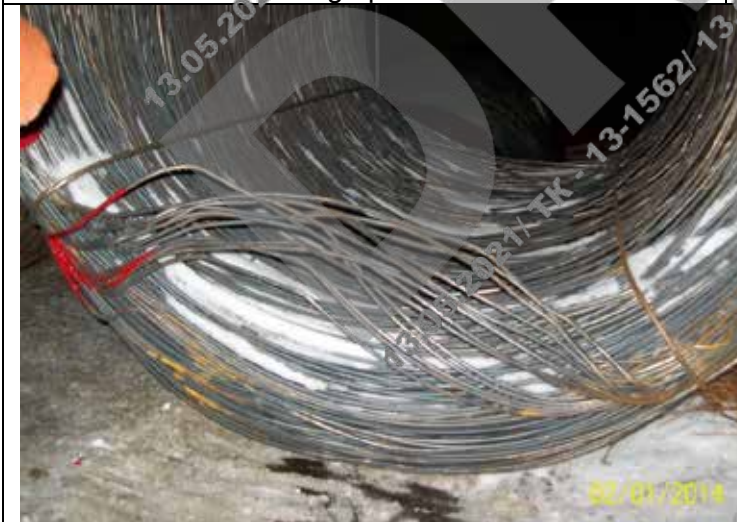
Condition of cargo	Quantity
Mechanical damages along outer/inner circumference.	15 coils

Damaged coils found

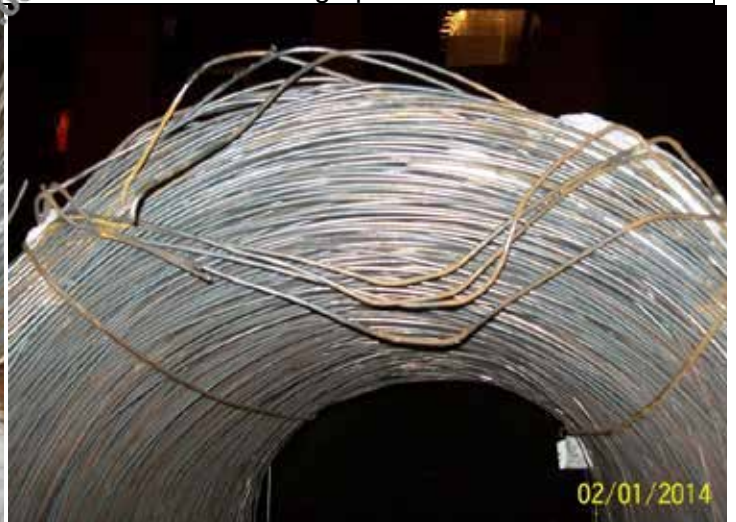
Damaged coils found
