SURVEY REPORT

IMPORTER : JORCORP S.A.

CARGO DESCRIPTION : GREEN FRESH BANANAS CAVENDISH VARIETY, FIRST

VESSEL : CMA CGM MARCO POLO

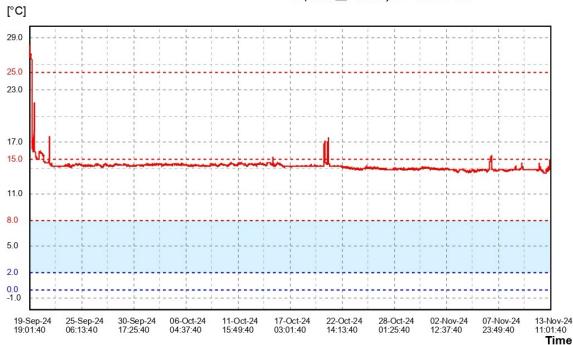
- The thermograph recordings began on September 19th and continued until November 13th. The temperature initially began at 28.3°C and gradually decreased to approximately 14.3°C by September 22nd.
- The recorded average temperature of 14.3°C.
- There were noticeable temperature breakdowns on October 20th (14.7°C to 17.2°C) and November 7th (14.9°C to 15.5°C). These breakdowns could have had a minor impact on the bananas, potentially affecting their ripening or storage conditions.

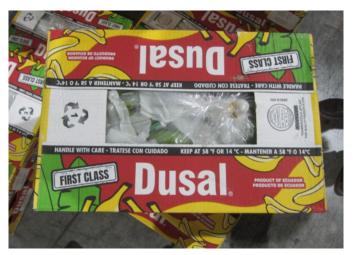
Overall view of the boxes

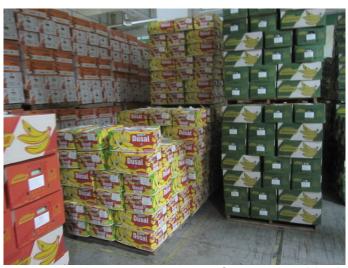
Cargo stored in the warehouse

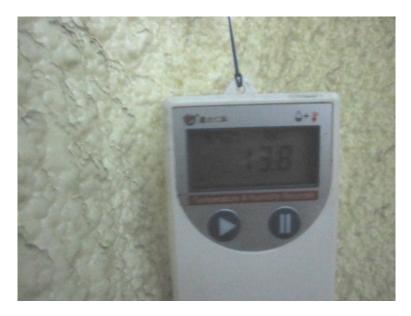
Warehouse cool room temperature

The temperature shown 13.8°C.

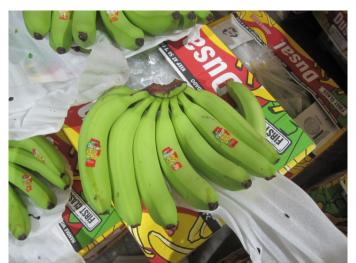
Initial maturation

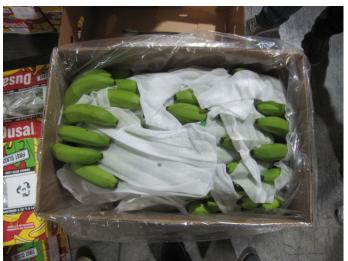
Initial maturation

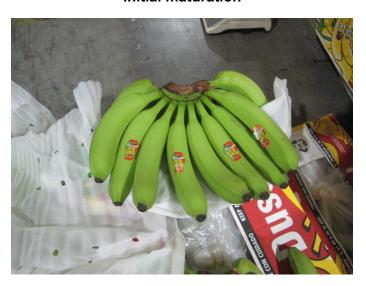
Initial maturation
