PRE-SHIPMENT INSPECTION REPORT

DESCRIPTION OF GOODS : FROZEN OCTOPUS
CLIENT : AQUA FROST LTD., UKRAINE.
PLACE OF INSPECTION : CAPITHAN EXPORTING COMPANY, KERALA, INDIA
DATE OF INSPECTION : 2ND SEPTEMBER 2021
SERVICE PERFORMED : Final Random Inspection

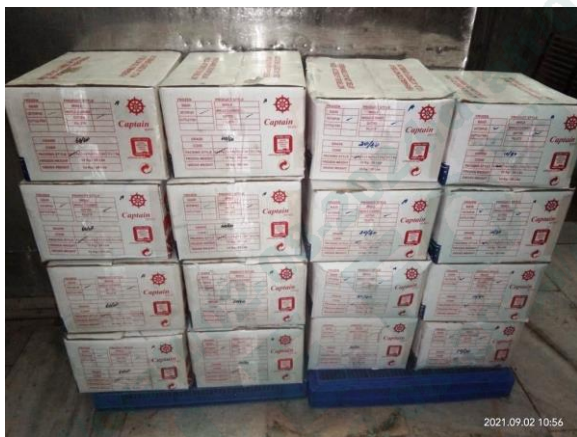
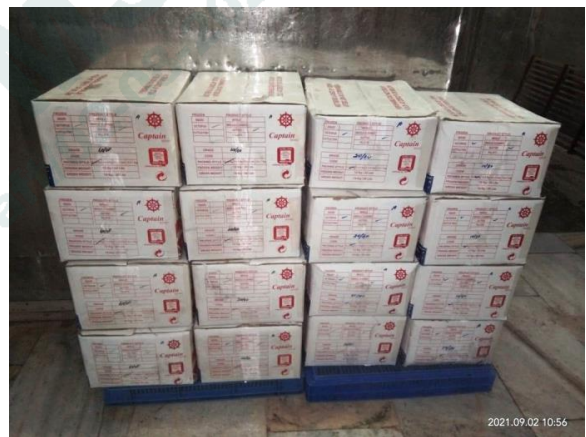
The subject cargo was placed on the cold storage of the supplier. Upon arrival, our inspector was directed to the same and presented with a complete cargo for inspection. The subject cargo was noted to be packed in cardboard boxes and stack in the cold storage of the supplier.

Cargo stacked in suppliers' cold storage

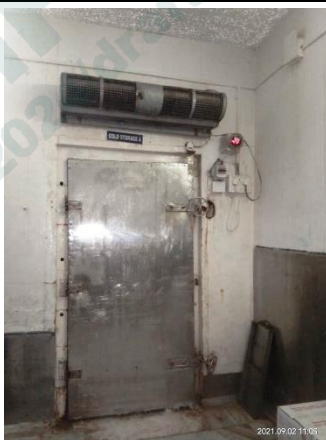
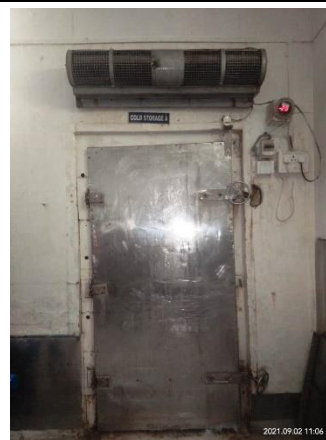
The temperature of the cold storage where the items were stowed was noted to be (-) 20.0°C & (-) 19.0°C. The subject cargo was checked by our inspector for any visible discrepancies/damages & none were identified. During the inspection, our inspector noticed 4 types of grades/size as follows, 10/20, 20/40, 40/60 & 60/UP. Grade wise our inspector checked the visual condition of the cargo. The cargo was in apparent sound condition. The cargo was packed grade-wise in 443 nos. of cardboard boxes. The details of packed boxes are mentioned in the below table.

The temperature of the cold storage

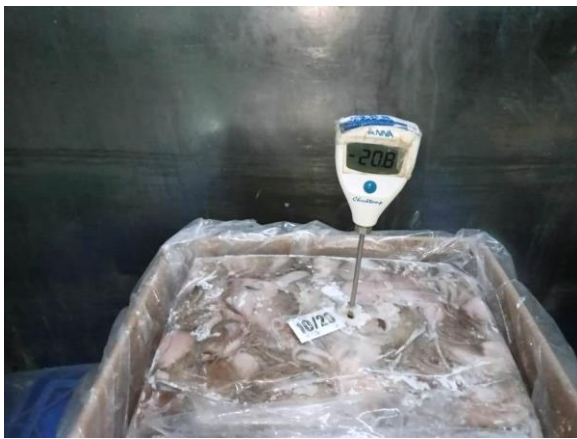
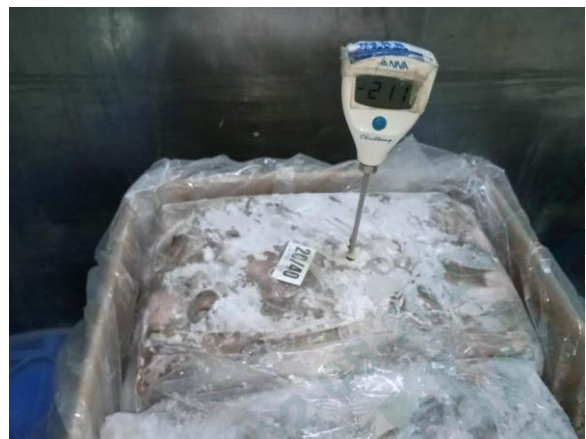
The temperature of the cargo

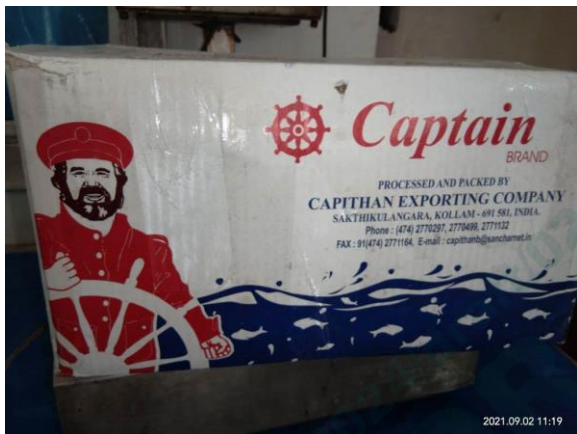
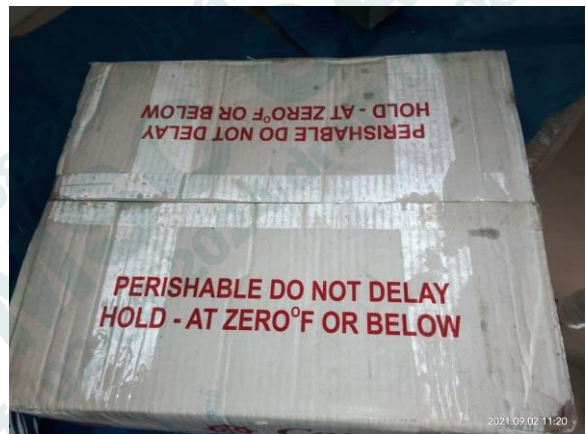
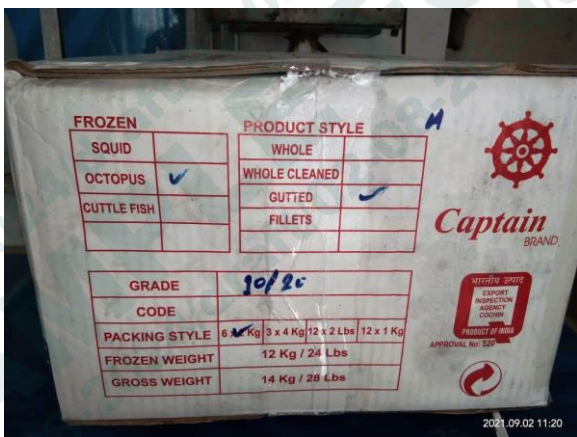
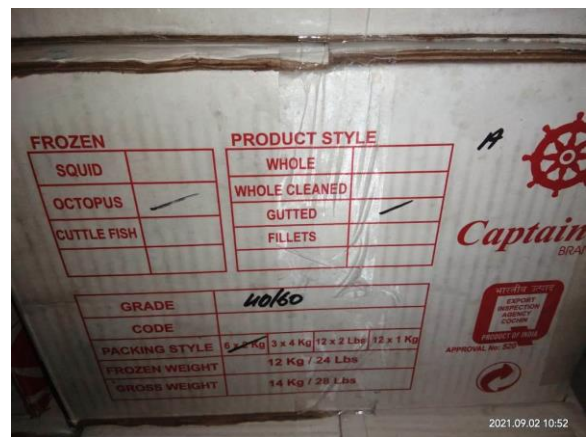
Marking on the boxes

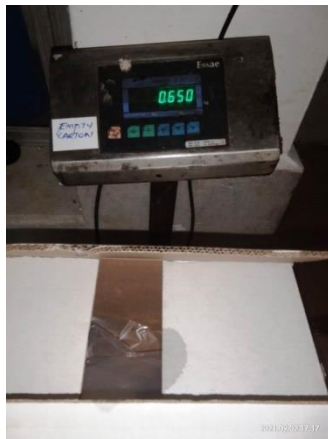
Weight checked of the empty box

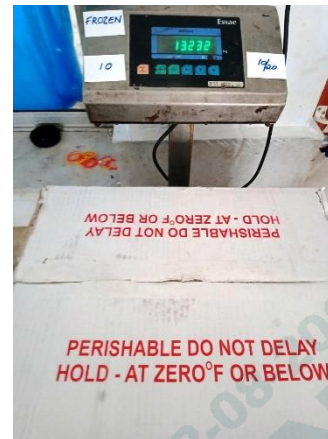
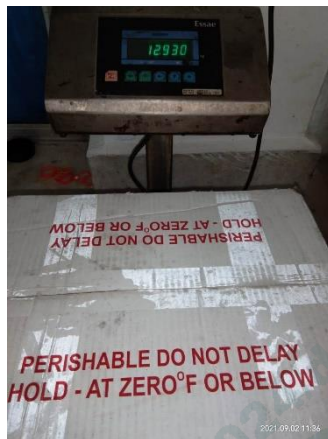
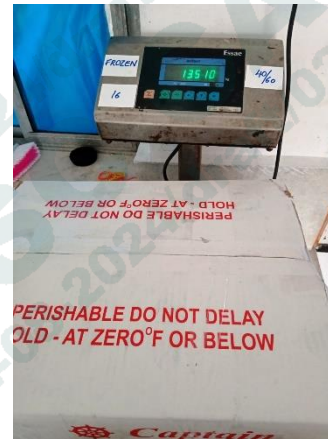
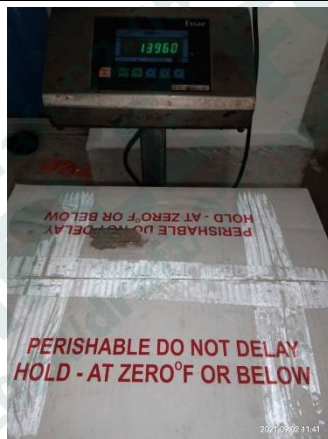
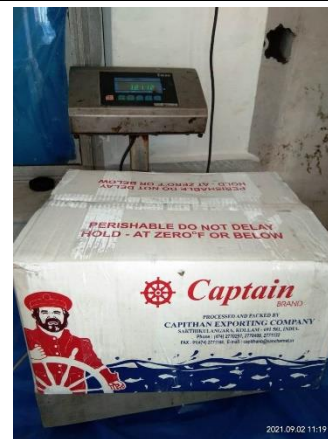
Gross weight checked of the boxes

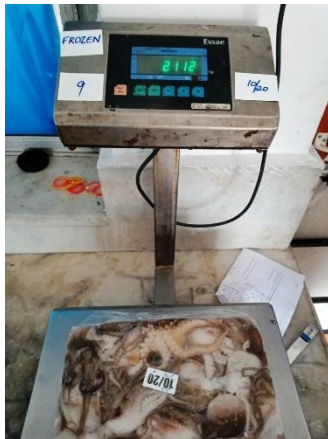
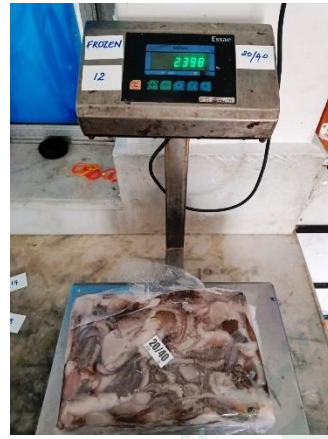
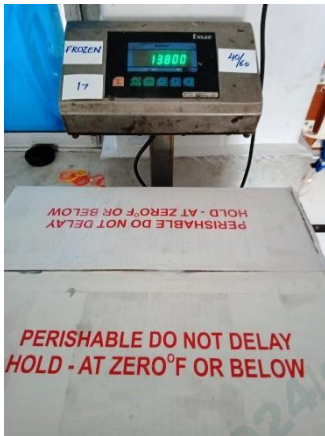
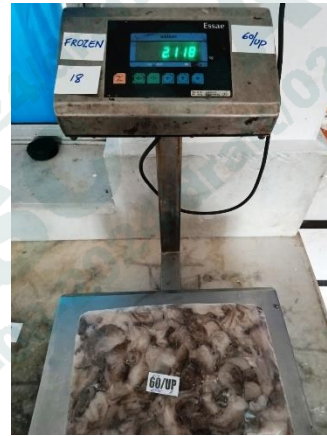
Weight checked of the selected block

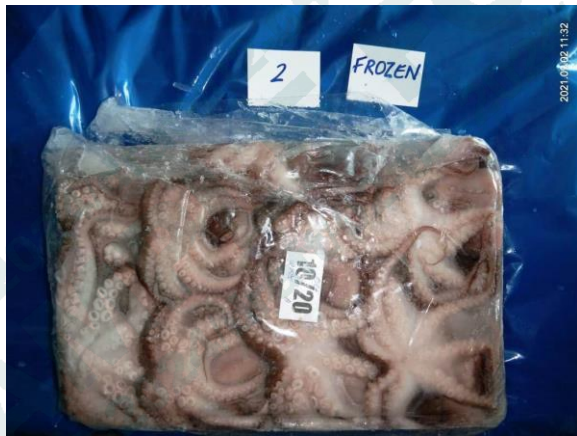
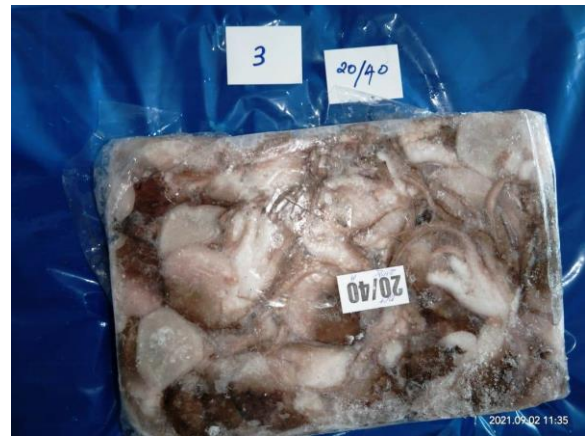
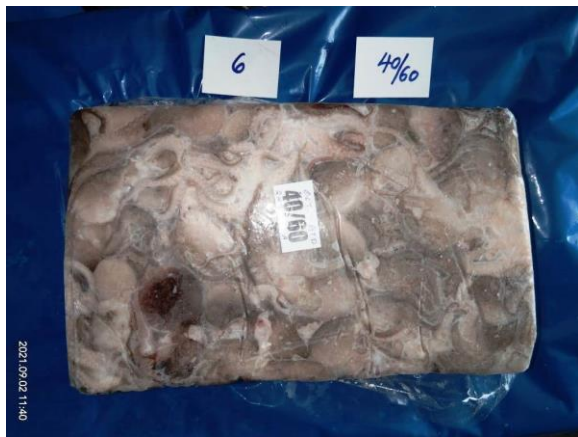
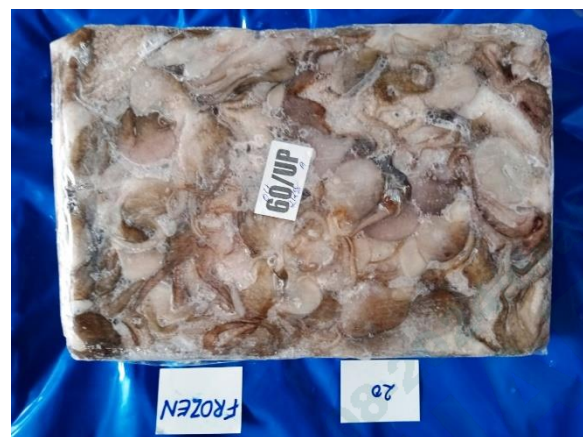
Grade-wise 1 block form each carton selected
for inspection

Grade-wise 1 block form each carton selected for inspection
