INSPECTION REPORT № 2512/14

Client:	XX
Description of goods:	HONEY POMELO
Quantity:	GROSS WEIGHT :20,850 MT as per B/L
Place of inspection:	UKRAINE, ODESSA
Date of inspection:	25.12.2014

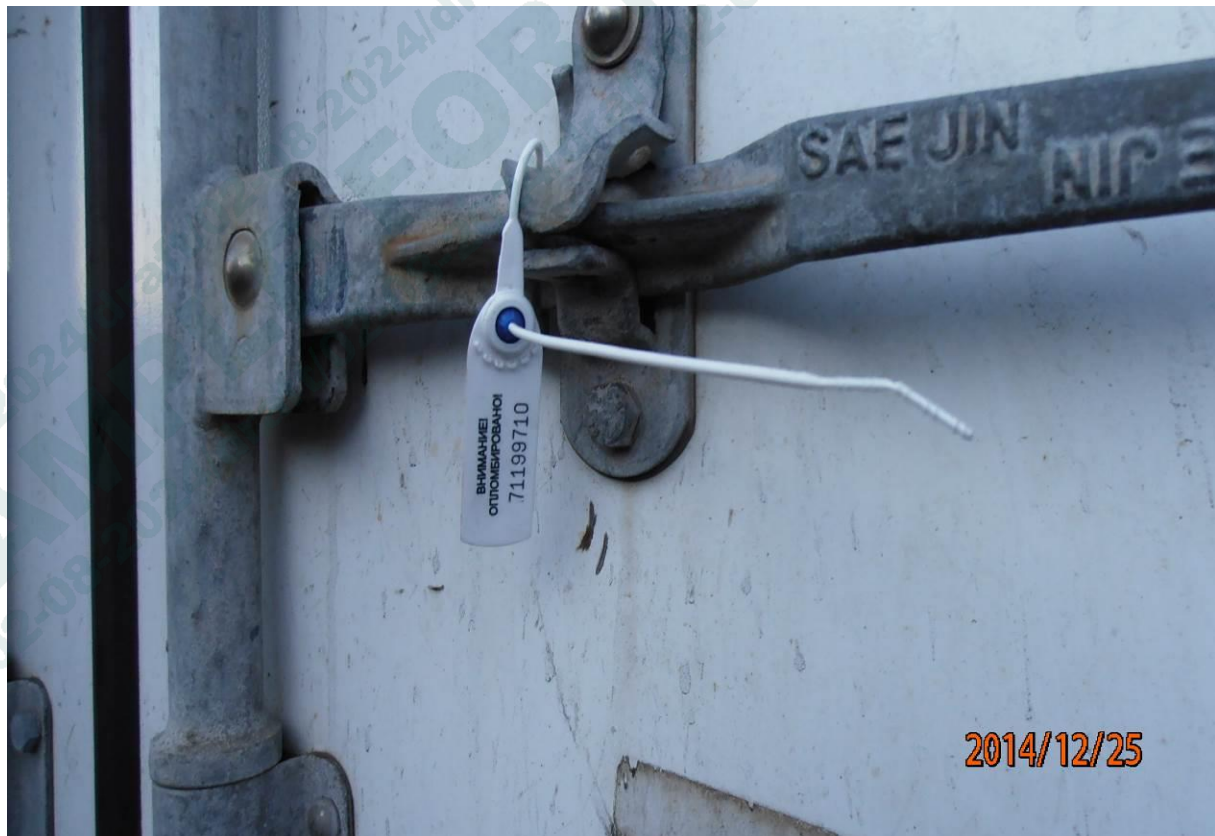
The cargo as presented to us was stored in refrigerator truck. The truck was sealed (seal №71199710).

Fruits were packed in paper boxes and stowed on wooden pallets.

Boxes stowed on the pallet were fixed by cardboard angles at the corners and cargo was without cover on top.

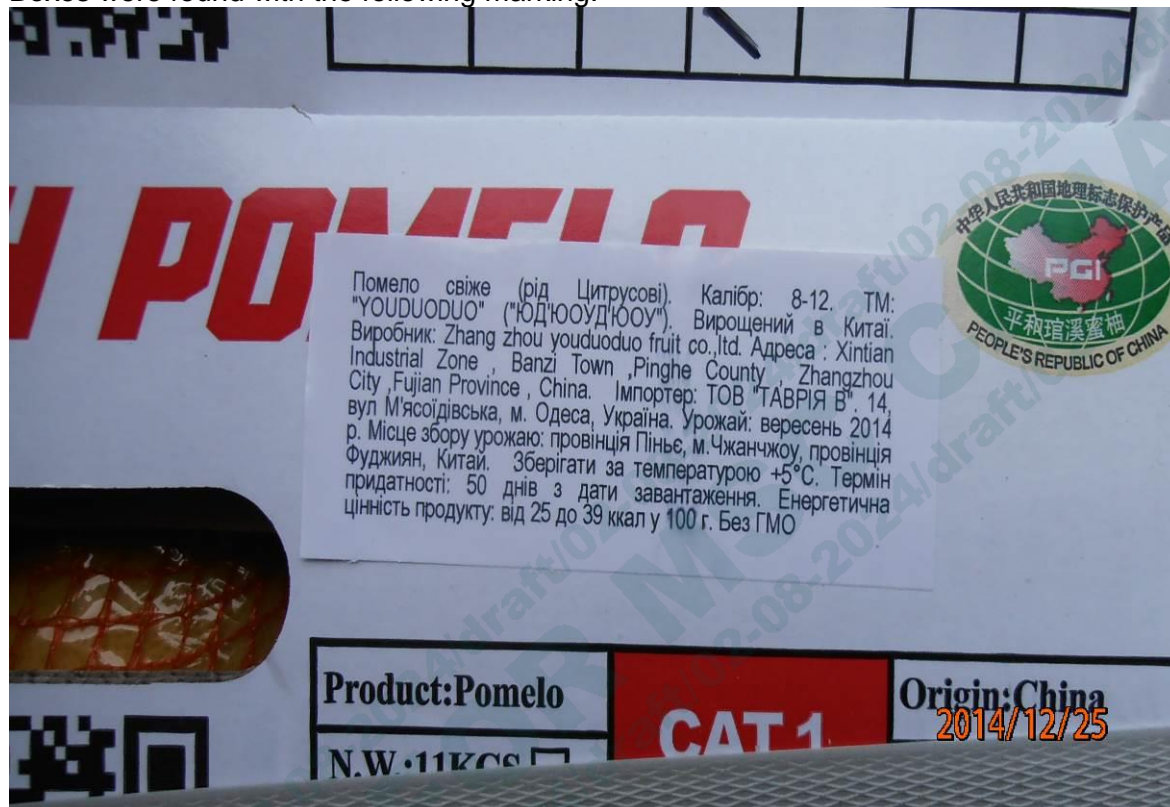
Boxes were found with the following marking:

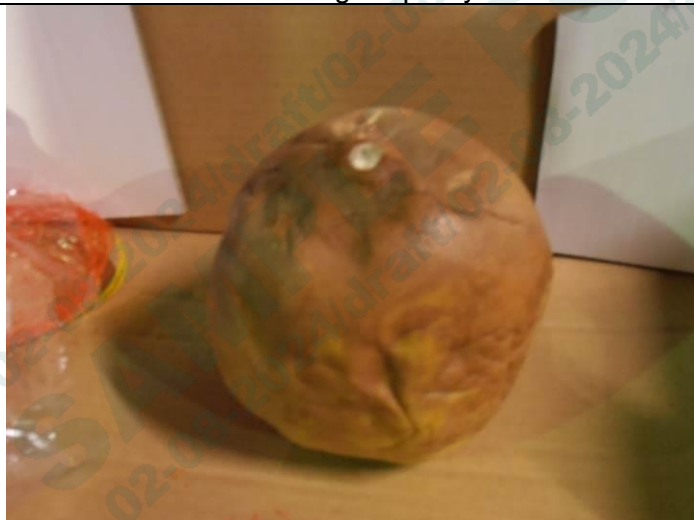
Abt. 45% of cargo was found with damage skin. Abt. 1% of cargo was found rotten.

Damages/Rotten

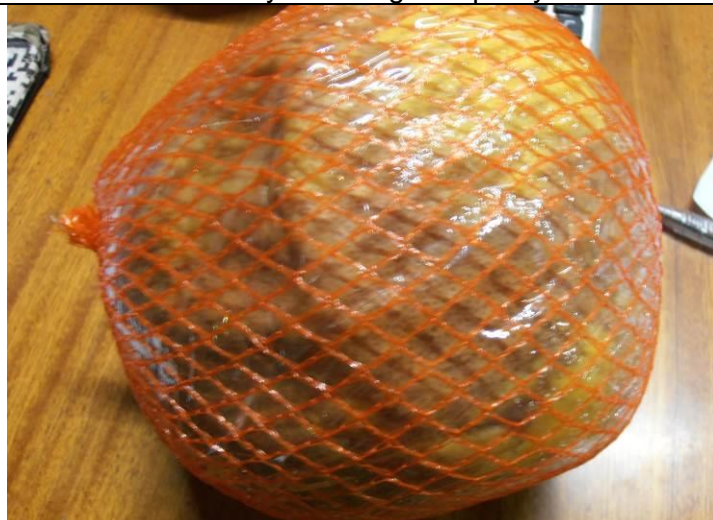
Damages/Rotten

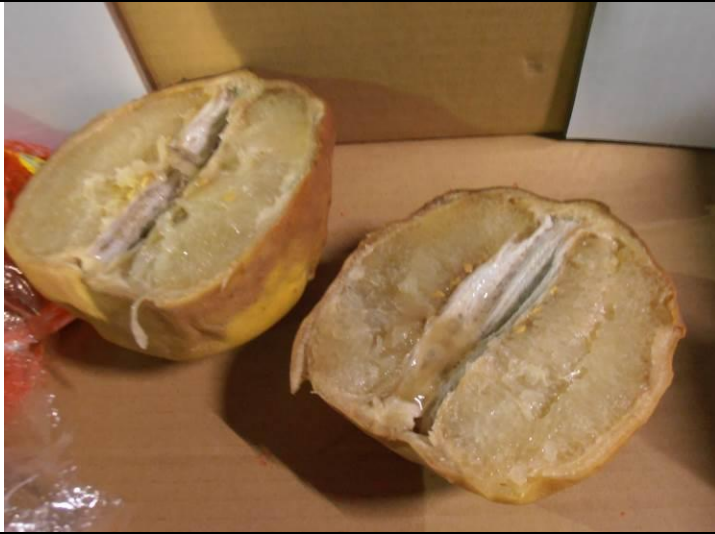
Damages/Rotten

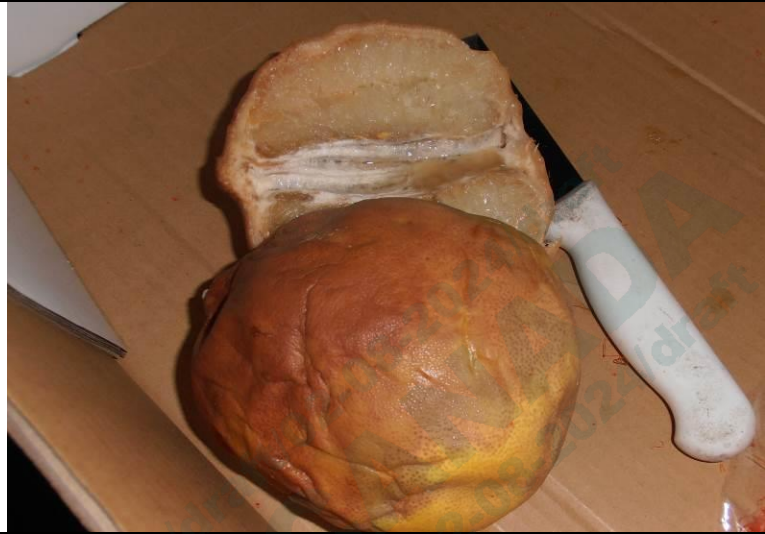
Damages/Rotten

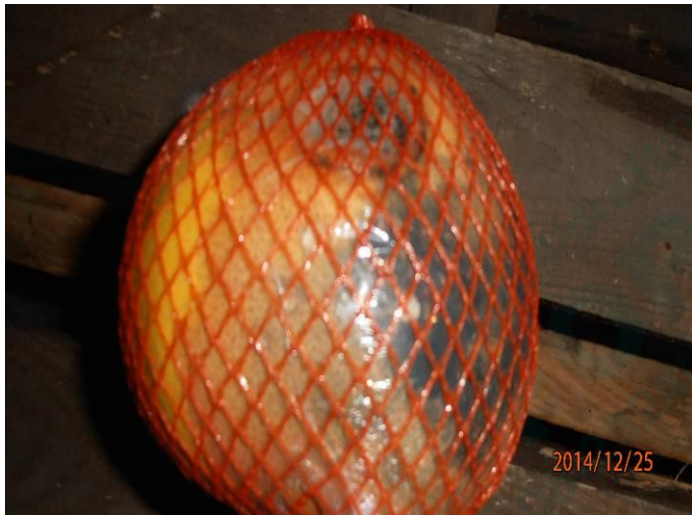
Damages/Rotten

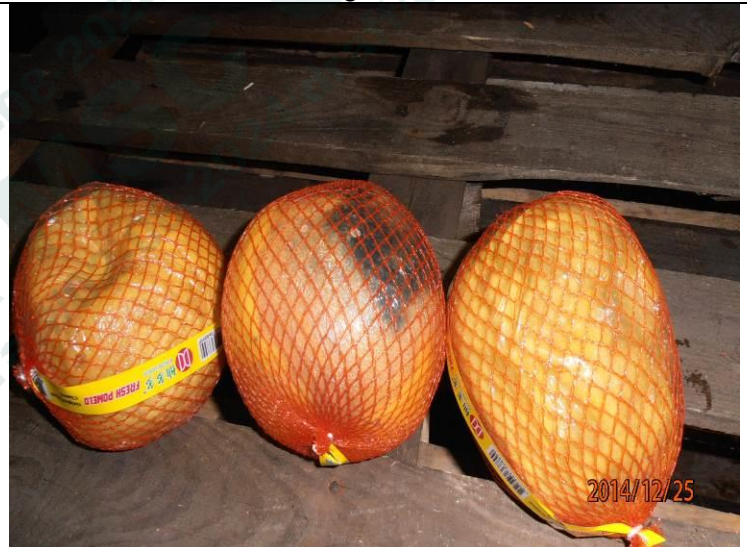
Damages/Rotten

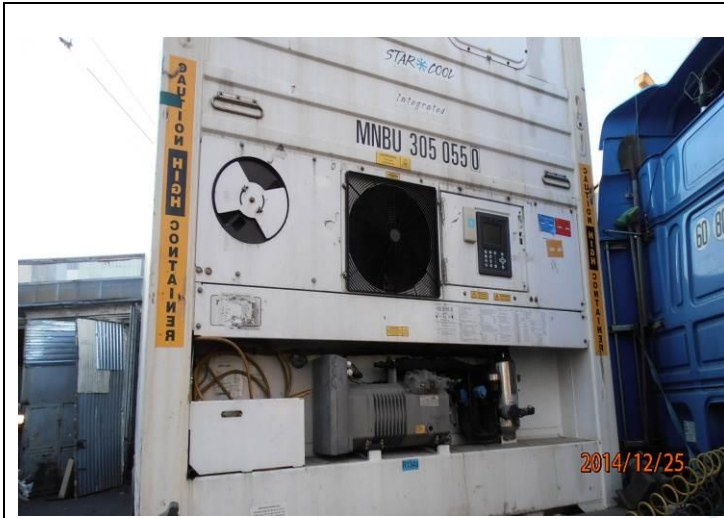
Checking the temperature of cargo was found + near 7.2 – 8.1 degree in cargo.

Checking the temperature sensor
