VESSEL GENERAL CONDITION INSPECTION REPORT

Tug boat "H.N. HODDER"

Address of inspection: 16031 River Road, Richmond,
B.C. Canada V6V 1X5
Date of inspection: October 10-th, Oct.13-th 2024
Time of inspection: 12:50 – 4:00 PM, 9:30-11:30 AM
CUSTOMER: Hodder Tugboats CO. LTD.

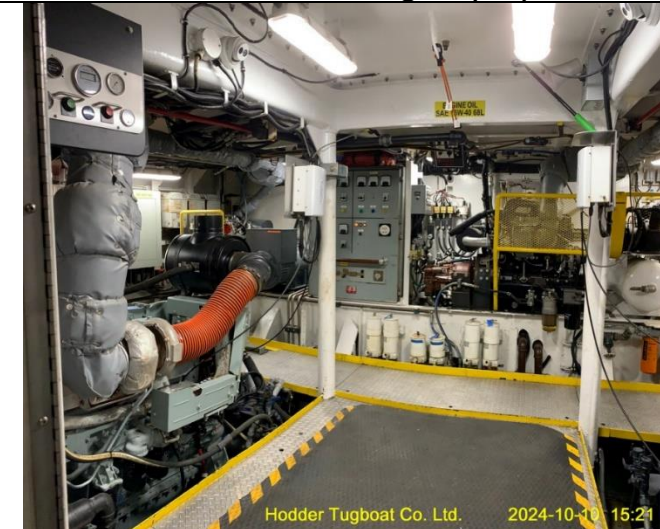
Port side main engine (ME)
