SURVEY REPORT

INSPECTION AT DOCKYARD AFTER FIRE ACCIDENT

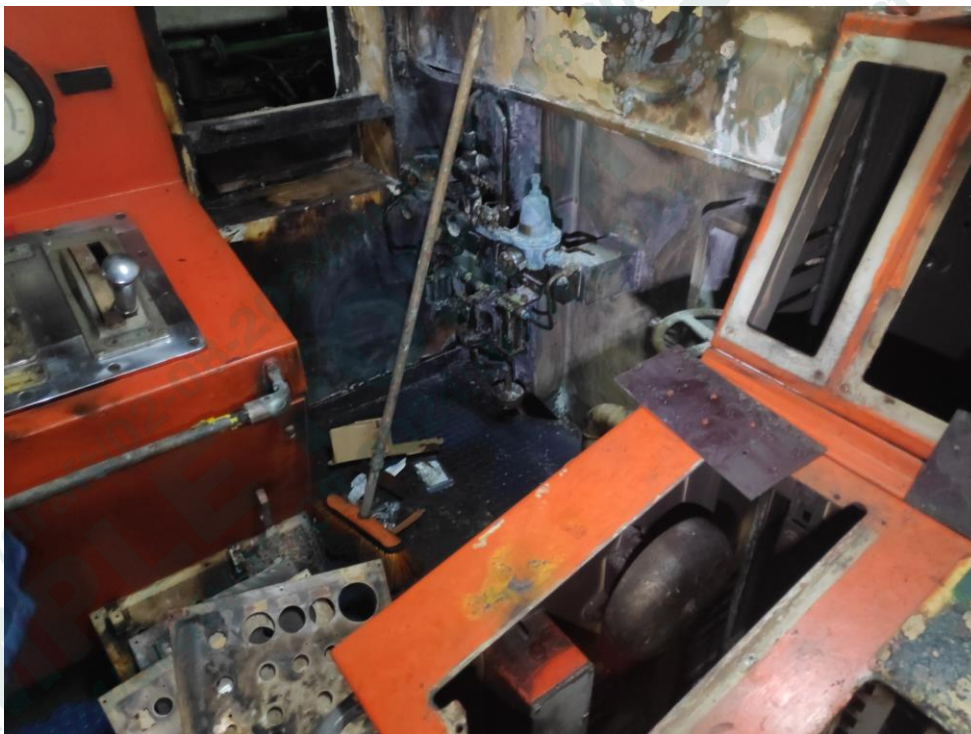
Main Switchboard.

- Main Switchboard was partly burned/affected (Photos 2, 3).
- Main Control Panel was totally burned/affected (Photo 5).
- Control Panels was partly burned/affected (Photos 6, 7).
- The ceiling was totally burned and removed (Photos 8, 9).
- The walls and floor were partly burned/affected (Photos 3-8). Floor was partly burned/affected at the area close to Main Switchboard.
- One window broken (Photo 10).
- The decks above and below the Control Room were not allowed for inspection, but as it could be seen, they were not damaged during the fire (Photos 11, 12).

- The main switchboard was affected;
 - The control panel of the main engine was affected;
 - The starting air system of the main engine was burned;
 - The whole ceiling, floor and walls were burned/affected;
