VESSEL GENERAL CONDITION INSPECTION REPORT

Tug boat "H.N. HODDER"

Address of inspection: 16031 River Road, Richmond,
B.C. Canada V6V 1X5
Date of inspection: October 10-th, Oct.13-th 2024
Time of inspection: 12:50 – 4:00 PM, 9:30-11:30 AM
CUSTOMER: Hodder Tugboats CO. LTD.

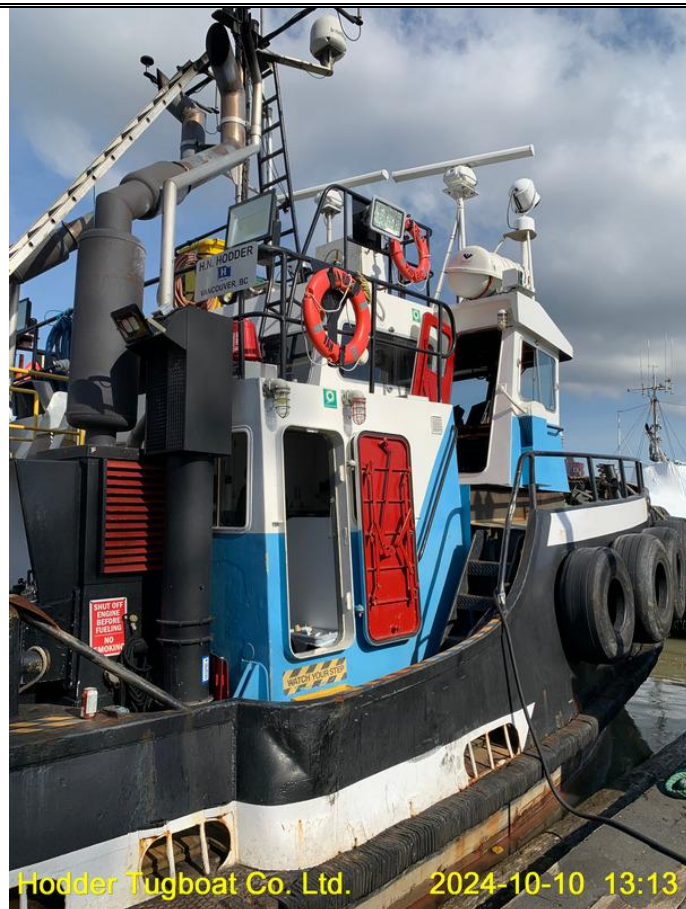
Starboard side general view

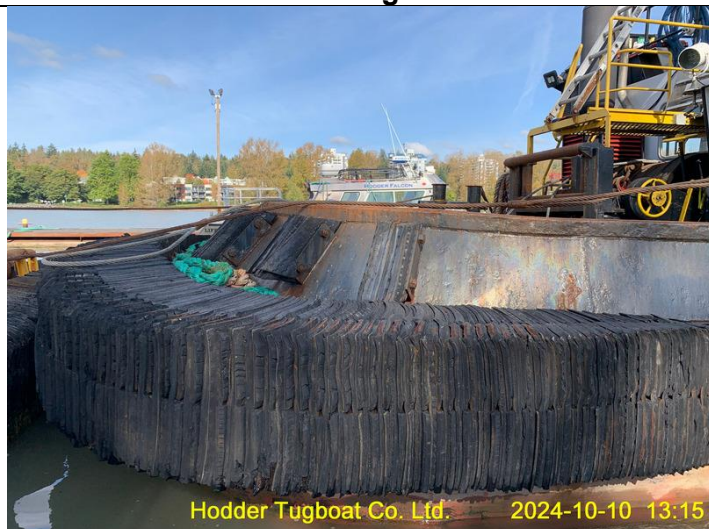
Stern fender/view from the starboard side

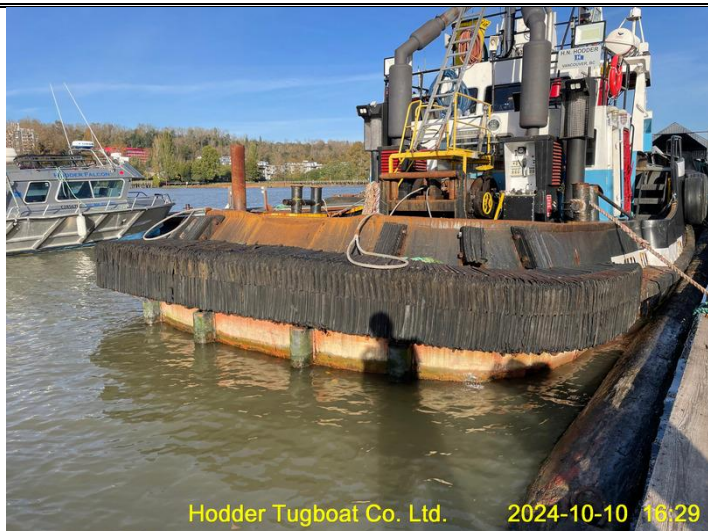
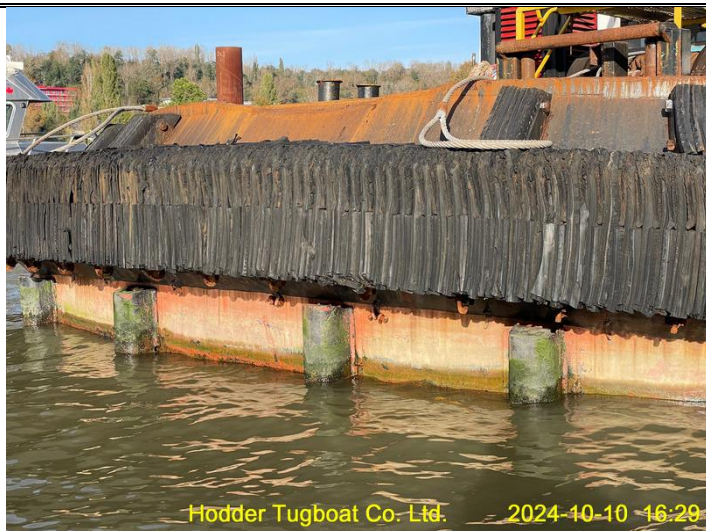
Stern fender/view from the starboard side

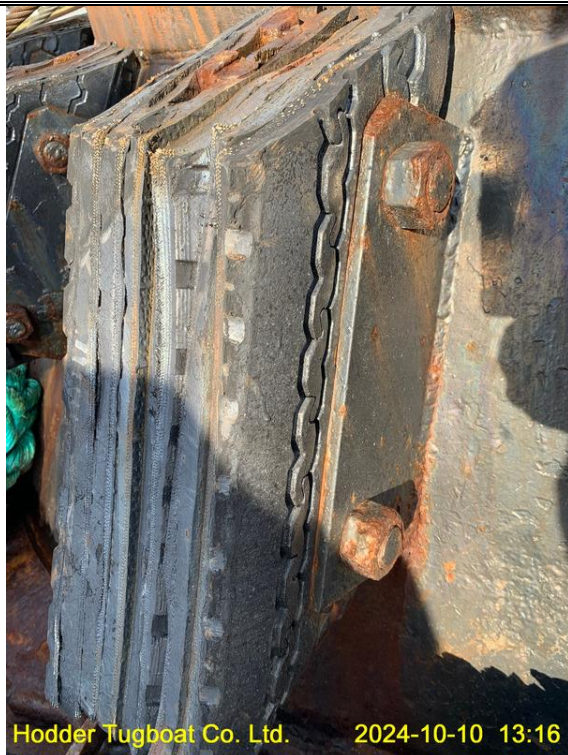
Stern fender close view

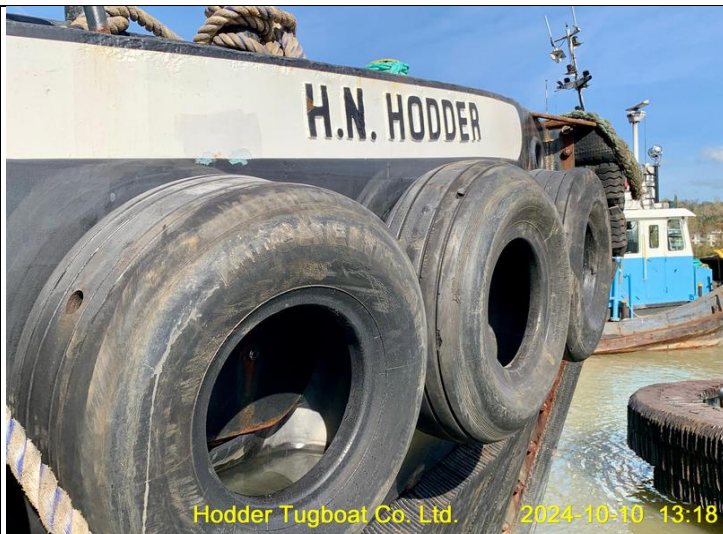
Starboard fenders, general view

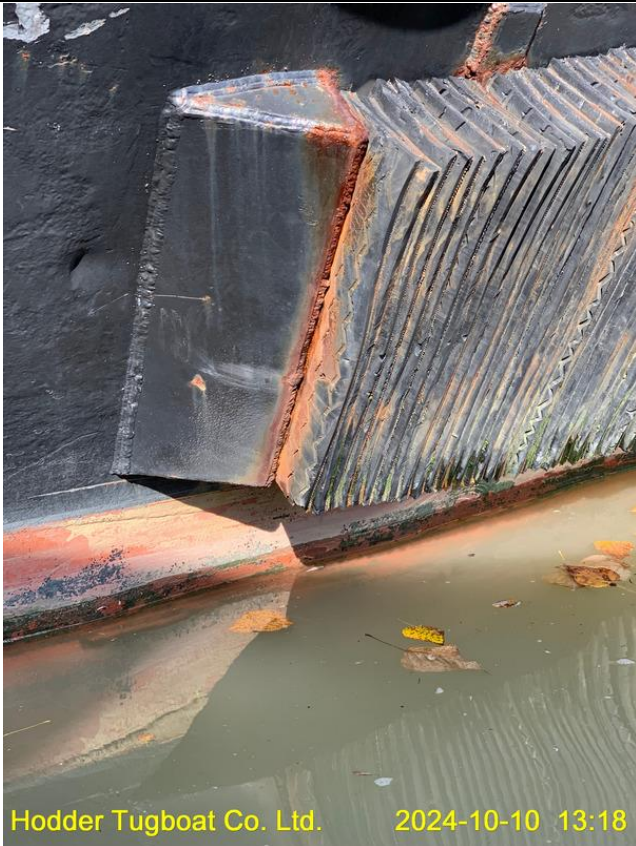
Starboard fender above the water line

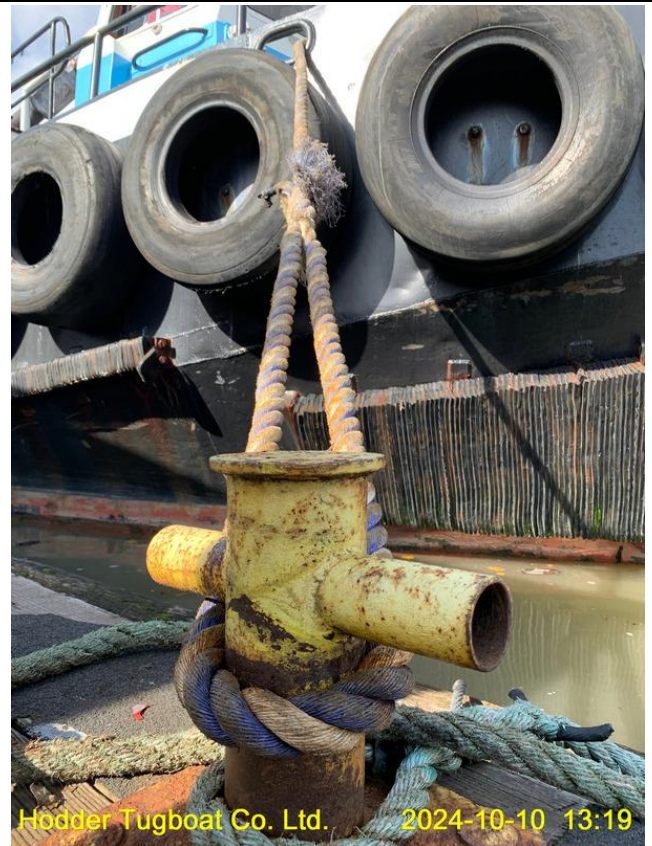
Berthed tugboat with nylon rope to mooring bollard

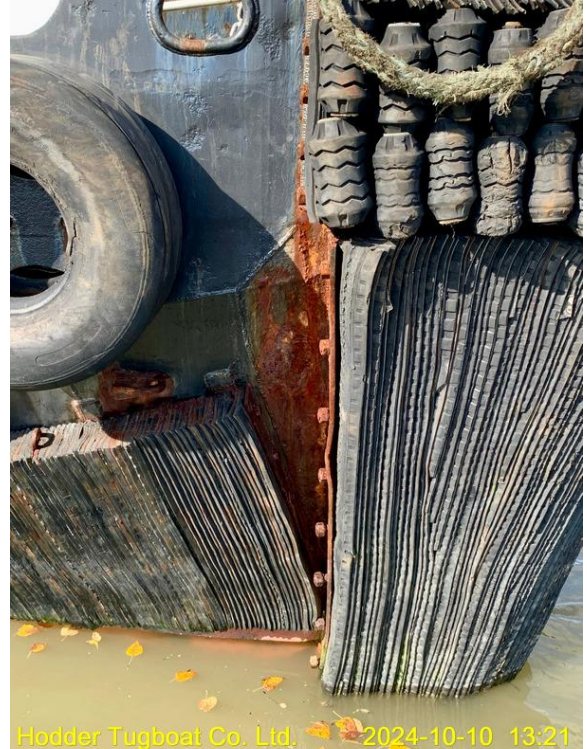
Bow fenders

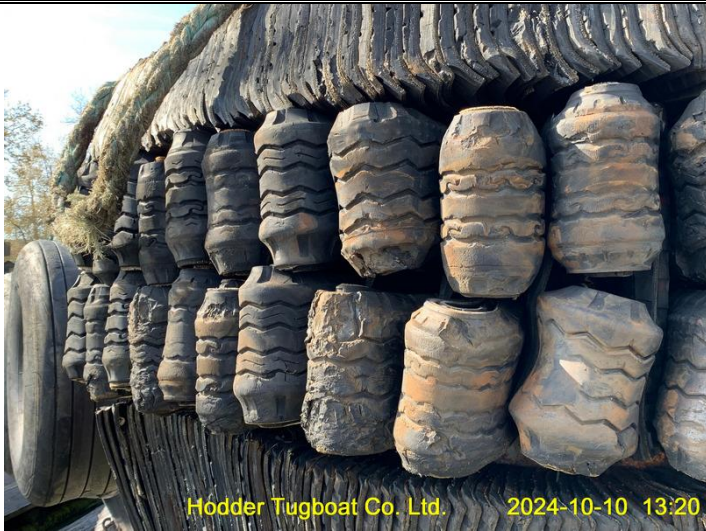
Bow fenders

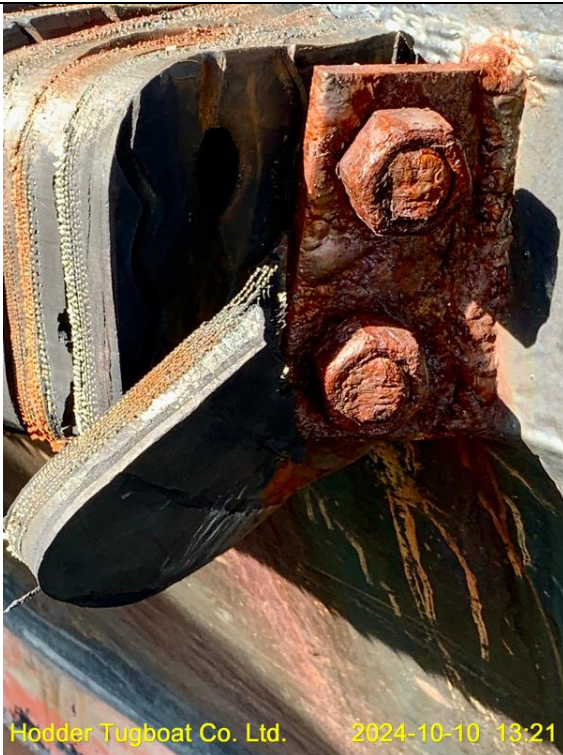
Starboard fender mounting

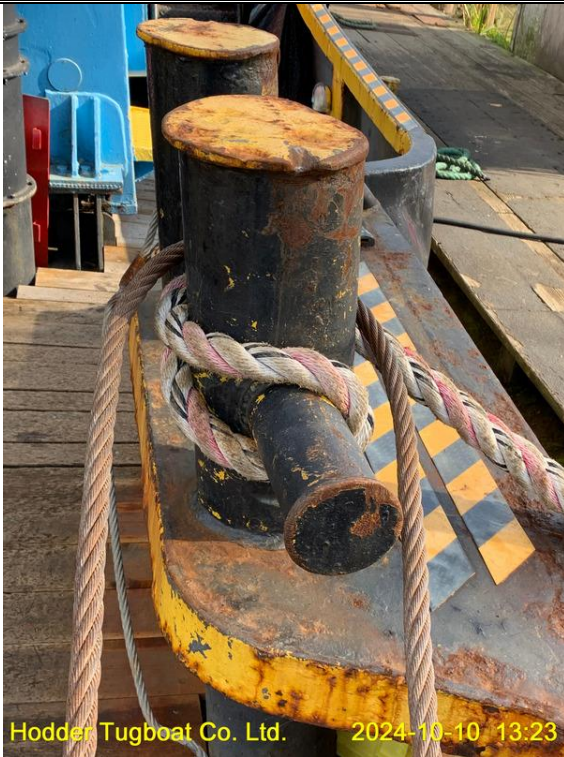
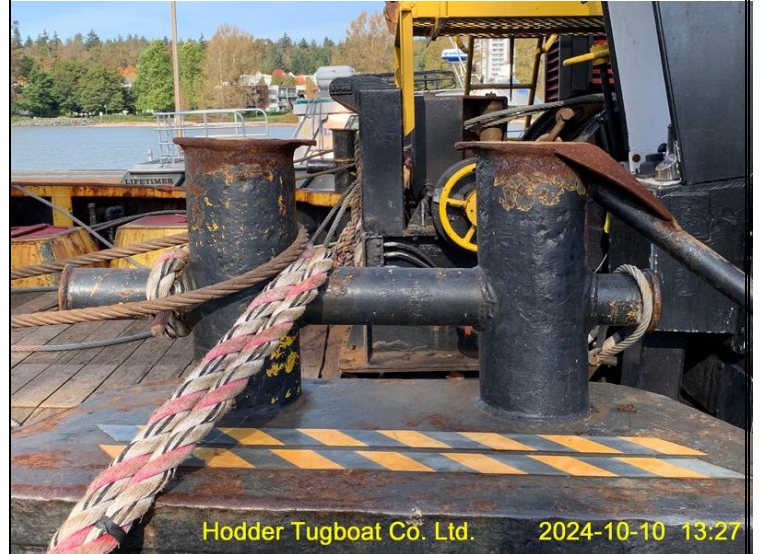
The boat's starboard mooring bollard

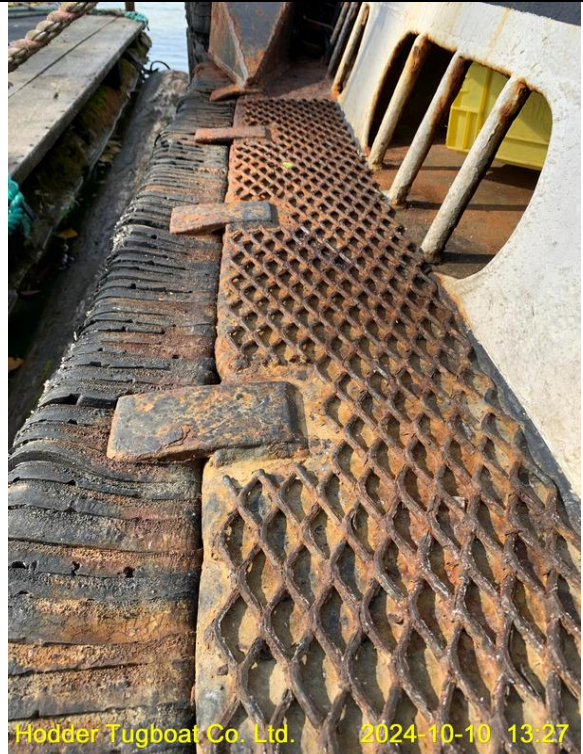
Anti-slip flooring

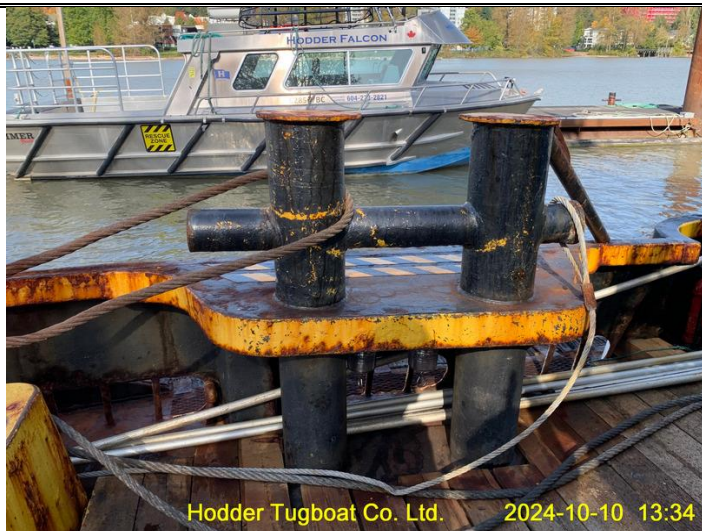
Port side mooring bollard

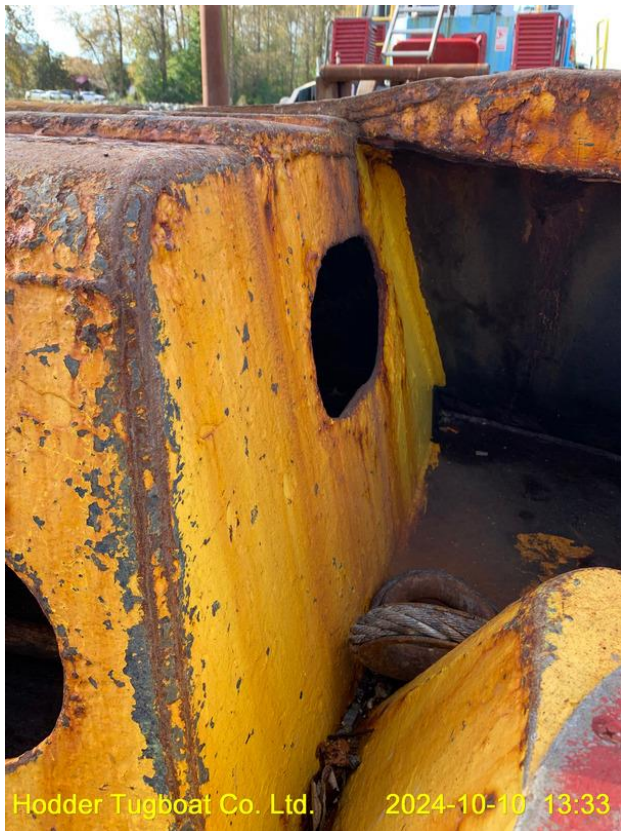
Side view of the fairlead roller foundation

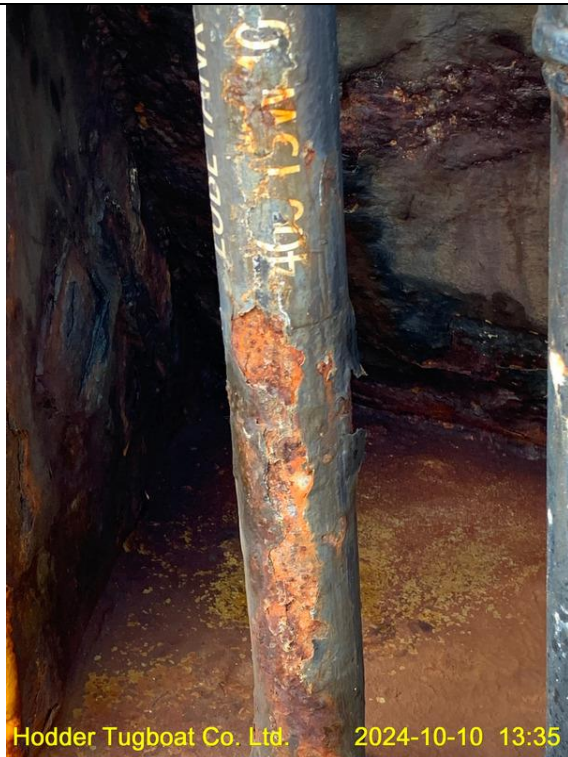
Rusted lube tank pipes and vent/air pipes

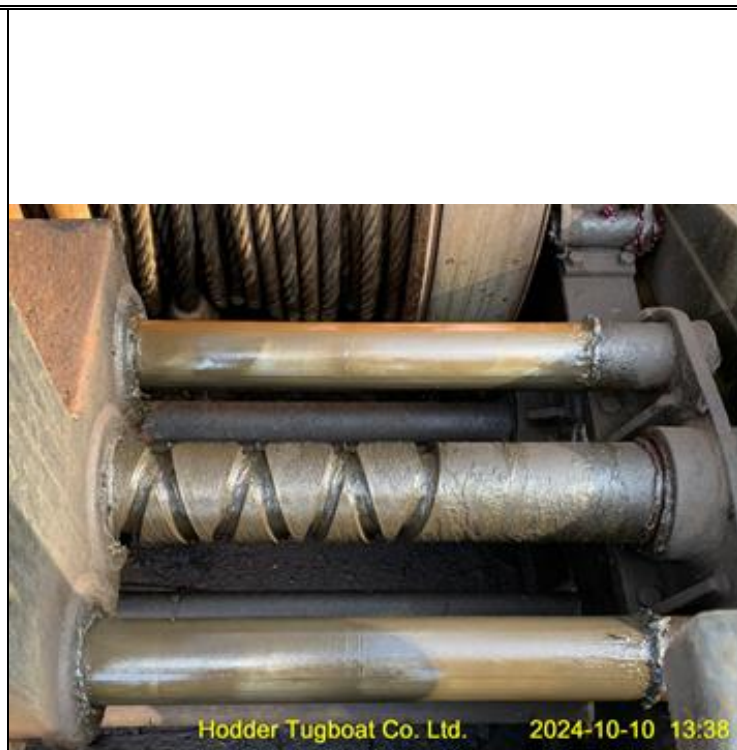
Lead roller operating range mechanism

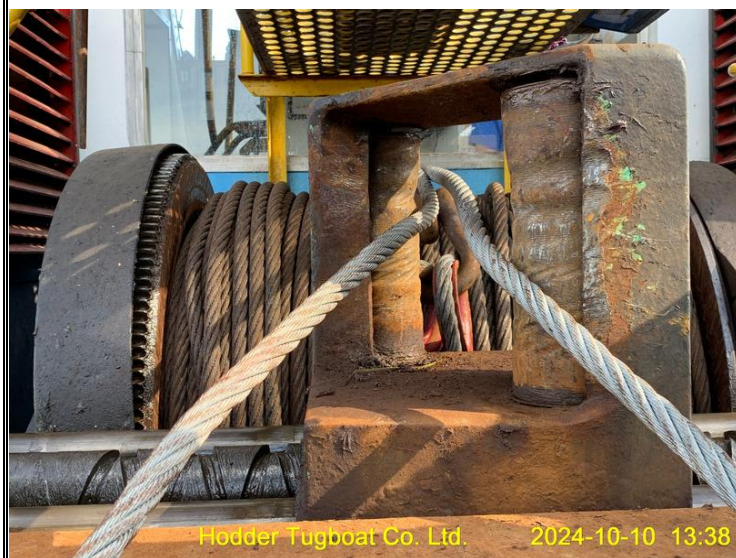
Lead rollers with wire ropes of the winch

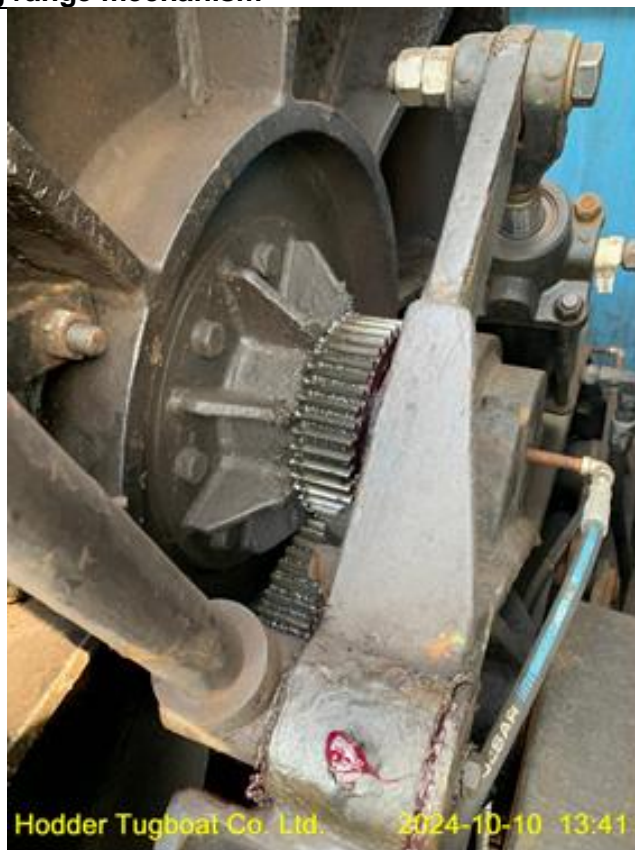
Winch gear transmission and braking system

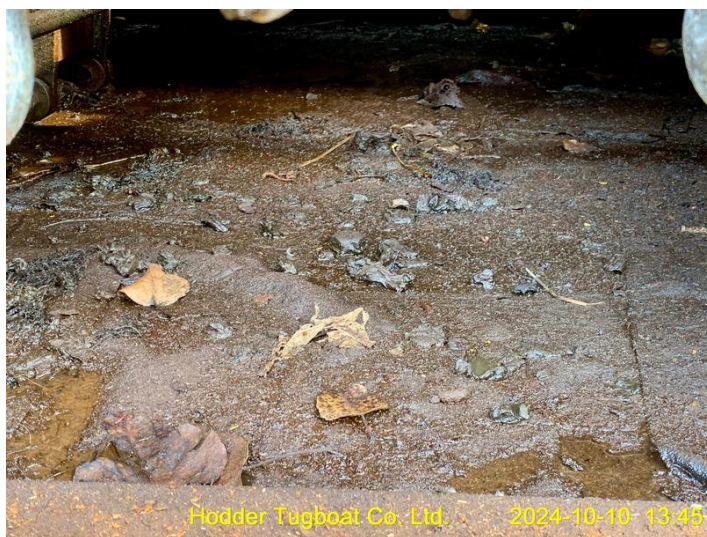
Dirty and greasy deck surface (under the towing winch)

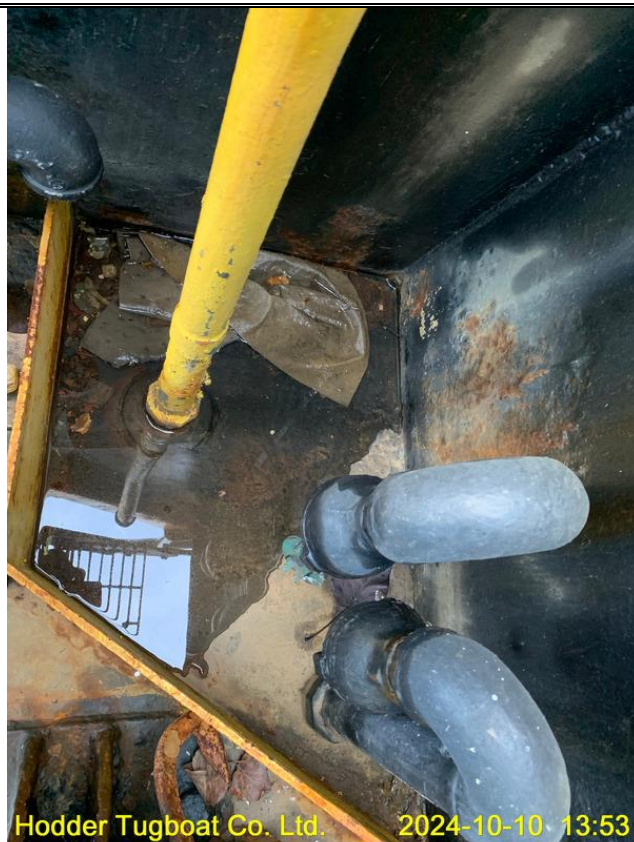
Bunkering piping section and oil spill area

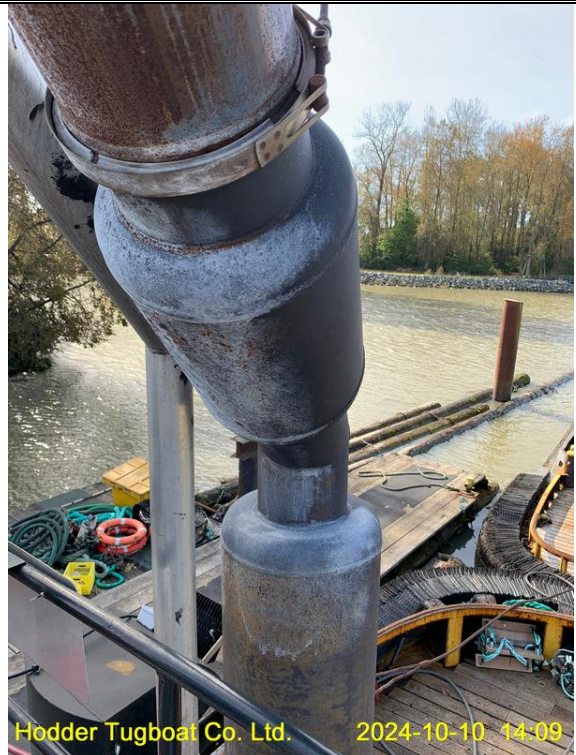
Exhaust gas pipes with muffler

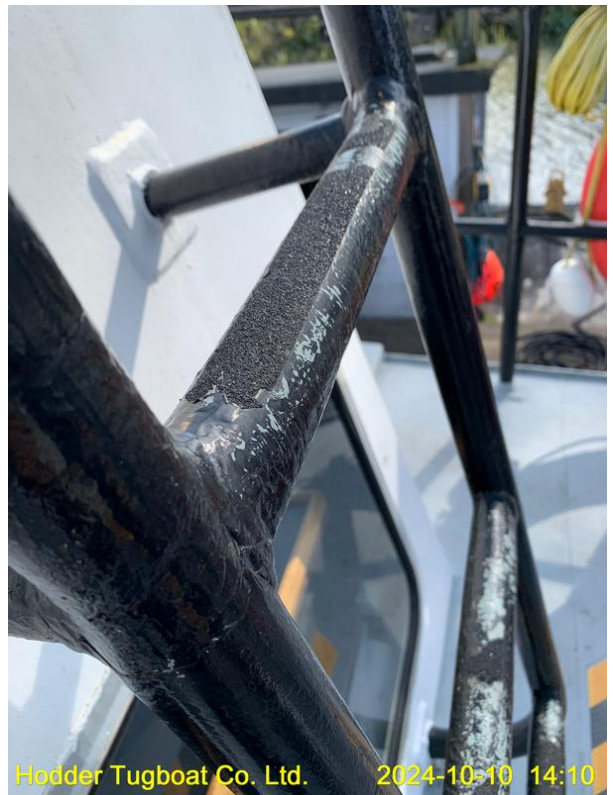
Grip equipped ladder

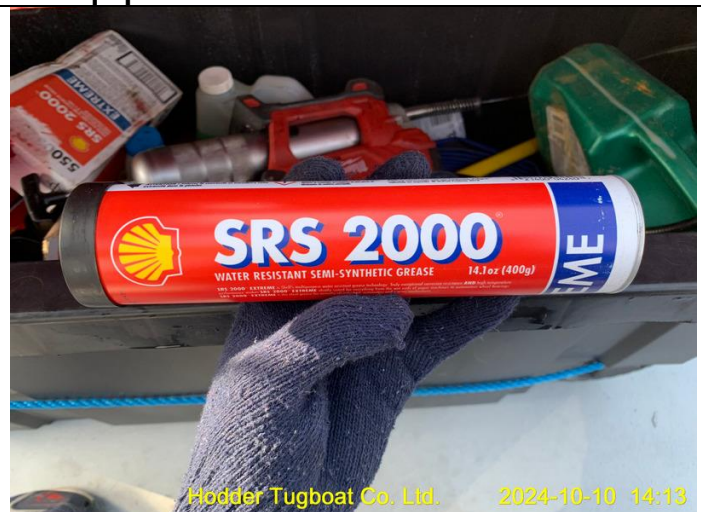
Reserve water resistant grease for deck machinery/bearings

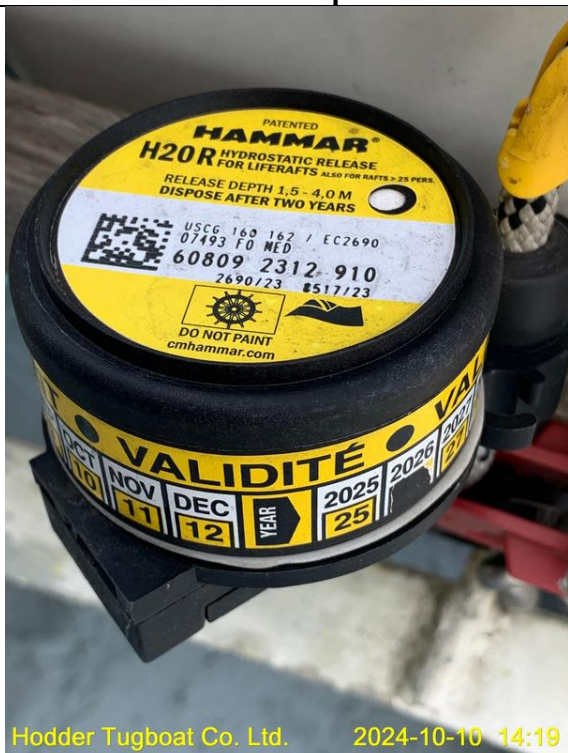
Up-to-date servicing and maintenance of the rafts

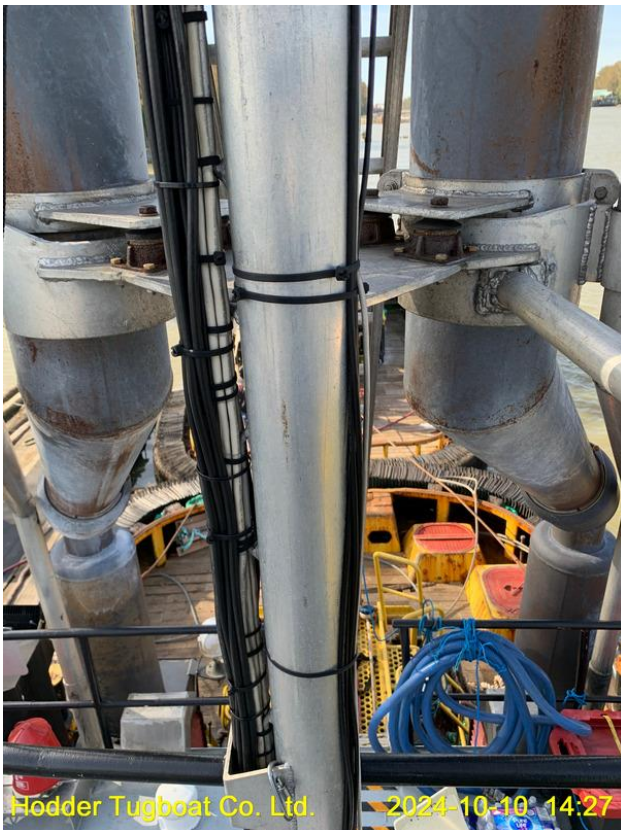
Exhaust gas pipe mounts

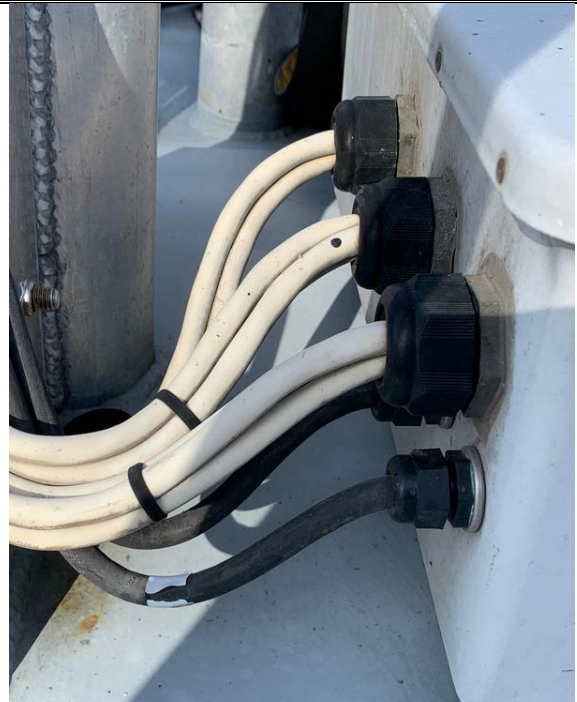
Water insulated wiring in electrical box

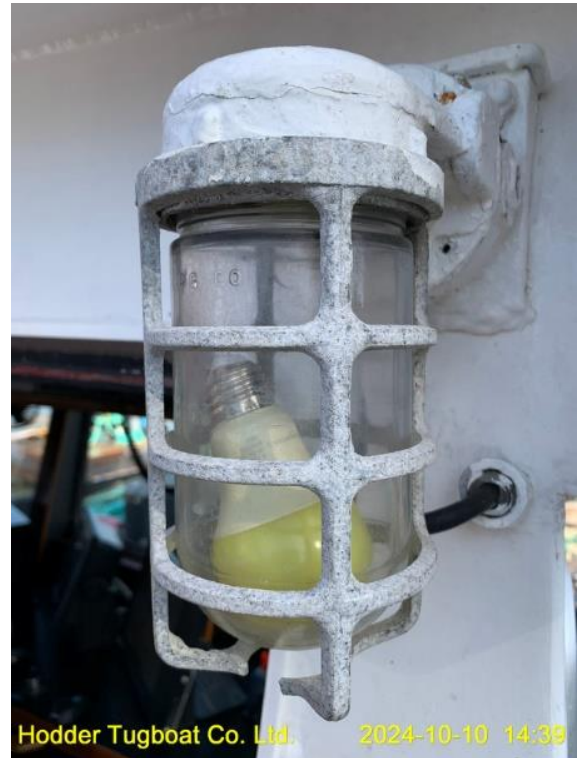
Light bulb, not in order

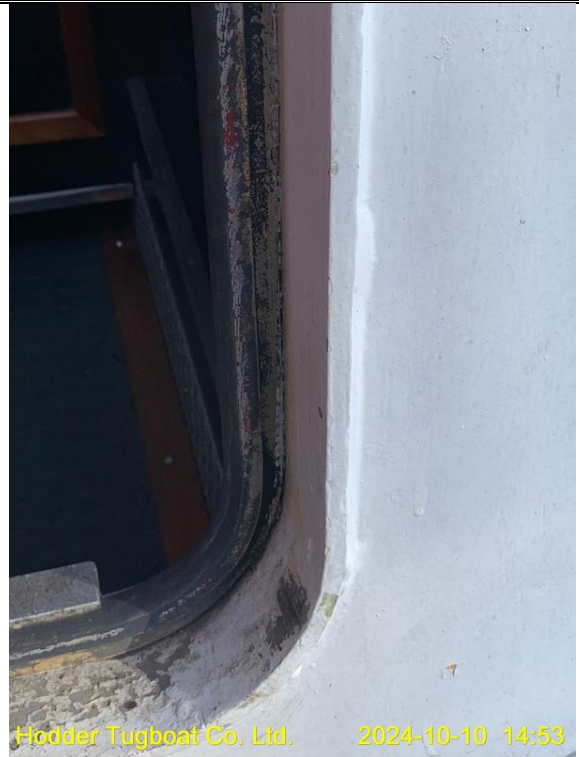
Condition of the doorway panel into the upper cabin

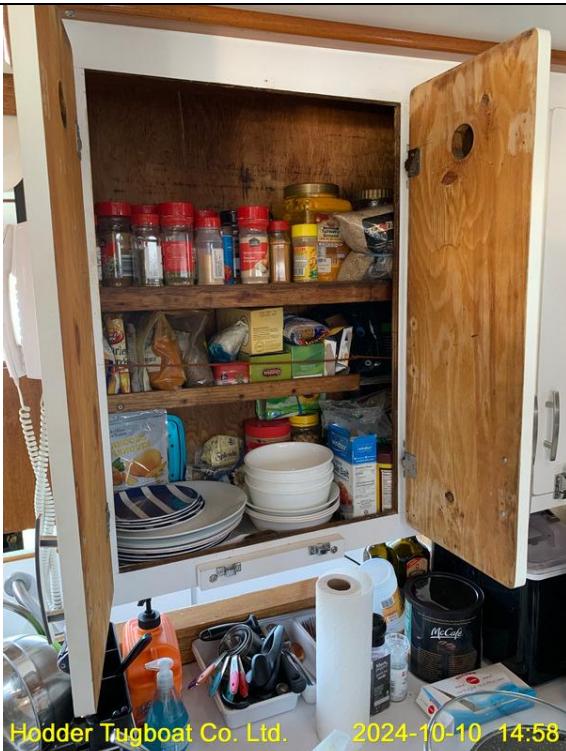
Galley bay

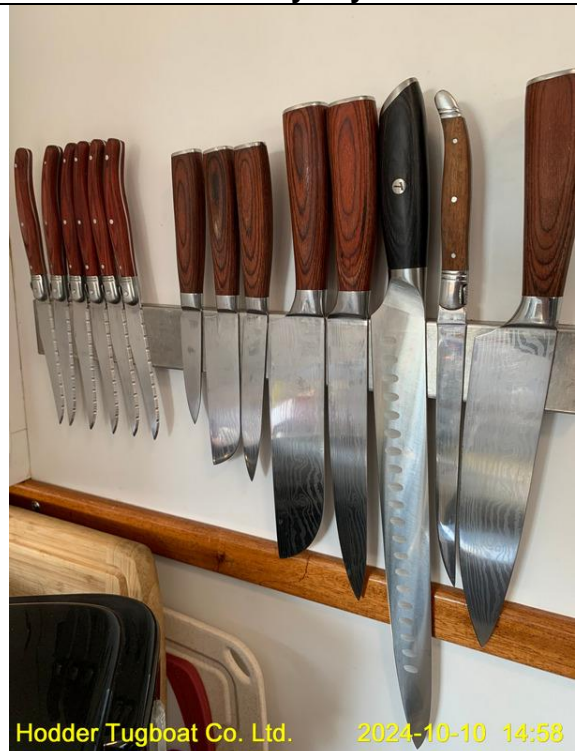
Cooking supplies

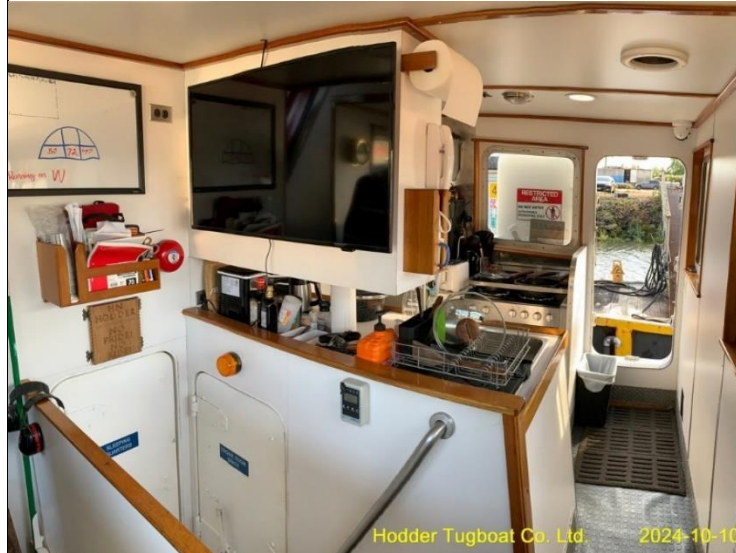
Galley view from starboard entrance

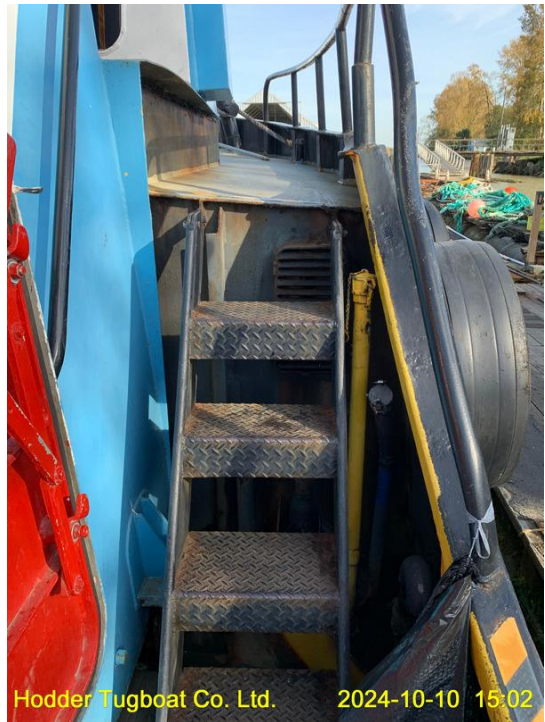
Starboard side entrance to the superstructure/galley area from the deck

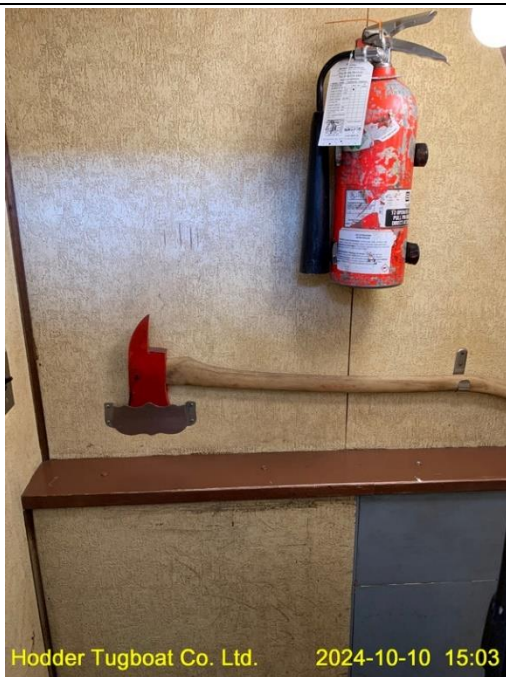
Firefighting equipment at the entrance

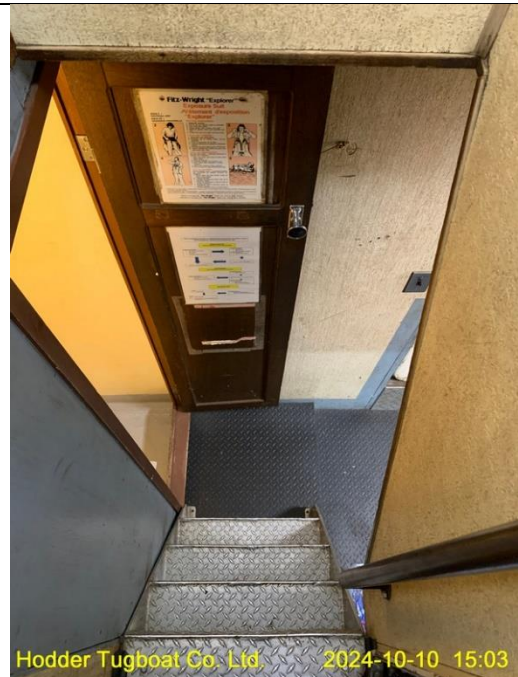
Stair way towards engine room

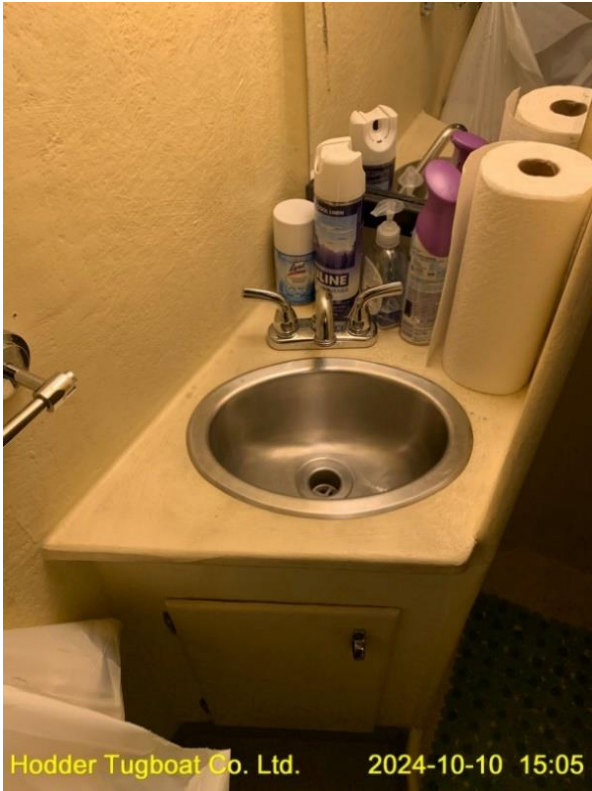
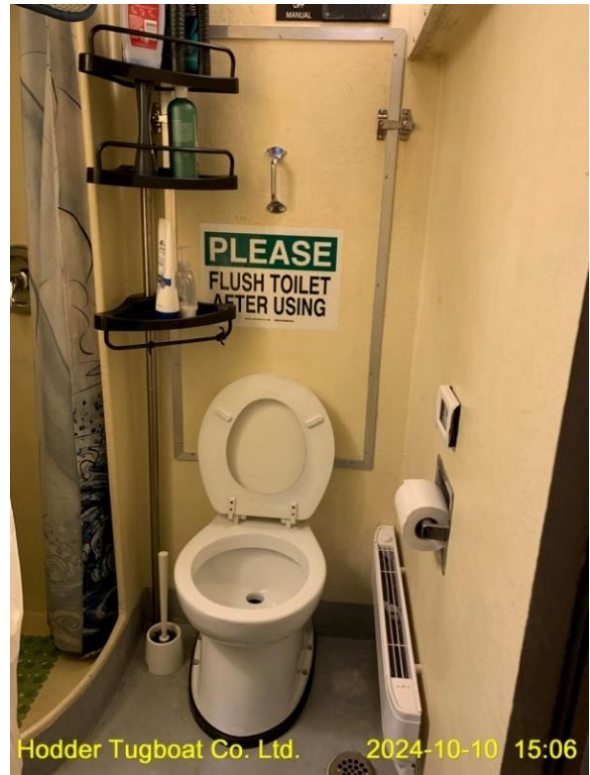
Washroom (toilet and shower) space

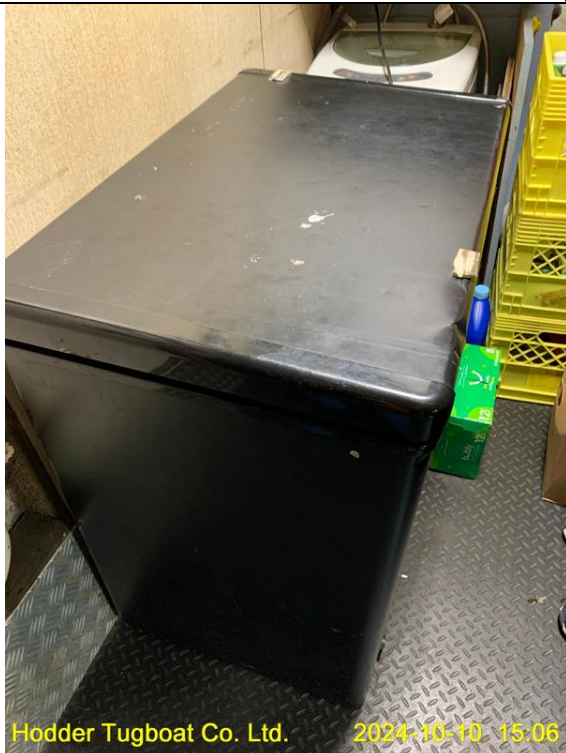
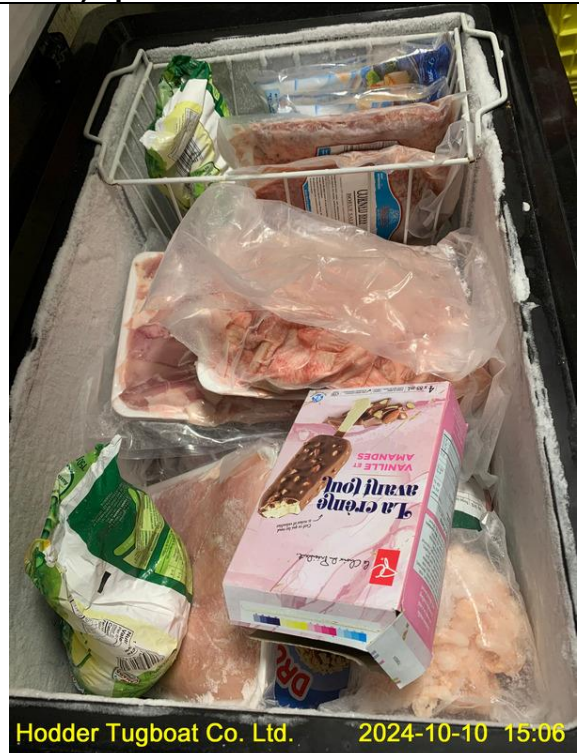
Food freezer

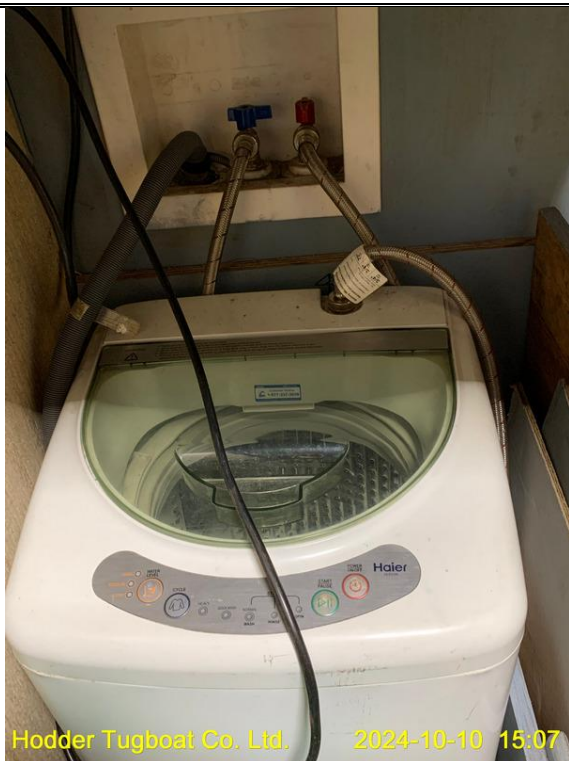
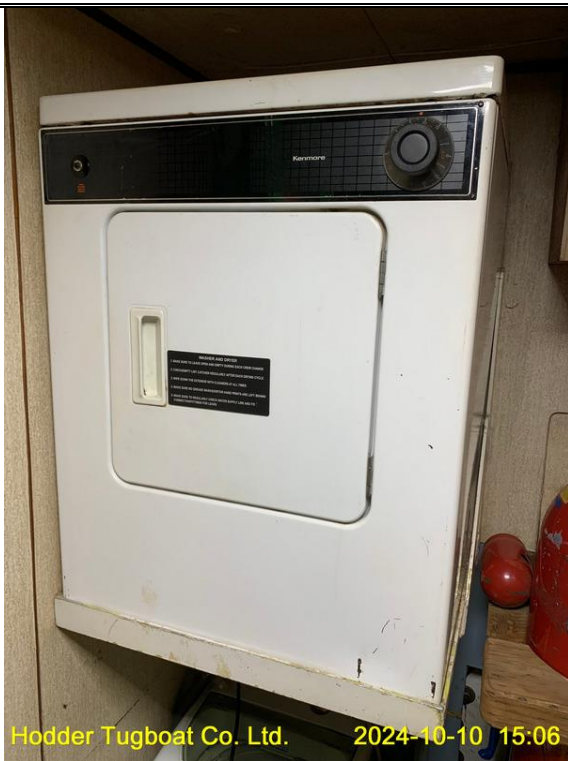
Washing machine and dryer

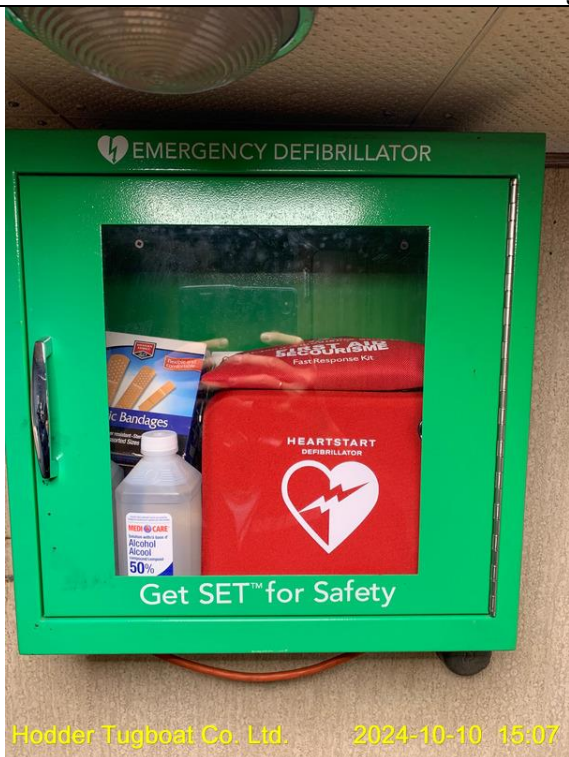
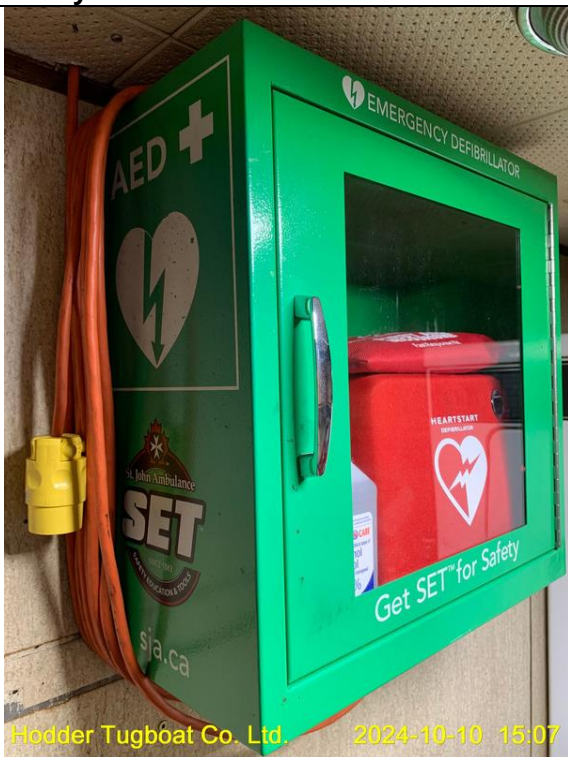
Emergency defibrillator and first aid kit

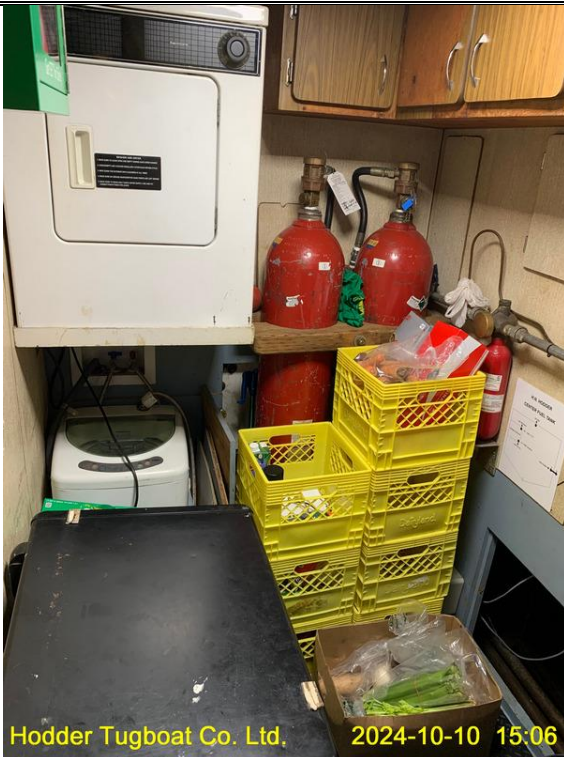
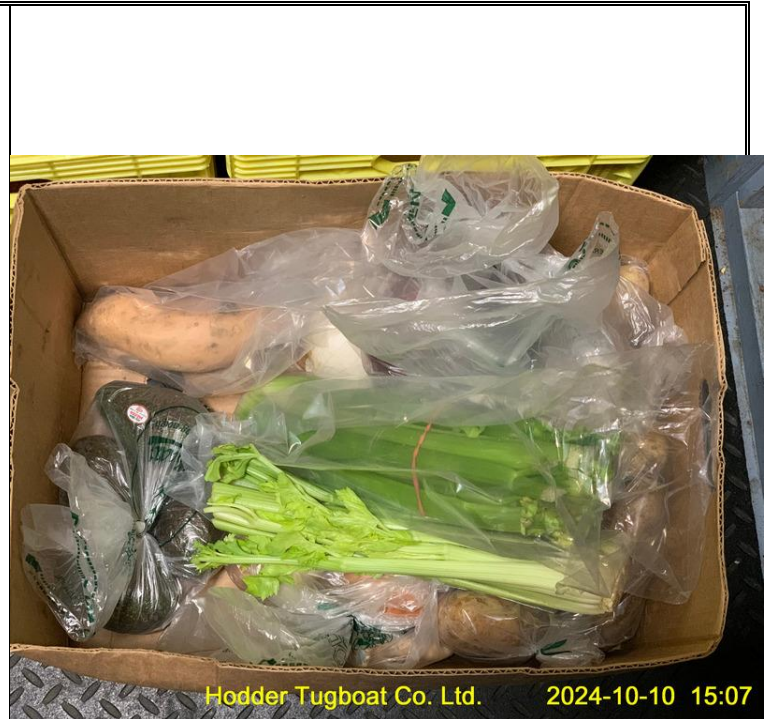
General view of the food storage area

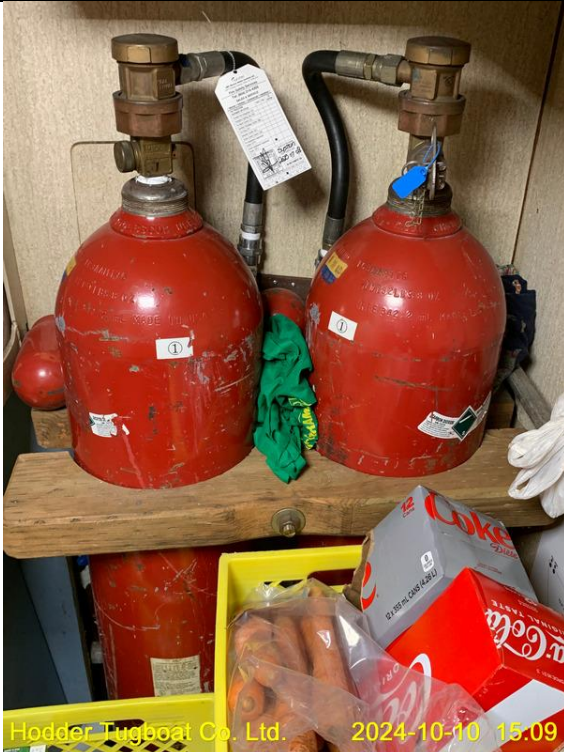
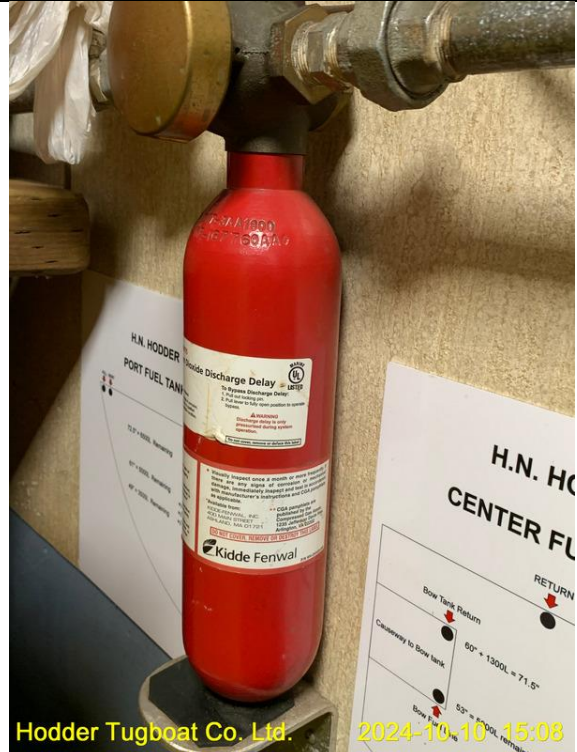
CO₂ firefighting system

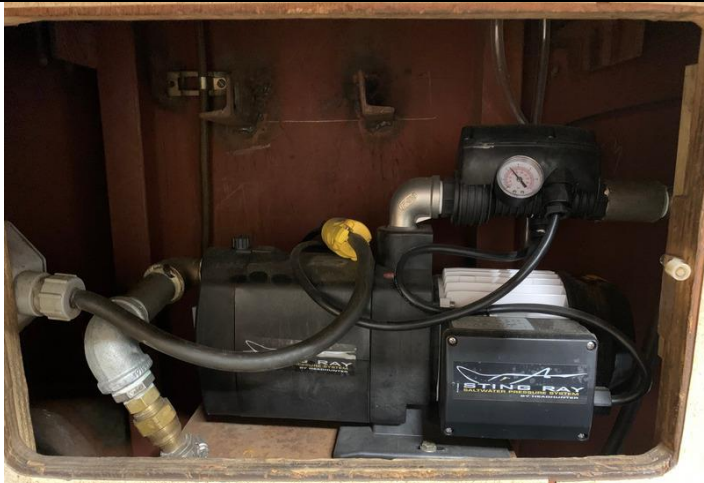
Water pressure pump

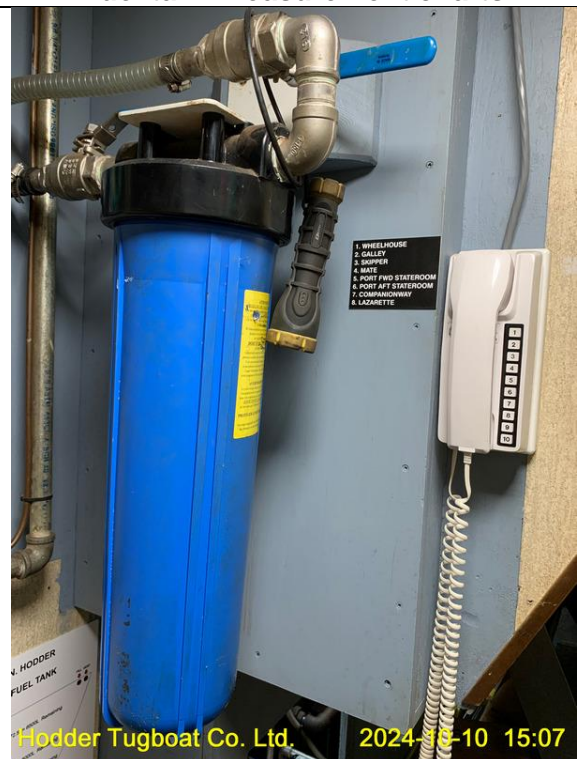
Water filtration unit and intercom phone

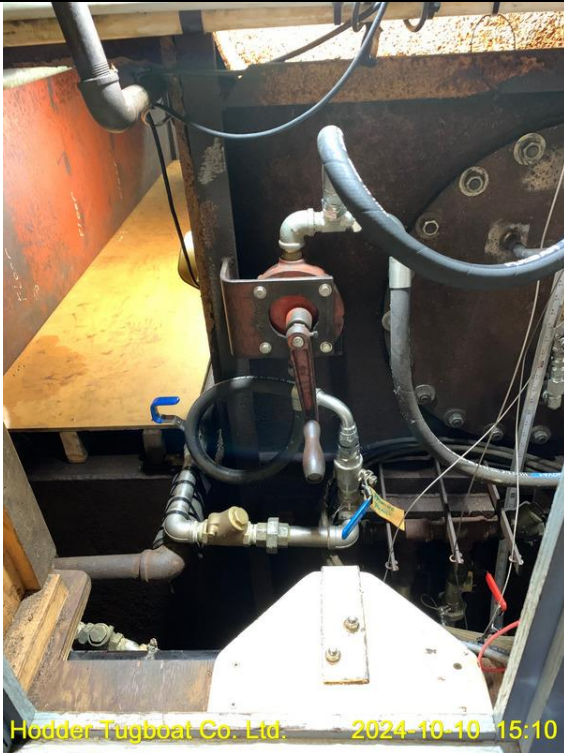
Fluid management and pumping system
