VESSEL GENERAL CONDITION INSPECTION REPORT

Tug boat "H.N. HODDER"

Address of inspection: 16031 River Road, Richmond,
B.C. Canada V6V 1X5
Date of inspection: October 10-th, Oct.13-th 2024
Time of inspection: 12:50 – 4:00 PM, 9:30-11:30 AM
CUSTOMER: Hodder Tugboats CO. LTD.

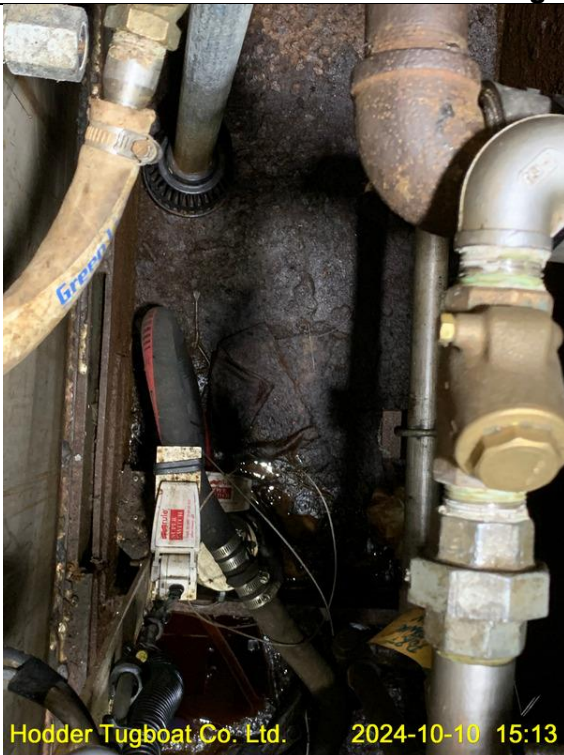
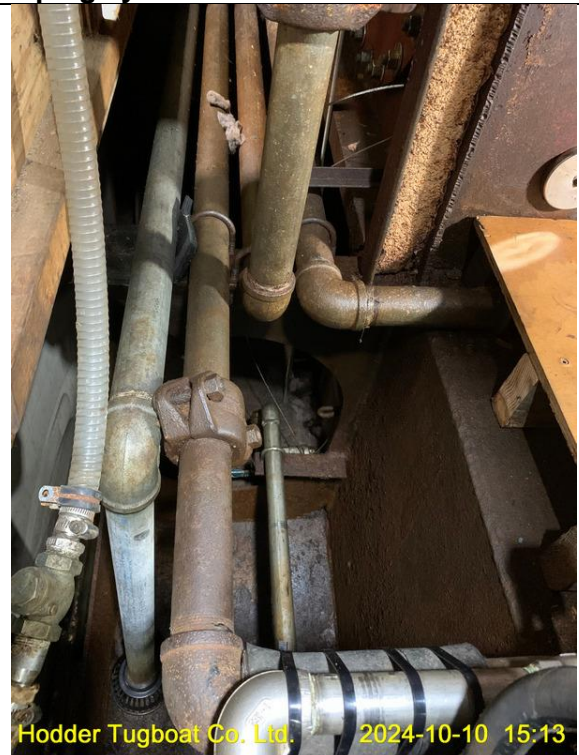
Oil transfer/ water piping system

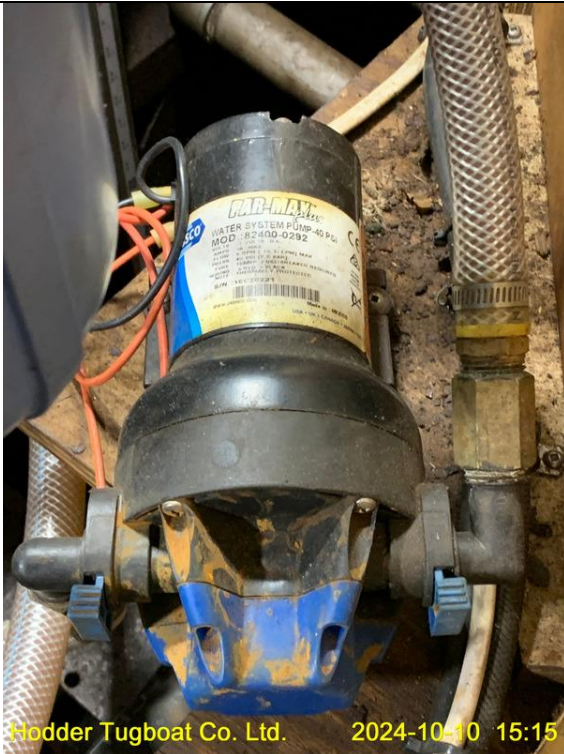
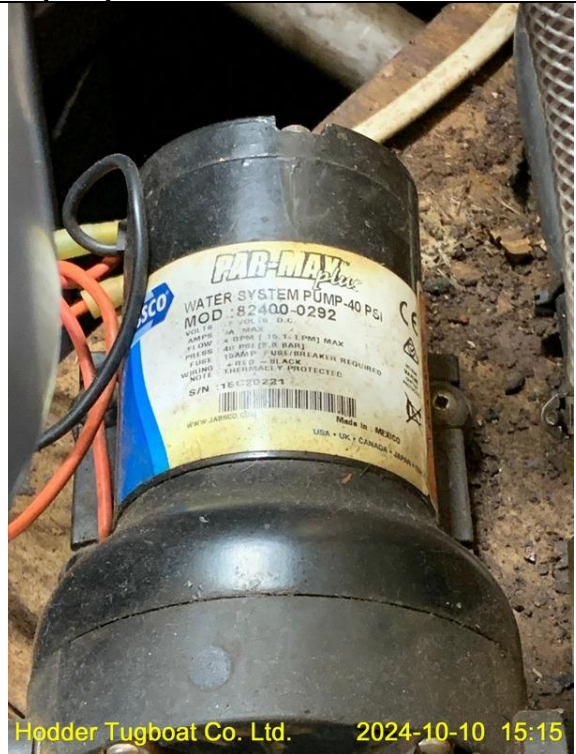
Water system pump

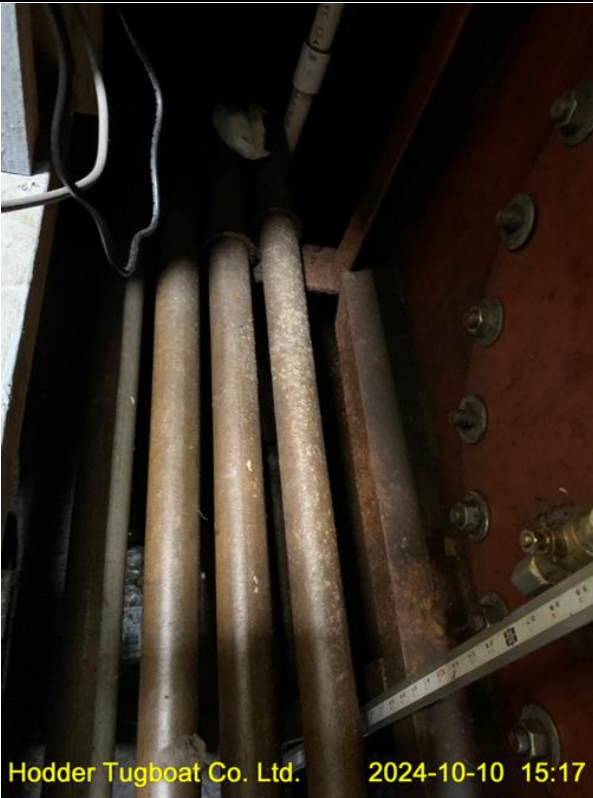
Fluid transfer systems

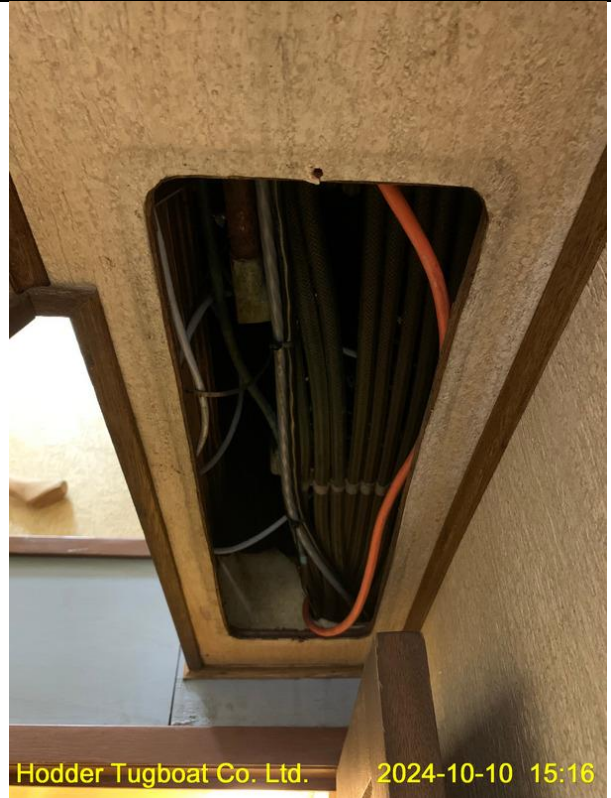
Overhead cable routing

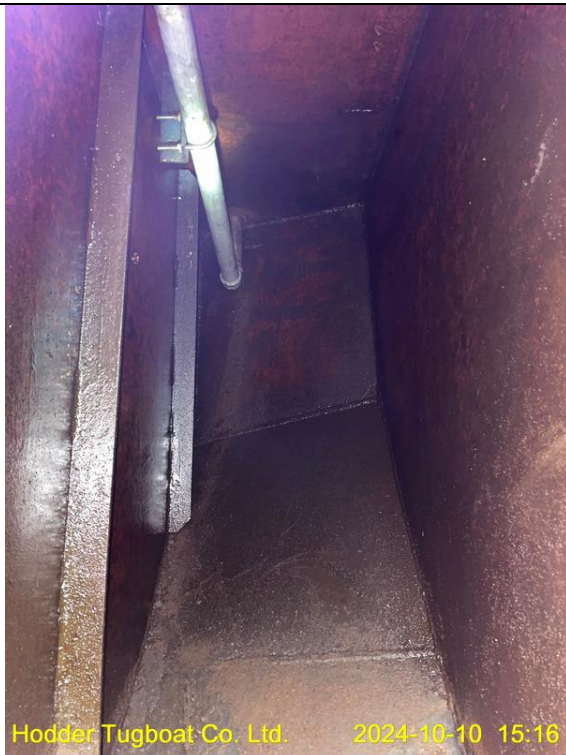
Cofferdam, fluid transfer systems

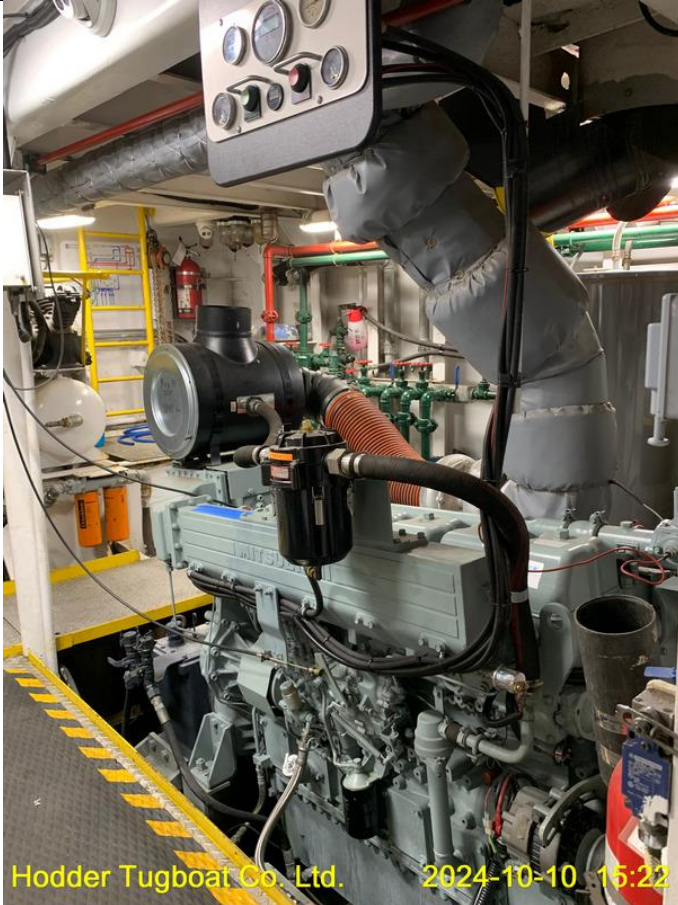
Engine room, view from entrance door

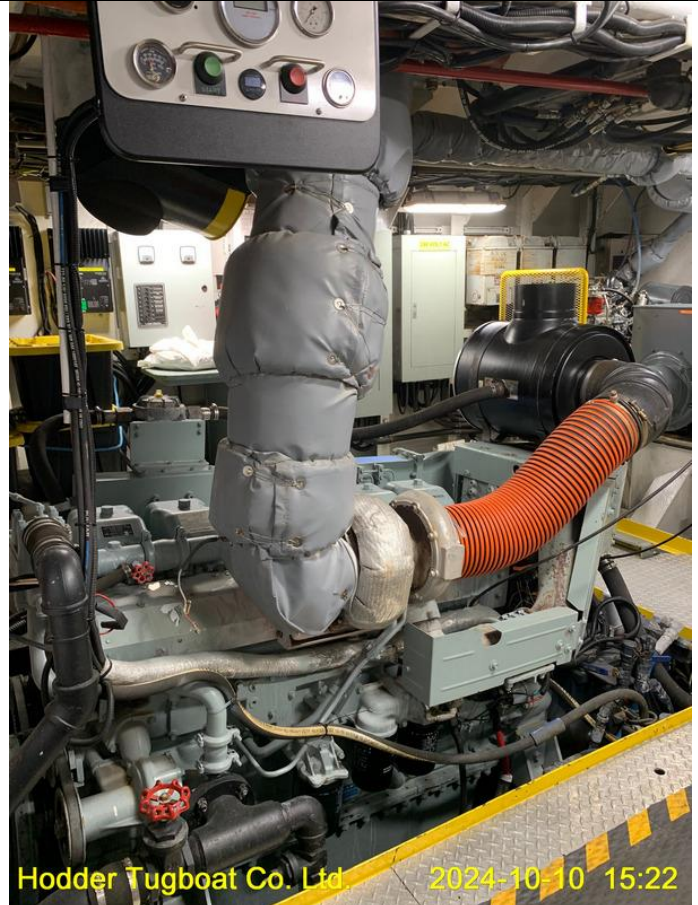
Port side main engine (ME)

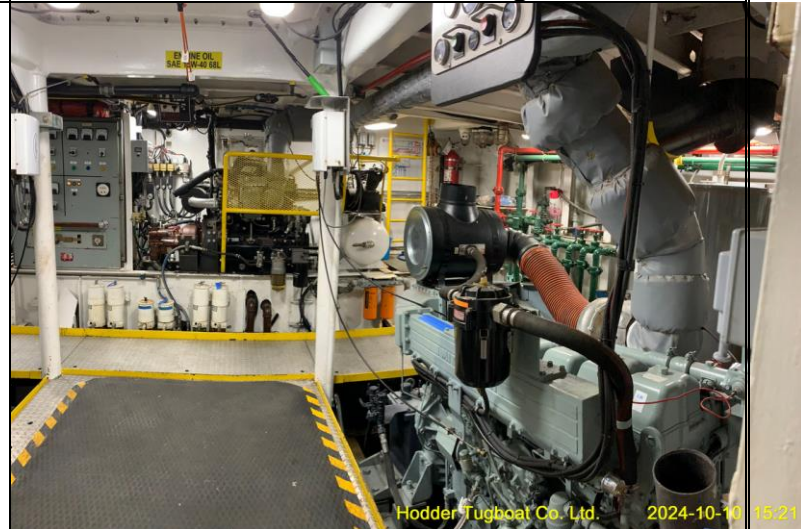
Starboard side main engine

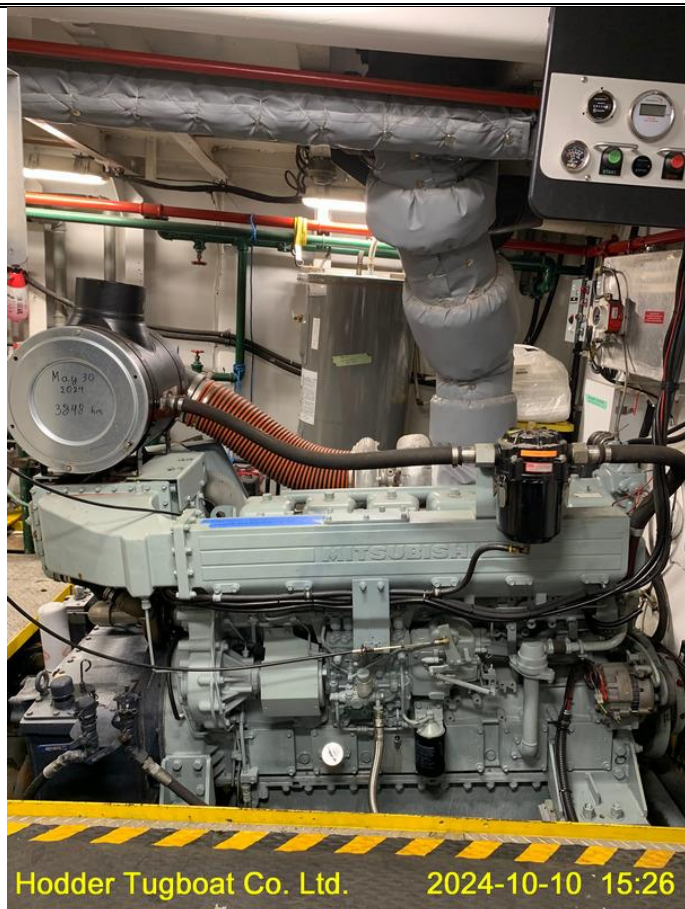
General view of both ME of the engine room

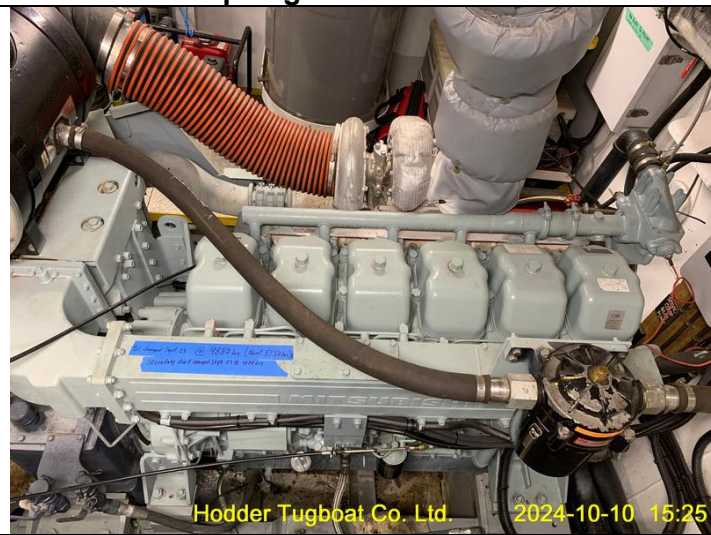
Engine fluid pipes and engine foundation view

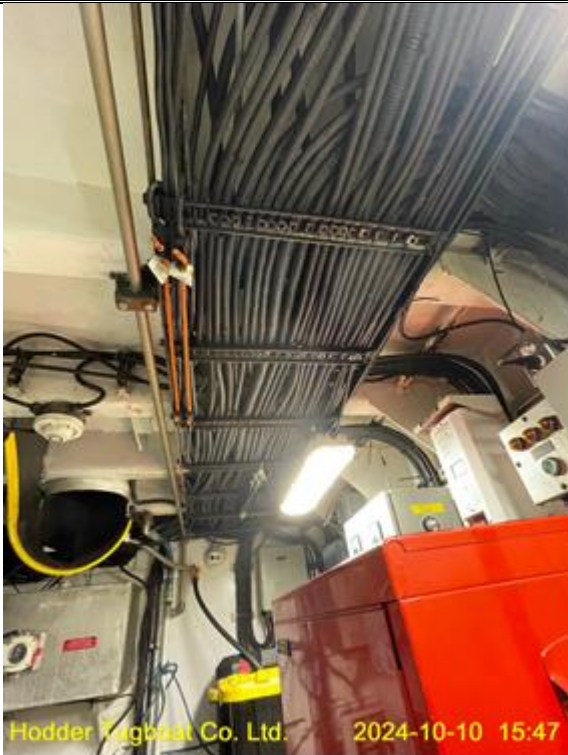
Organized bundles of electrical cables

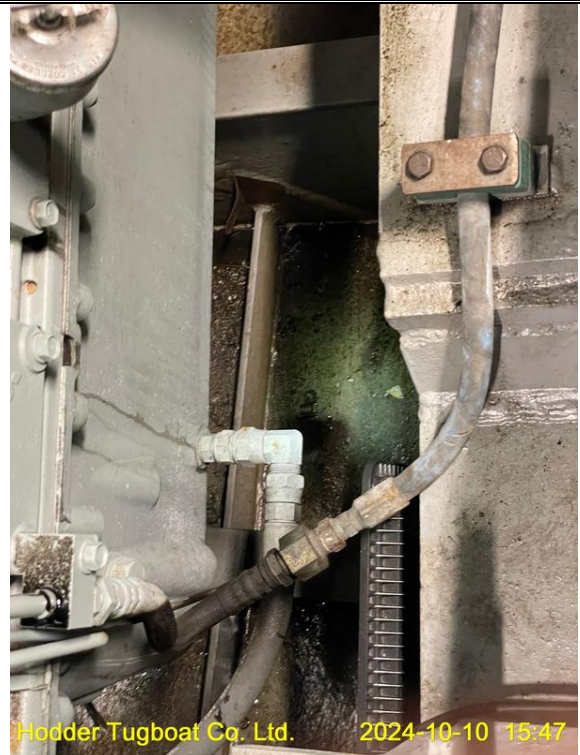
Bilge area, underneath the main engine

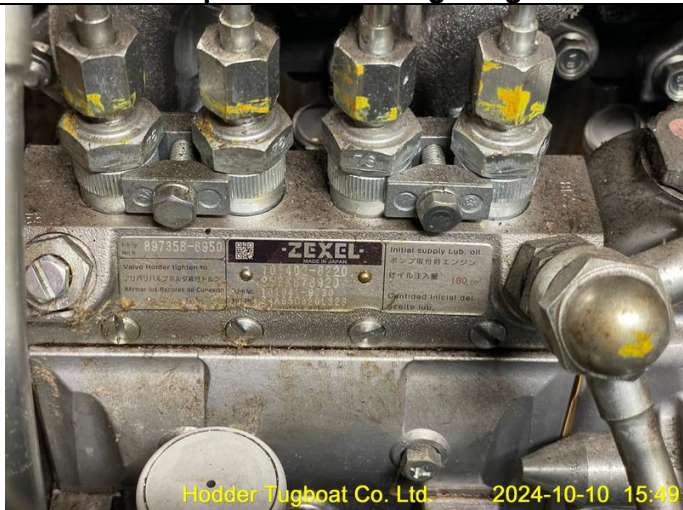
Zexel fuel pump

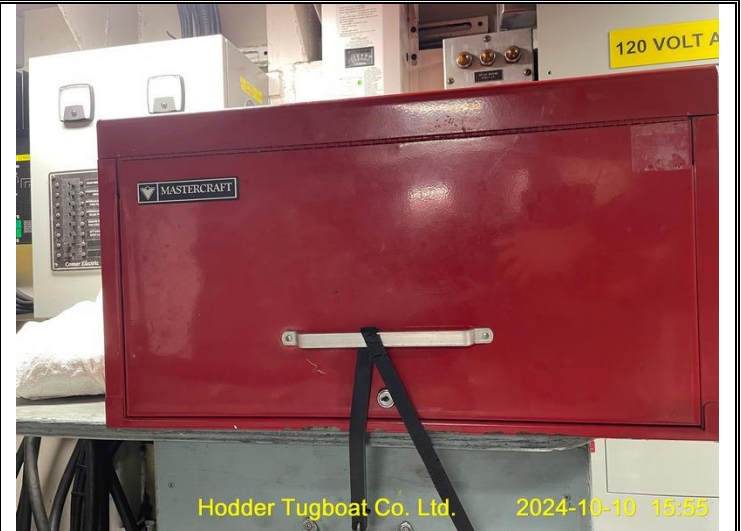
Mastercraft work tools box

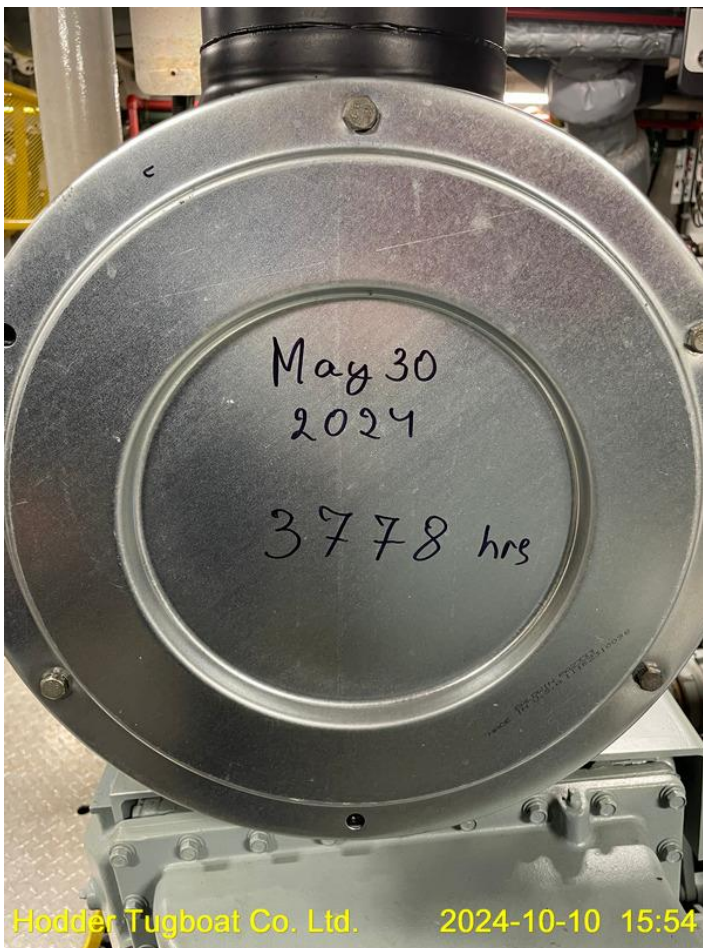
ME's inlet air filter

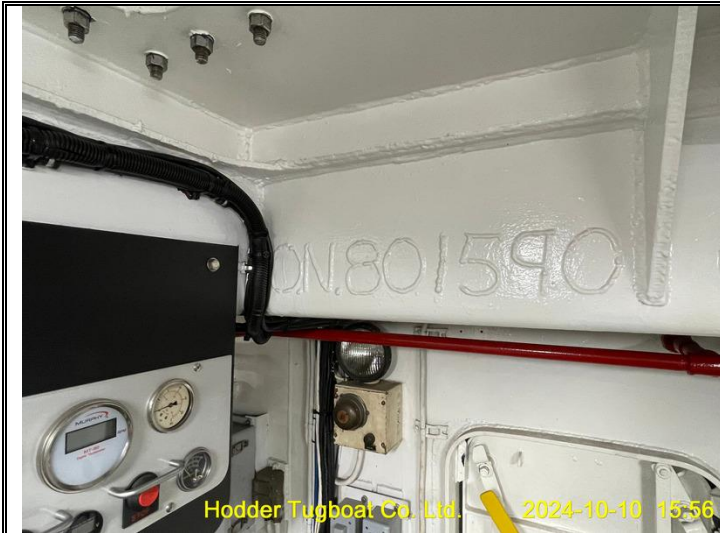
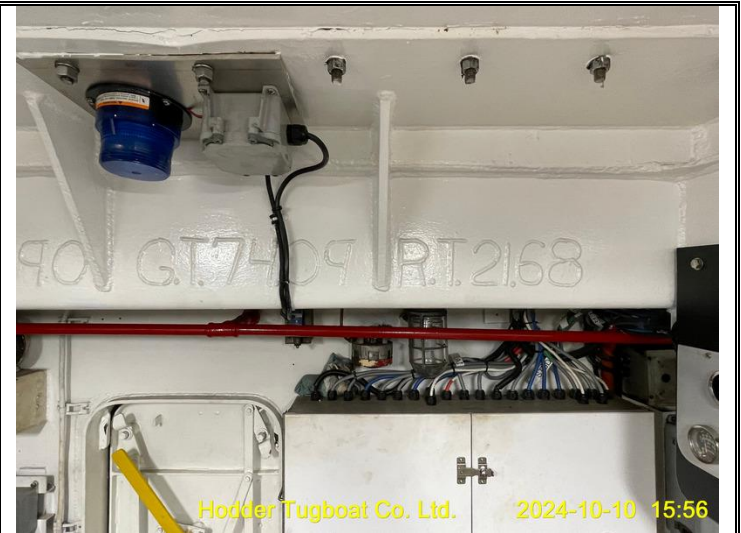
Boat's hull number, gross tonnage

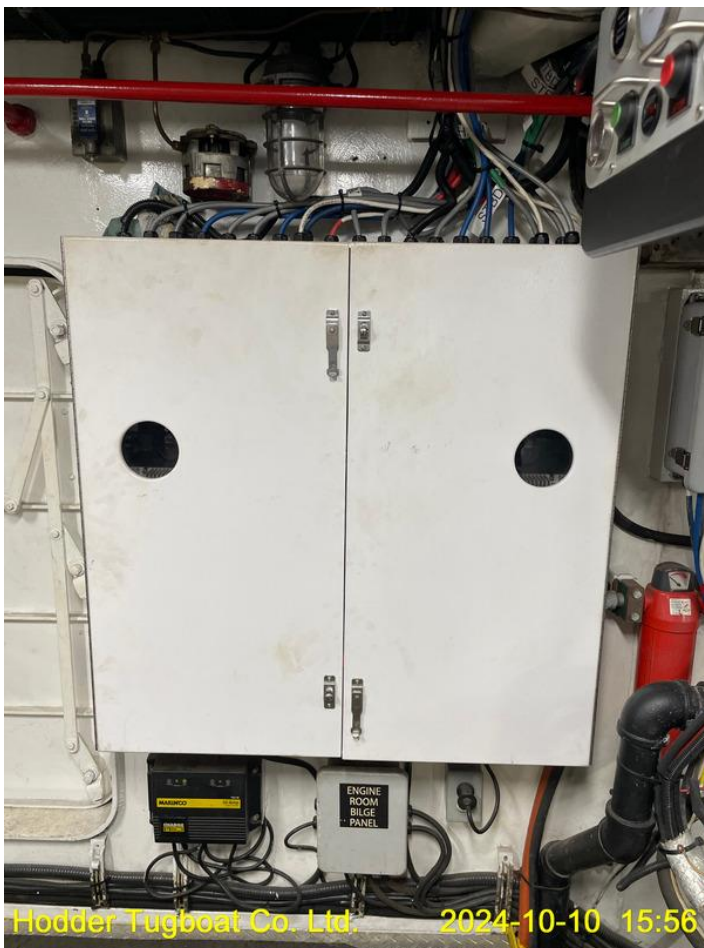
Main electrical panel

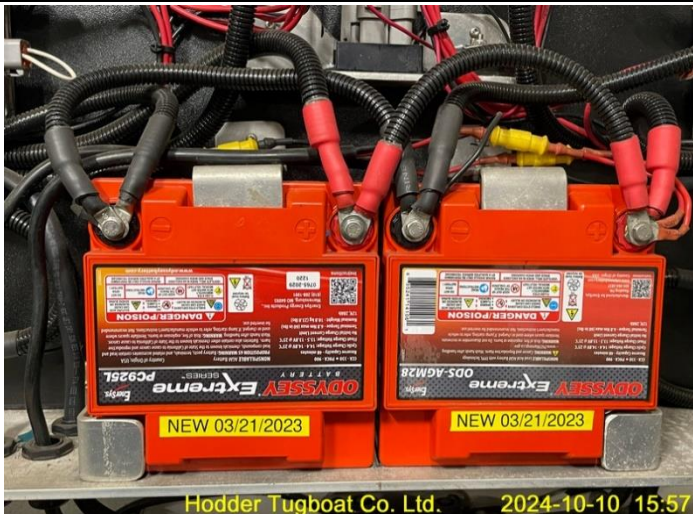
Batteries

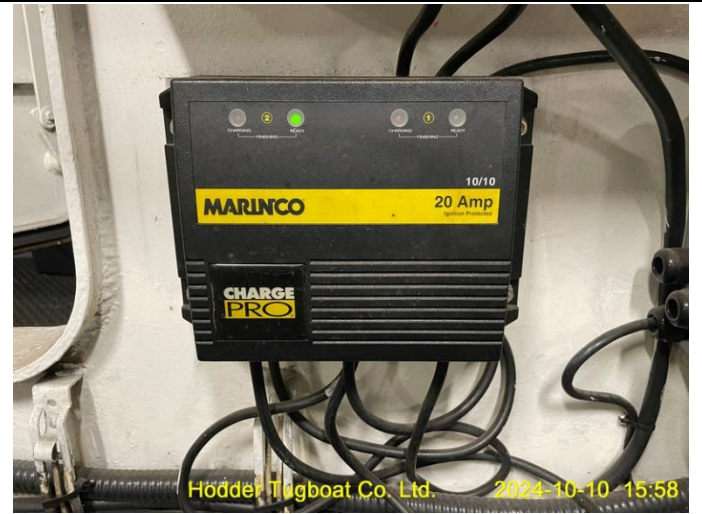
Marine battery charger

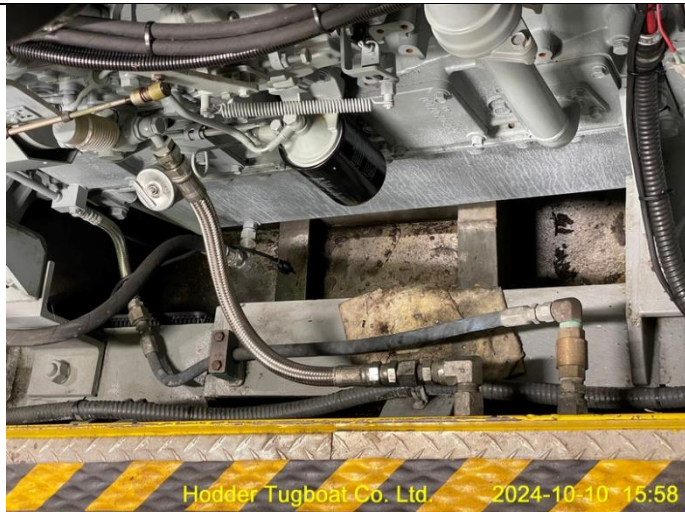
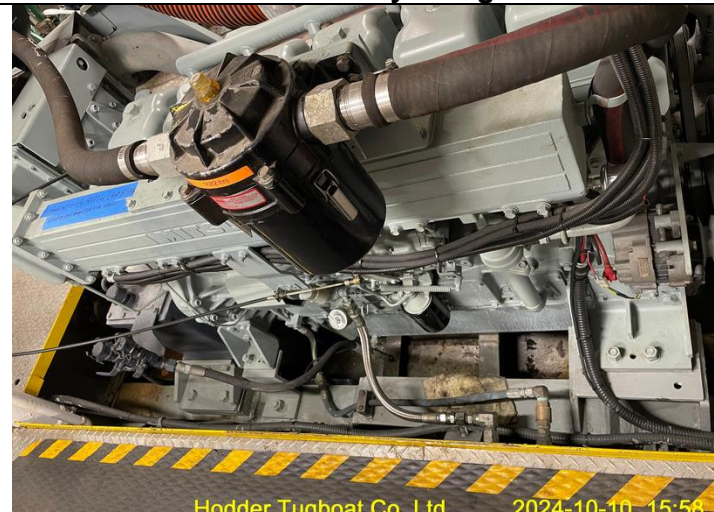
Engine side views

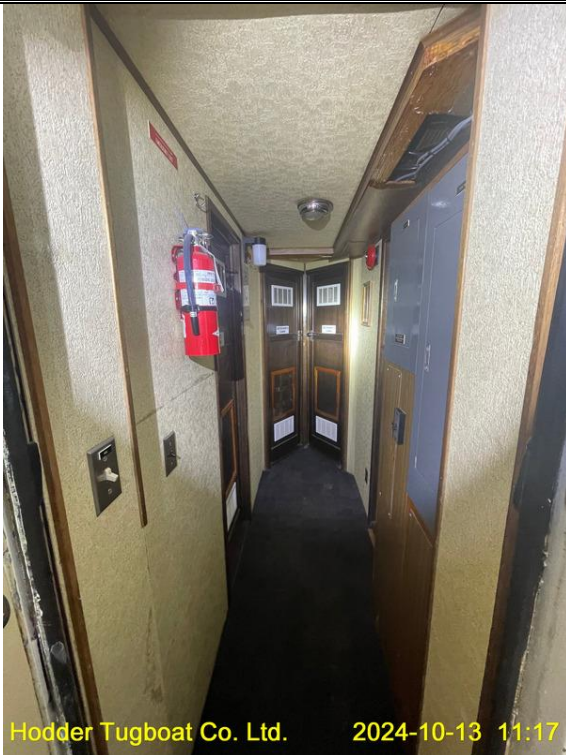
Sleeping crew cabins hallway

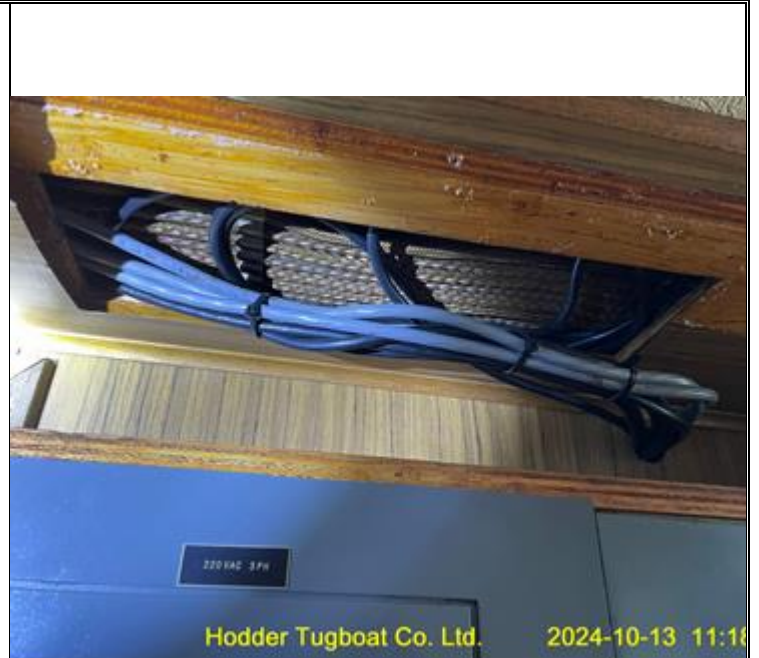
Cabin's electrical cable routing system

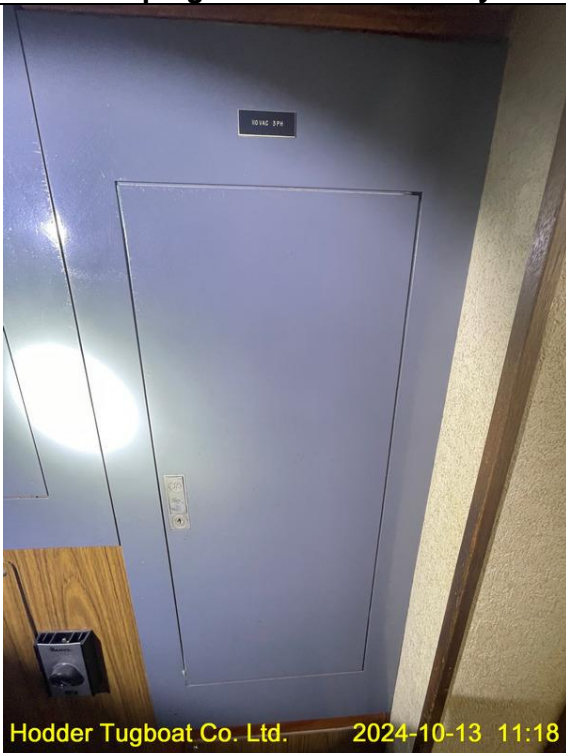
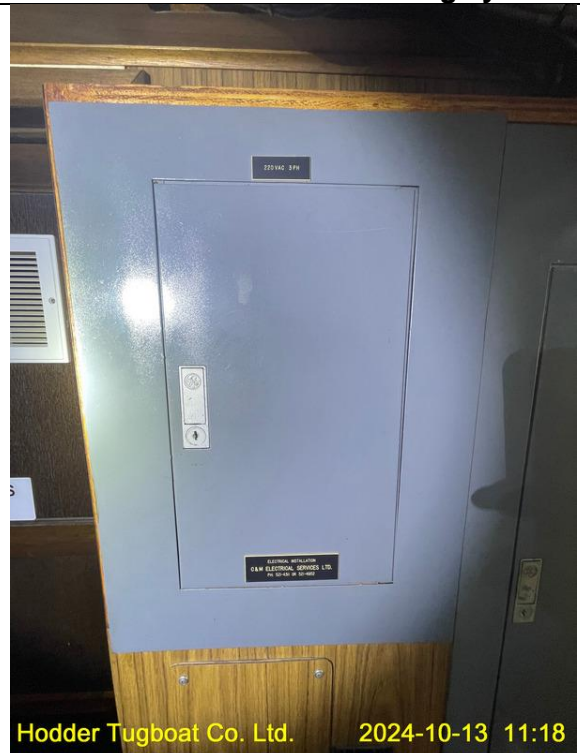
Electrical panels/switchboard in the cabins

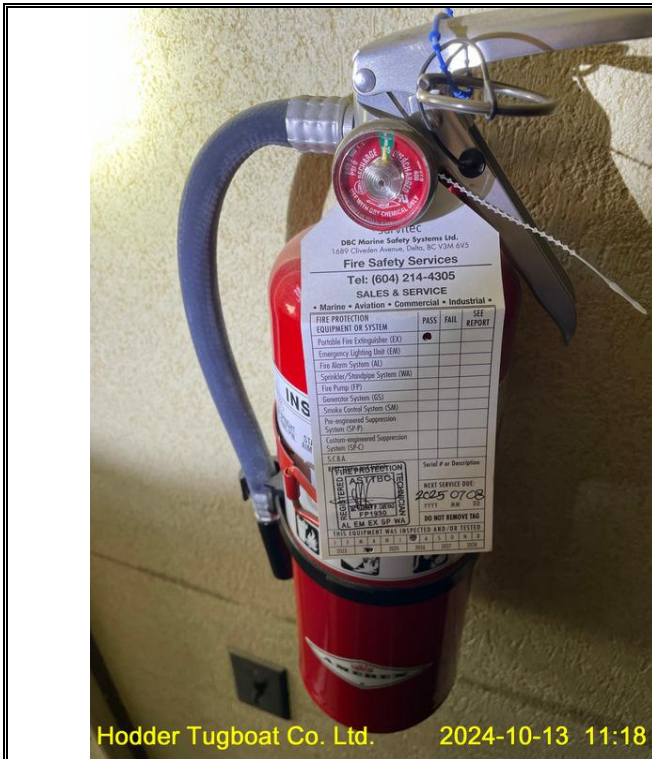
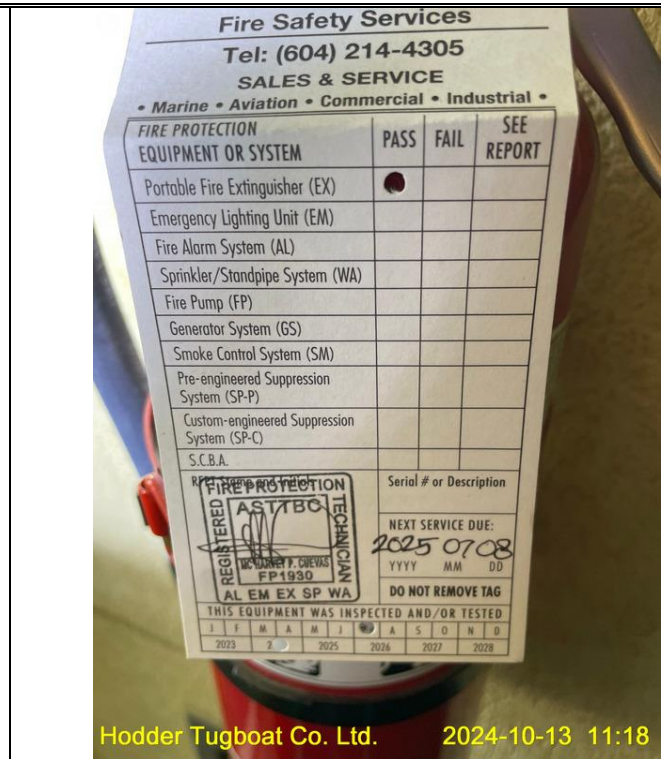
Fire extinguisher in the crew cabin

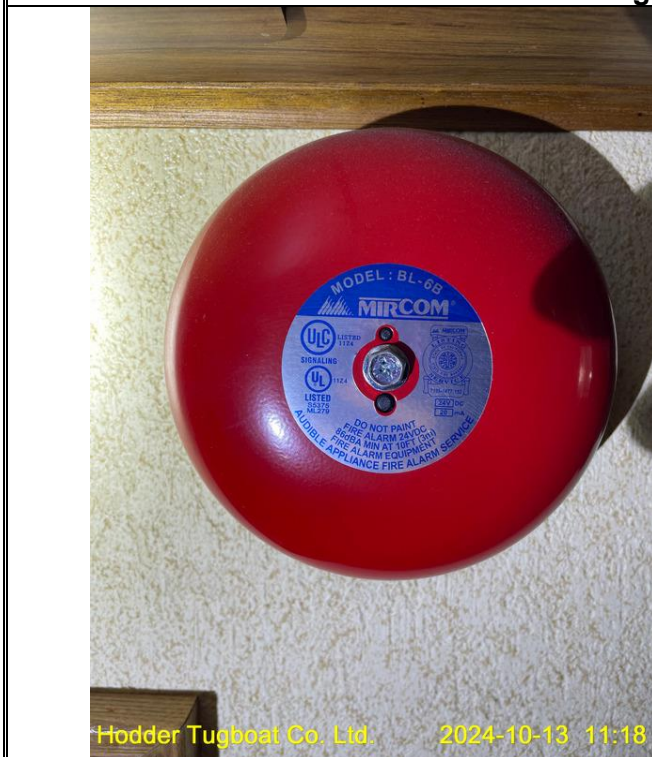
Alarm bell and light
